INSPECTION REPORT

For the Property at:
712 WISTERIA LANE
METAIRIE, LA 70003

Prepared for: JOHN JONES
Inspection Date: Friday, July 6, 2018
Prepared by: Jason Pepitone and Matthew Del Buono

RE: Report No. 8116, v.3
712 Wisteria Lane
Metairie, LA
70003

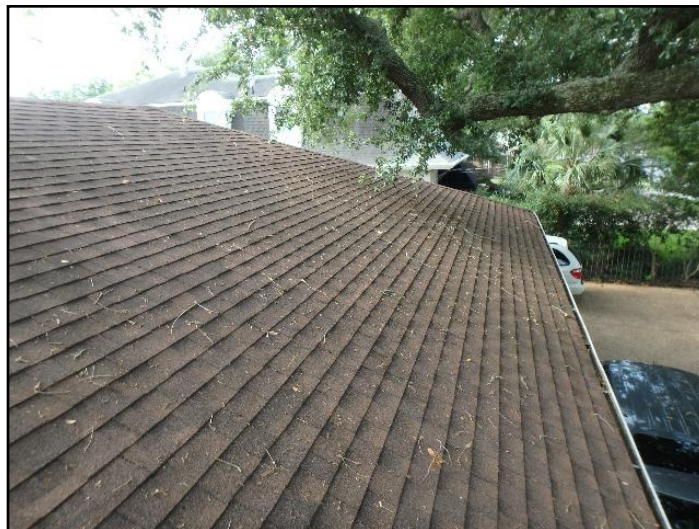
Condition: • Debris build-up on roof

Location: Front Roof

Debris build-up on roof

Task: Remove.

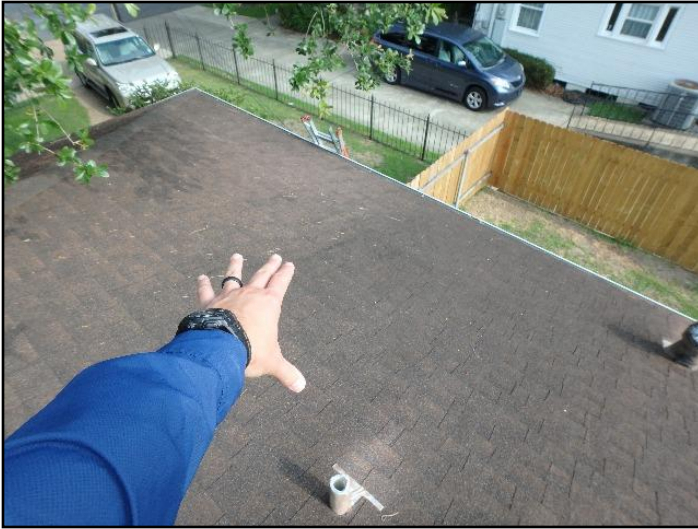
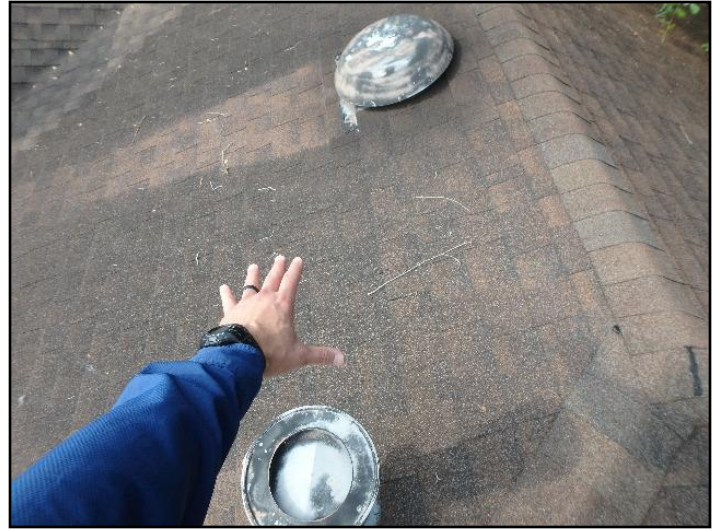
Condition: • Surface stain or biological growth

Surface stain or biological growth

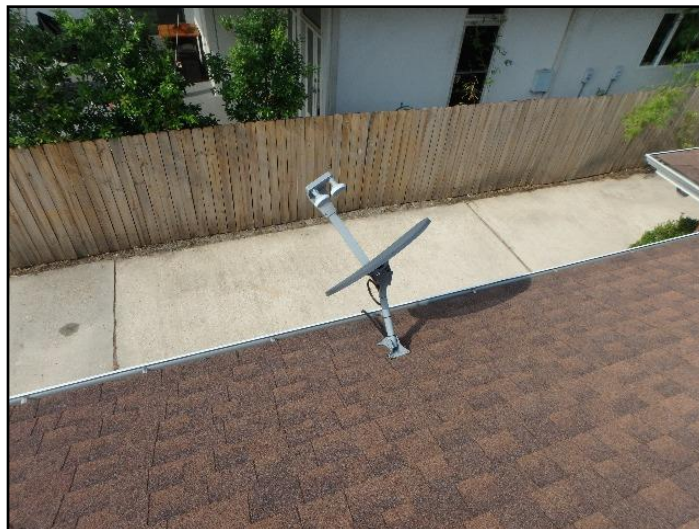
Condition: • [Satellite TV dish attached to roof covering](#)

These dishes, when attached directly to the roof, are a potential area for leakage or for damage during high winds. It is preferred to attach these to the exterior wall or fascia, or to a pole, where the possibility for damage is reduced.

Location: Back Right Side Roof

Satellite TV dish attached to roof covering

Task: Remove if not in use. Improve location if possible. Monitor for leakage or damage.

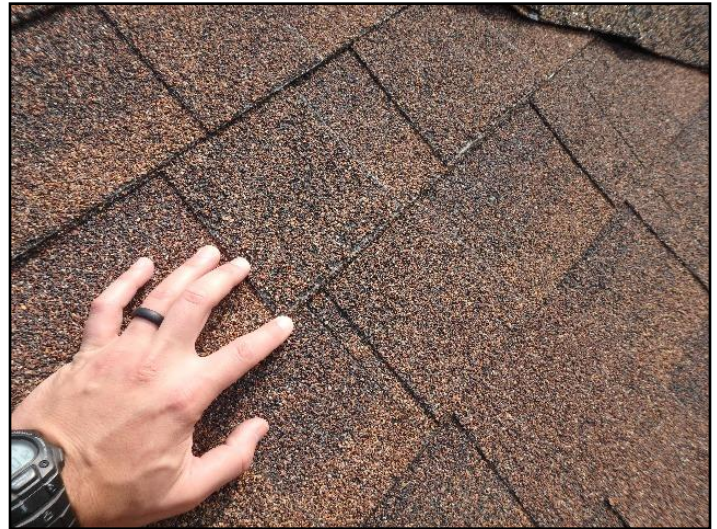
Condition: • [Granule loss](#)

Minor granule loss was noted on the asphalt shingle roof covering. This is typical for a roof covering of this age and should be monitored.

Granule loss

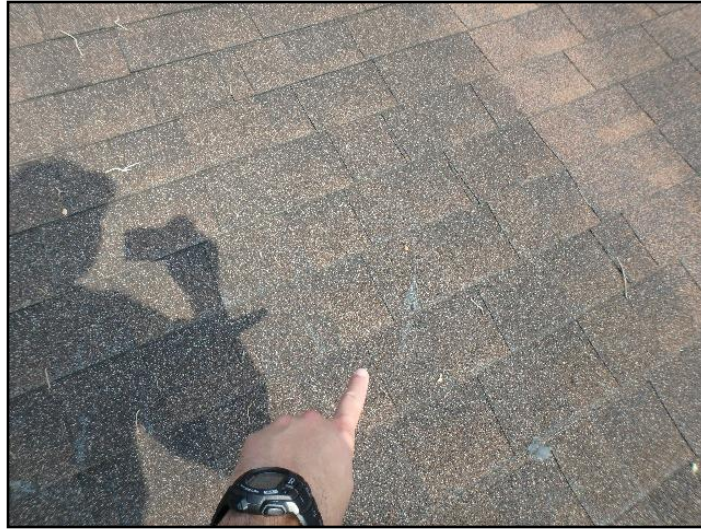
Condition: • [Missing, loose or torn](#)

Missing, loose or torn

Task: Repair or replace as needed.

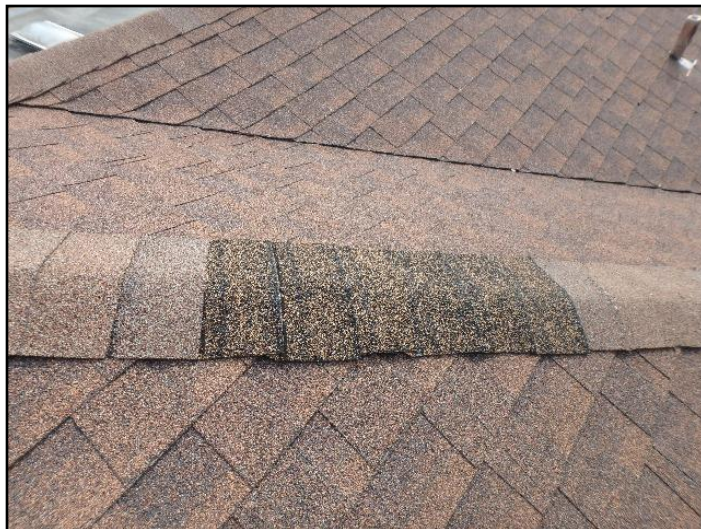
Condition: • [Patched](#)

Location: Rear Roof

Patched

Task: Prior repairs should be periodically monitored.

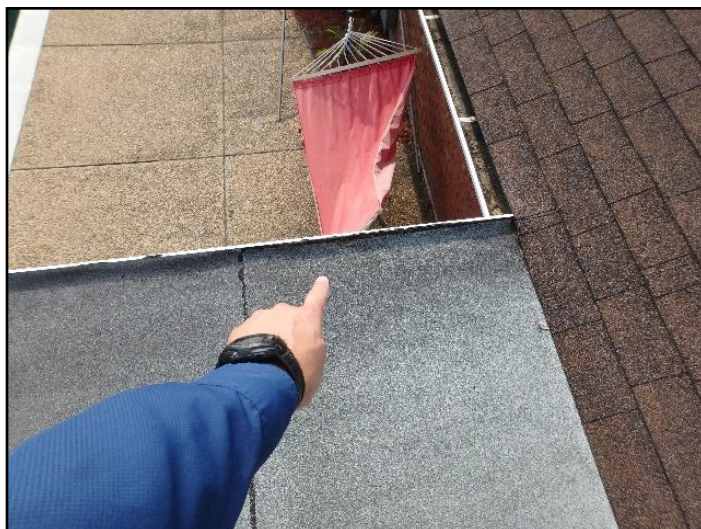
Condition: • [Openings at seams or flashings](#)

Openings at seams or flashings

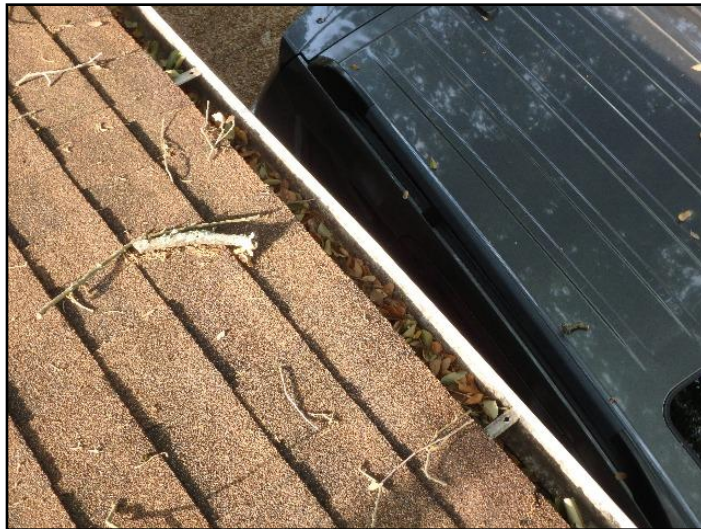
Condition: • [Clogged](#)

Clogged

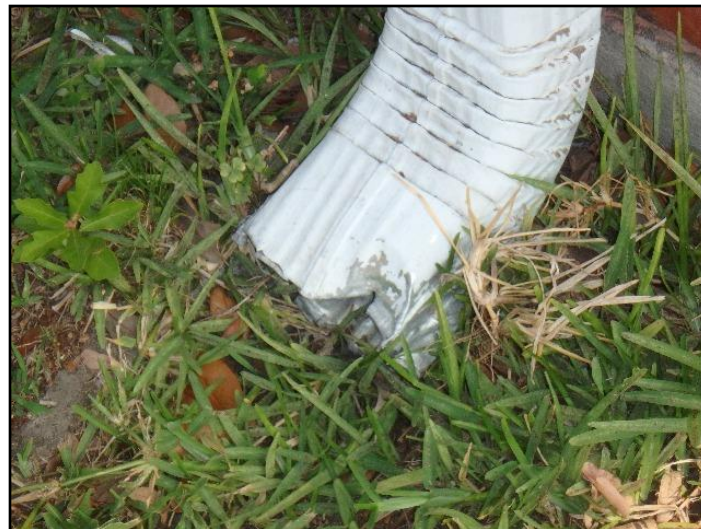
Condition: • [Damage](#)

Damage

Task: Repair or replace.

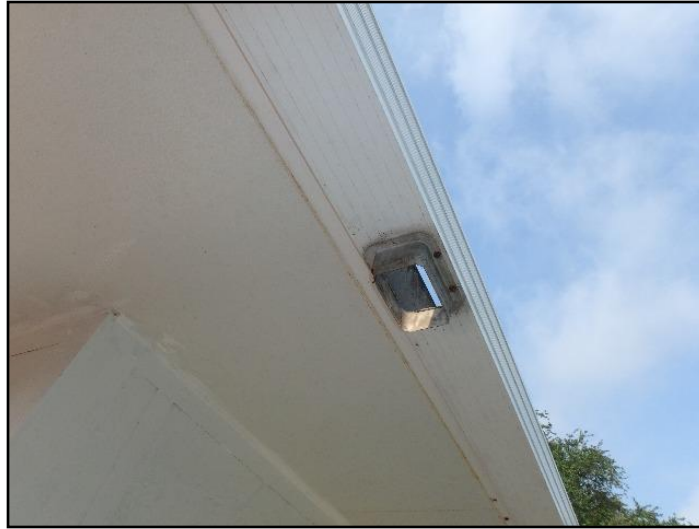
Condition: • [Missing](#)

Missing

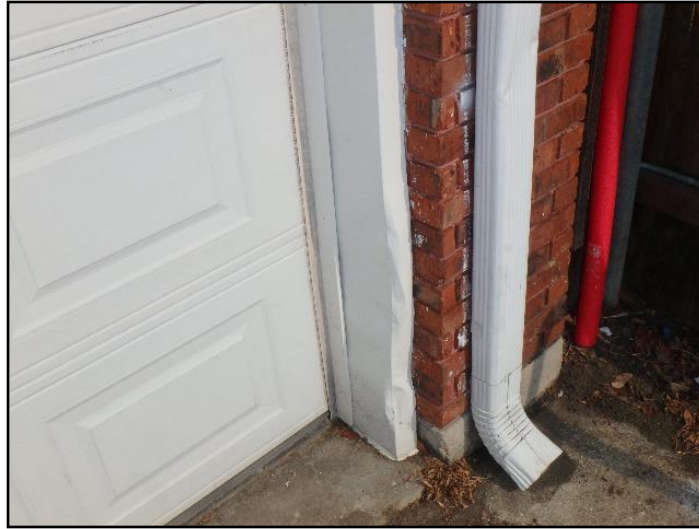
Condition: • Damaged trim.

Damage

Task: Repair or replace.

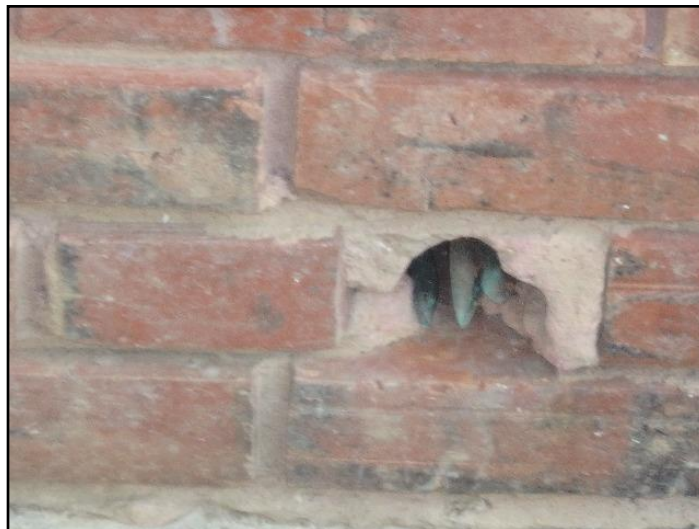
Condition: • Holes or openings

Location: Various Right Side Exterior

Holes or openings

Task: Seal openings

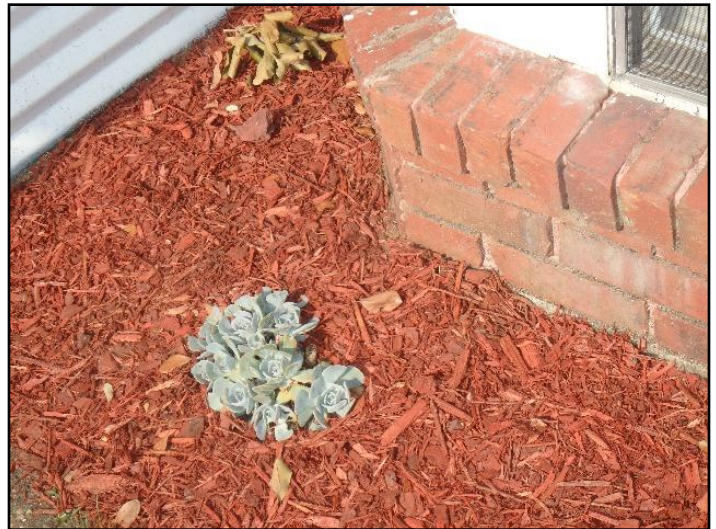
Condition: • [Too close to grade](#)

Too close to grade

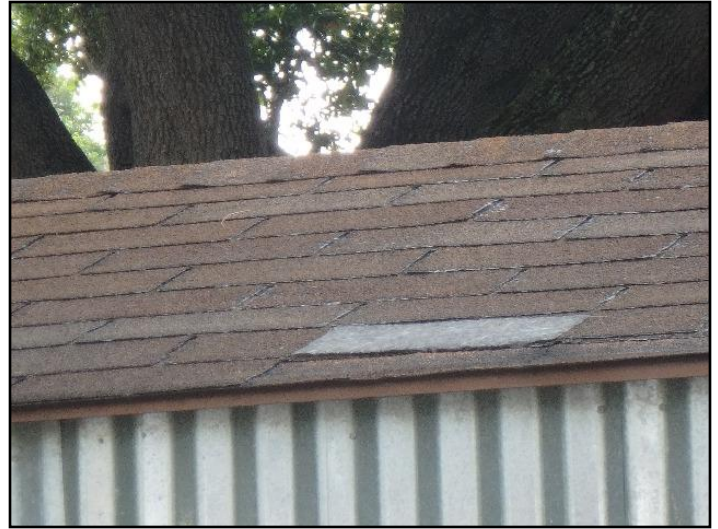
Condition: • Rear shed issues

The rear shed had water damage to the door and siding, and an aging roof.

Rear shed issues

Task: Repair or replace.

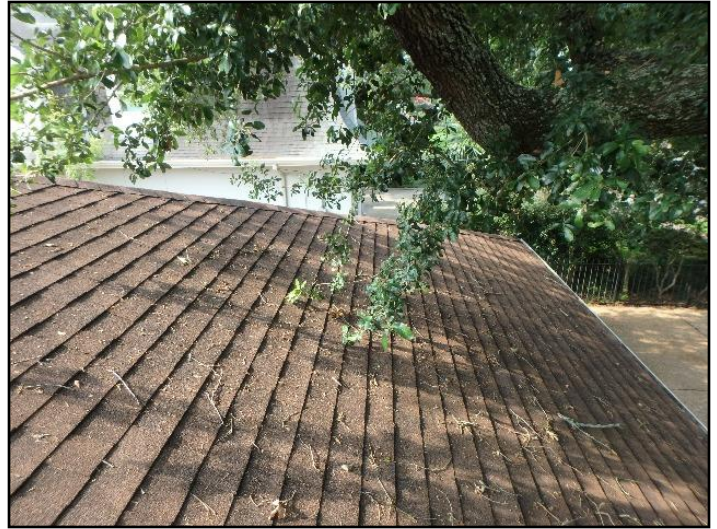
Condition: • [Trees or shrubs too close to building](#)

Location: Right Side Exterior/ Front Roof

Trees or shrubs too close to building

Task: Correct.

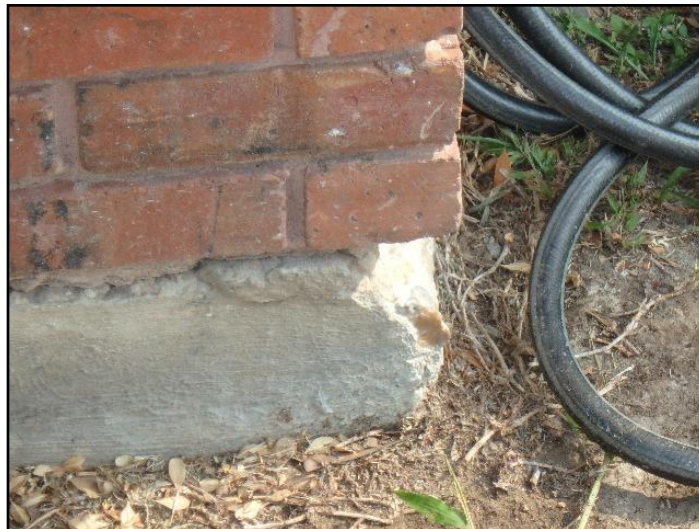
Condition: • Most slab-on-grade foundations will develop corner cracks or wedge cracks. These cracks develop as a result of the expansion of the brick veneer when it is warmed by the sun. When the temperature of the brick veneer rises, the brick veneer wall expands in length and pushes or slides against the slab surface. These cracks do not indicate anything unusual about the foundation. If the cracking at a corner becomes very bad, the concrete wedge may become loose and even fall off. Should the cracks spread over a significant distance, support for the brick veneer may be compromised and a patch or repair is recommended. This is a concrete repair and not a foundation repair.

Location: Rear Right Side Exterior

Task: Monitor.

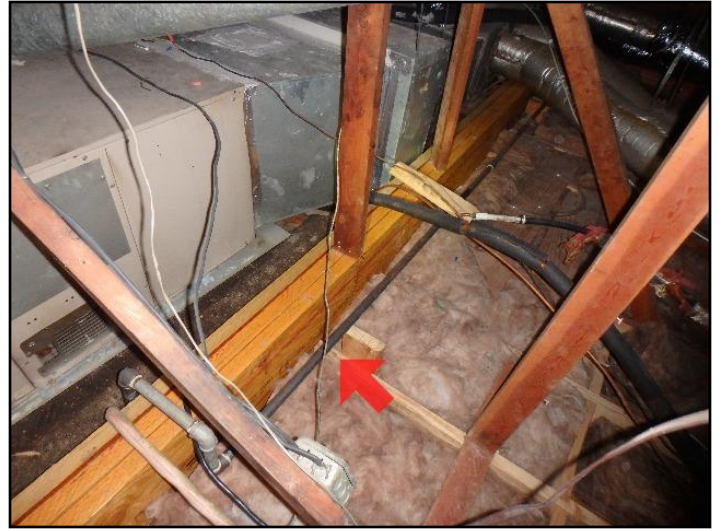
Condition: • It appeared that a load bearing wall was removed in the living area below and was replaced by a beam in the attic space. This modification appeared to be adequate, but it should be monitored.

Monitor

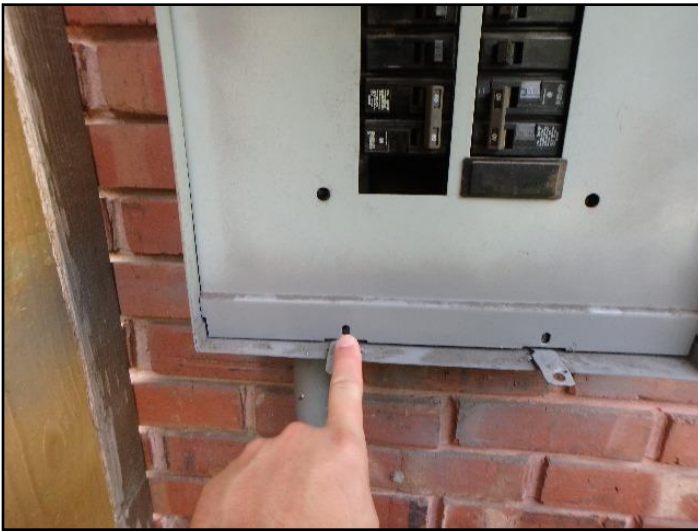
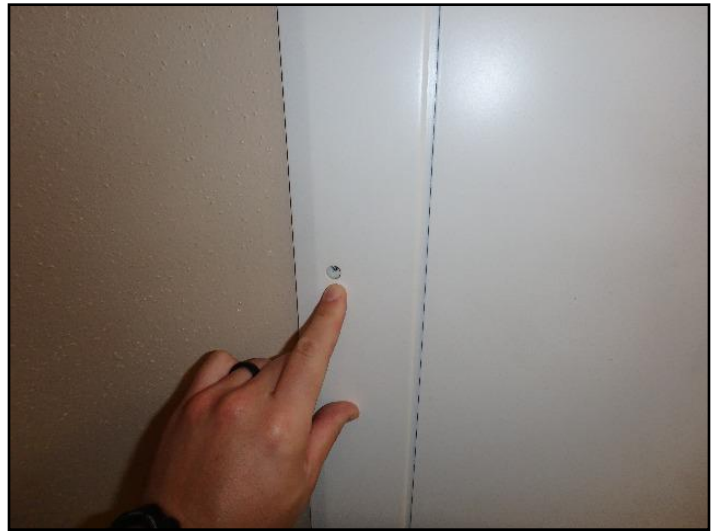
Condition: • Loose panel cover. Screws missing.

Location: Left Side Exterior and Laundry Area

Loose panel cover. Screws missing.

Task: Provide or install.

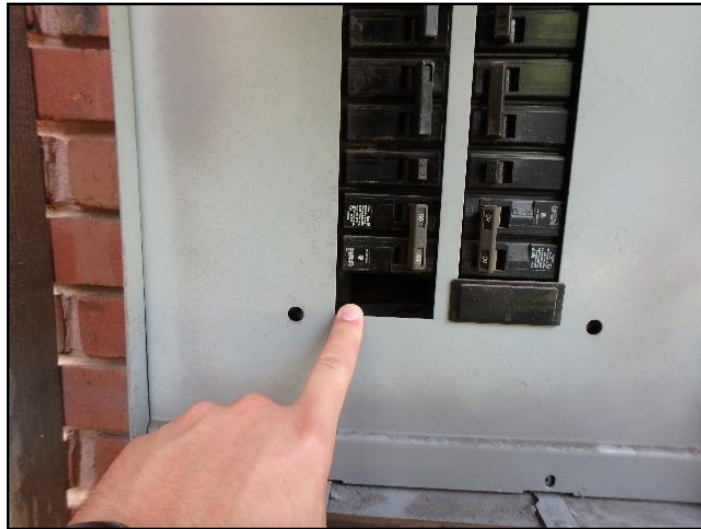
Condition: • Openings in panel: There should be no openings in the panel that allow someone to reach in and touch a live electrical component. This may occur where the panel has room for more circuits, or where a break block has no breaker. Wherever this situation exists, the opening should be covered with appropriate insert. Any unprotected openings at the side or bottom of the panel should be blanked off.

Openings in panel: There should be no...

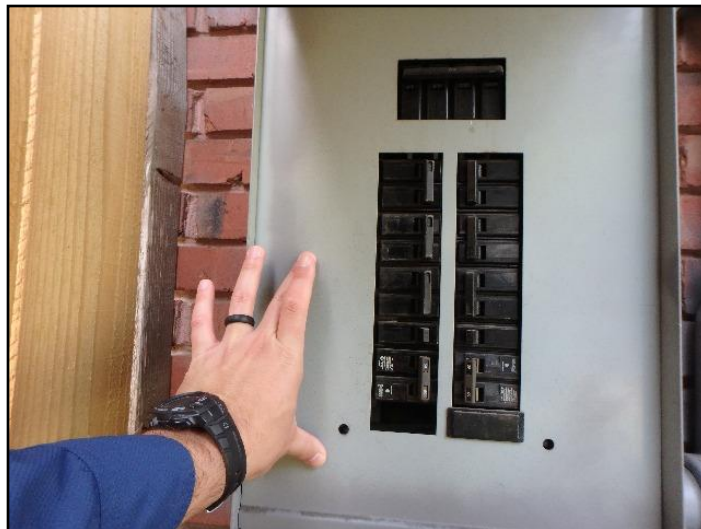
Condition: • [Circuits not labeled](#)

Location: Left Side Exterior

Circuits not labeled

Task: Label

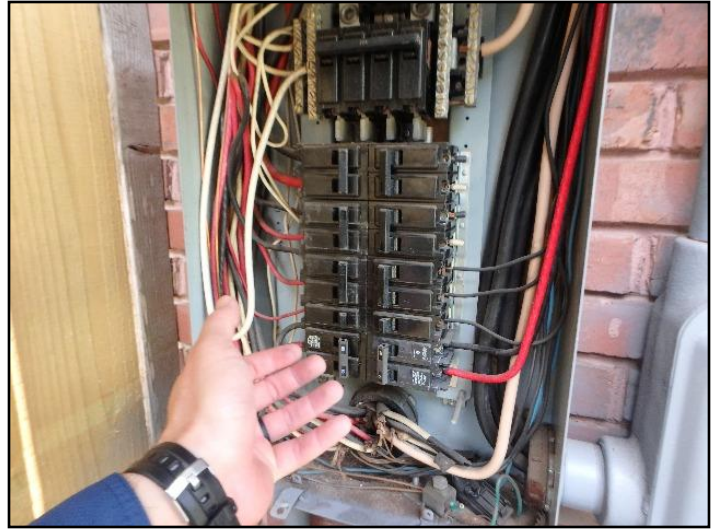
Condition: • [No Arc Fault Circuit Interrupter](#)

No Arc Fault Circuit Interrupter

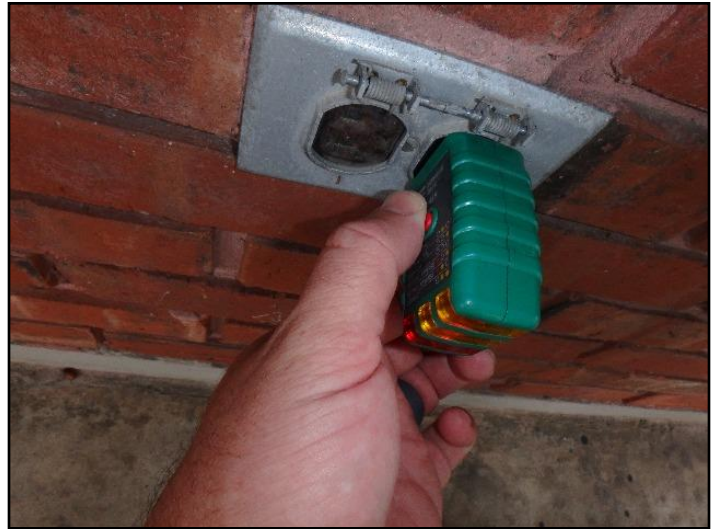
Condition: • [GFCI/GFI needed \(Ground Fault Circuit Interrupter\)](#)

For safety reasons, it is recommended that all countertop kitchen outlets, attic outlets, bathroom outlets, exterior outlets, and garage outlets be protected by a GFCI either at the panel or the outlet. Unable to determine if outlets were GFCI protected.

GFCI/GFI needed (Ground Fault Circuit...

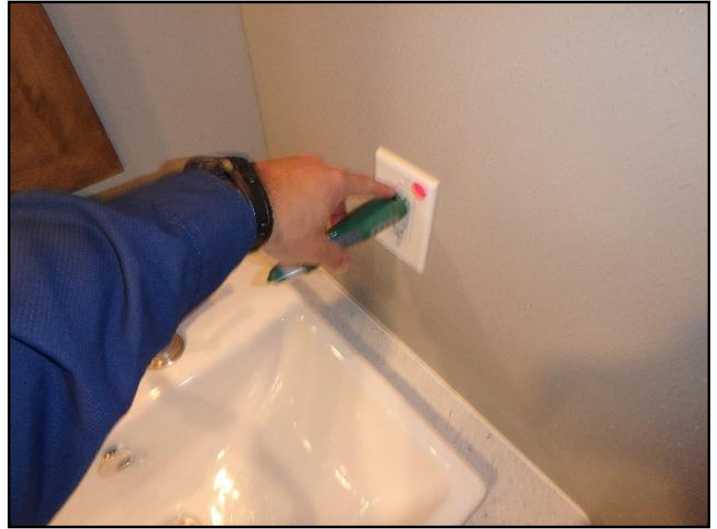
Condition: • [Test faulty on GFCI/GFI \(Ground Fault Circuit Interrupter\)](#)

Test faulty on GFCI/GFI (Ground Fault...

Task: Repair or replace.

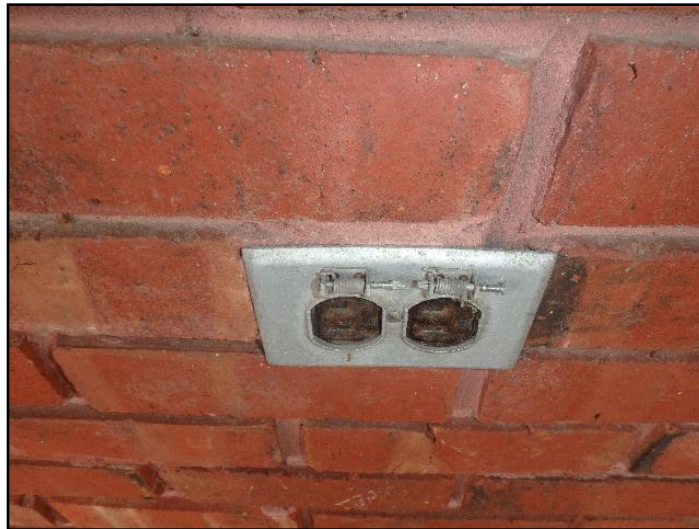
Condition: • [Missing](#)

Weather proof covers are recommended for exterior outlets.

Location: Front Exterior

Missing

Task: Replace.

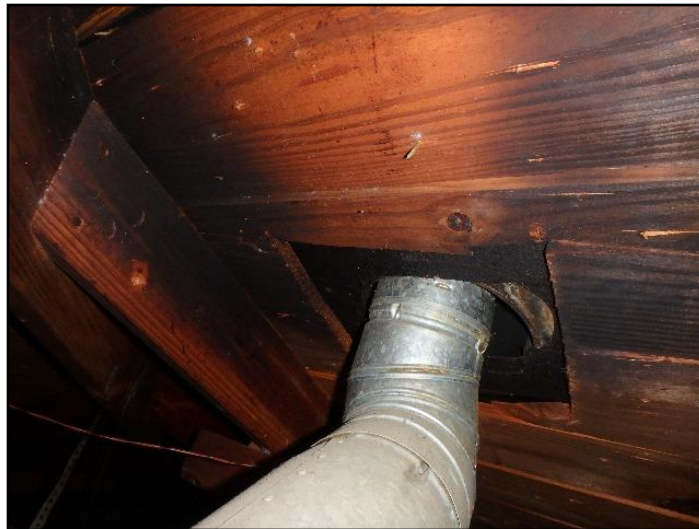
Condition: • Soot and minor charring was noted to the roof decking around the furnace exhaust. No visible signs of loose connections or leaks were noted, however, this could not be positively determined at the time of the inspection. This may have been from an old leak.

Location: Attic

Charring

Task: Further evaluation recommended.

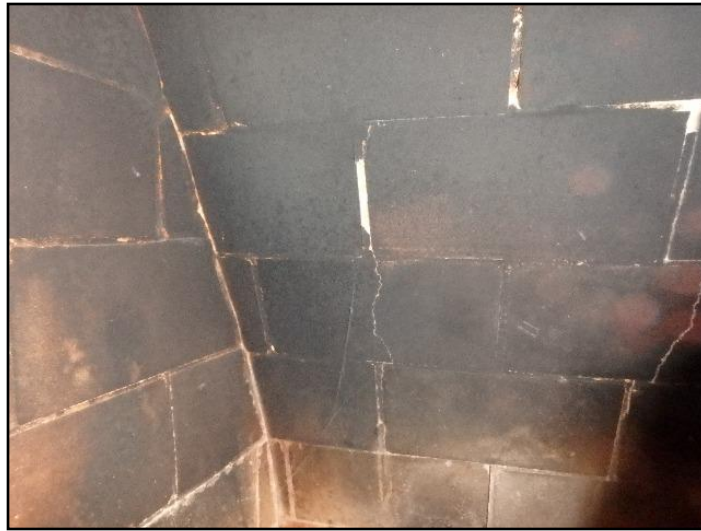
Condition: • [Creosote build-up](#)

Creosote build-up

Task: Service. Clean.

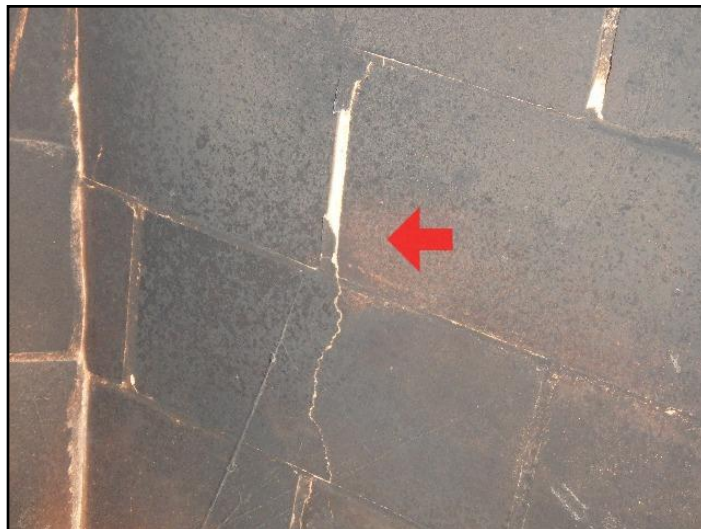
Condition: • [Cracked masonry or refractory](#)

Location: Living Room

Cracked masonry or refractory

Task: Repair or replace.

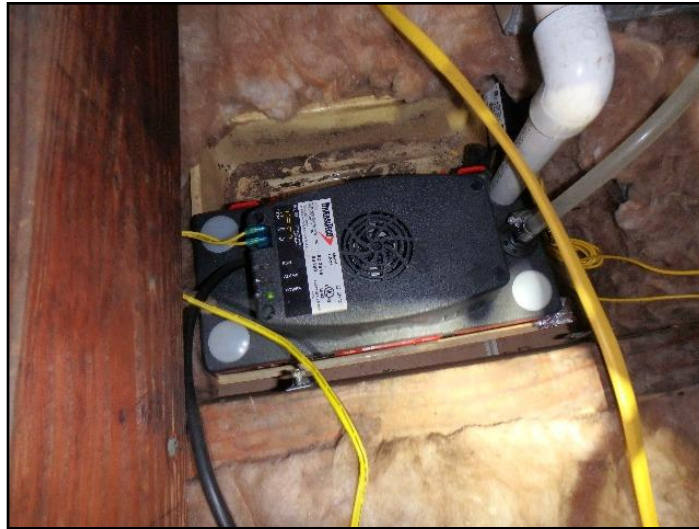
Condition: • Condensate pump (electric) noted.

Location: Attic

Condensate pump (electric) noted.

Task: Monitor. Maintain as needed.

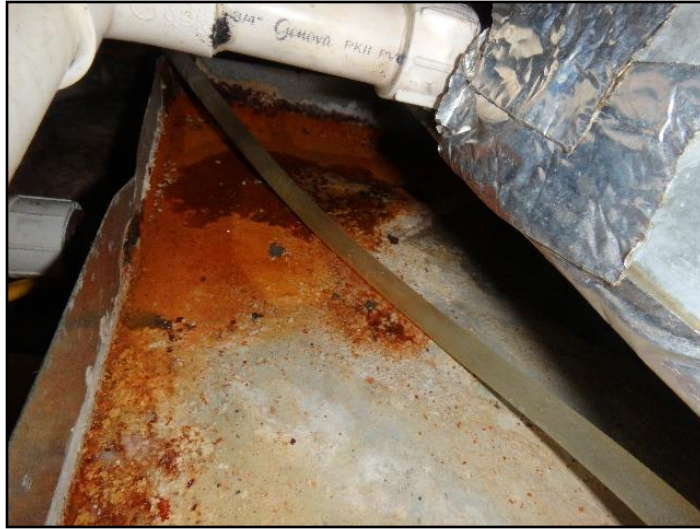
Condition: • [Rust or holes in pan](#)

Rust or holes in pan

Task: Replace.

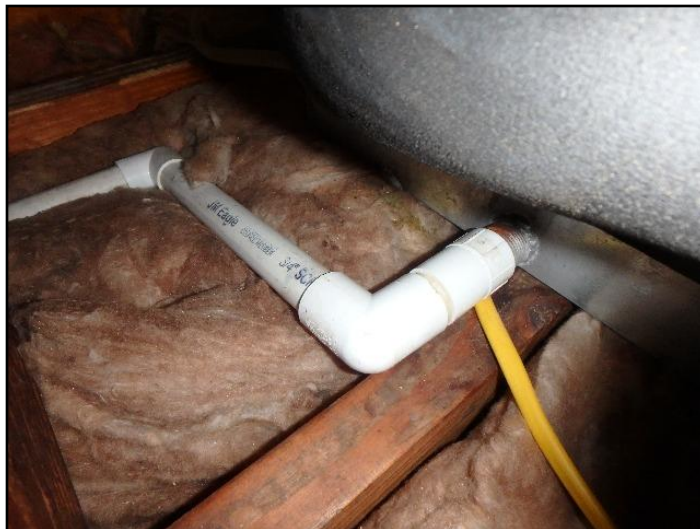
Condition: • [No float switch](#)

Location: Attic

No float switch

Task: Provide or install.

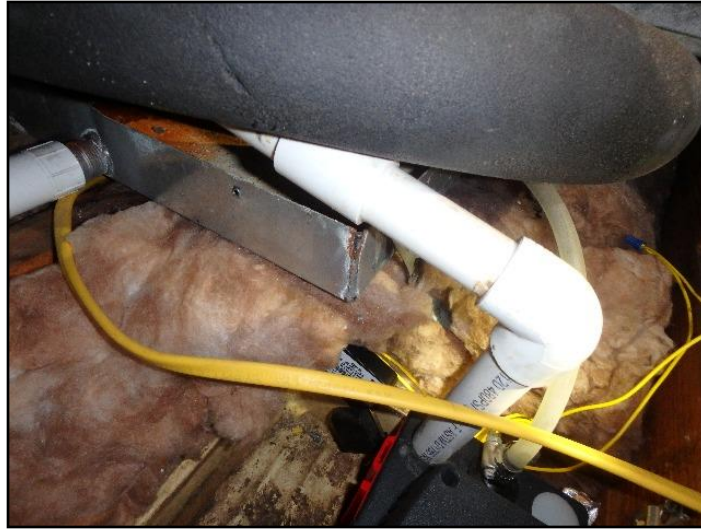
Condition: • Line not insulated

Line not insulated

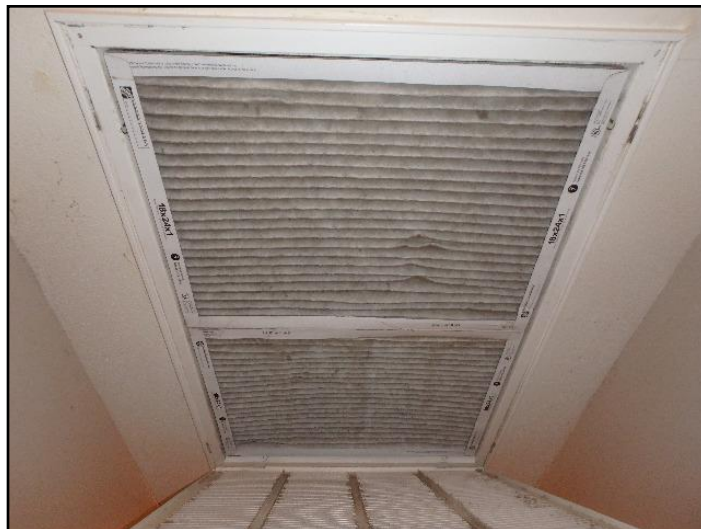
Location: Hall

Return air filter dirty

Task: Replace.

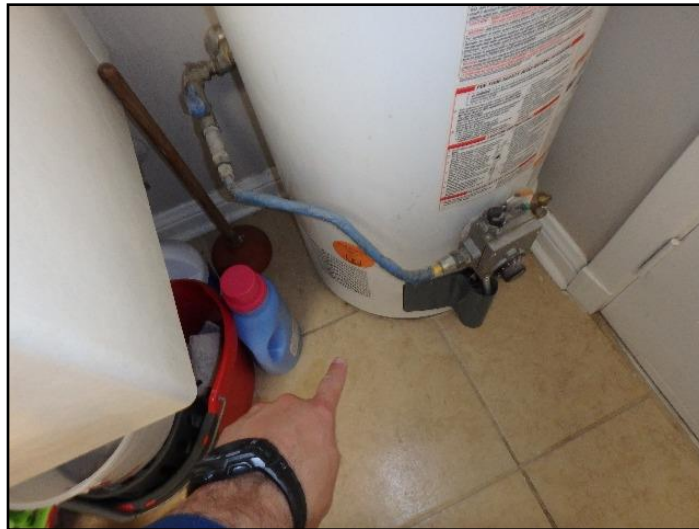
Location: Laundry Area

Safety pan and drain missing

Task: Provide or install.

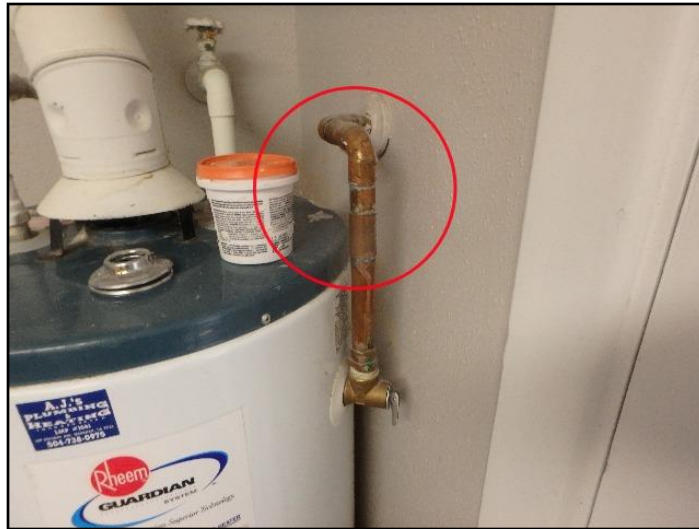
Condition: • Temperature pressure relief discharge tubes are required to flow downhill and not have any dip where water can collect.

Poor Slope

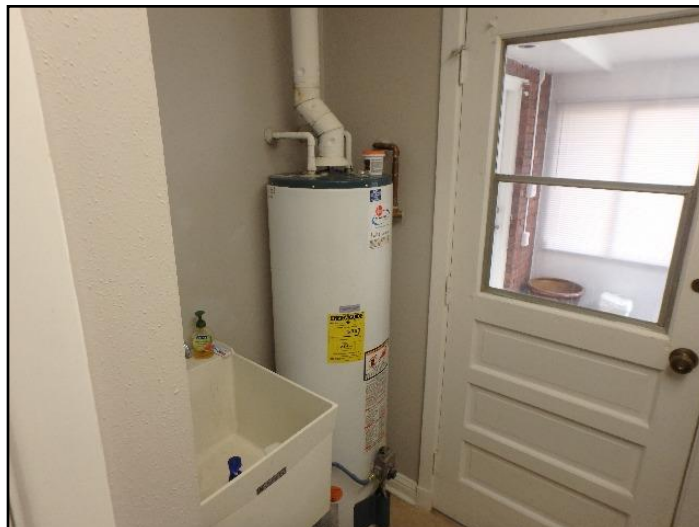
Location: Laundry Area

Inadequate combustion air

Task: Add vent to door or similar solution to provide adequate combustion air.

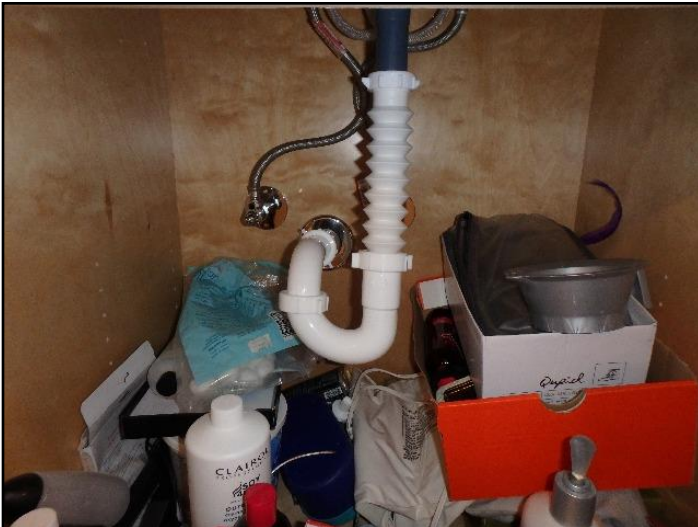
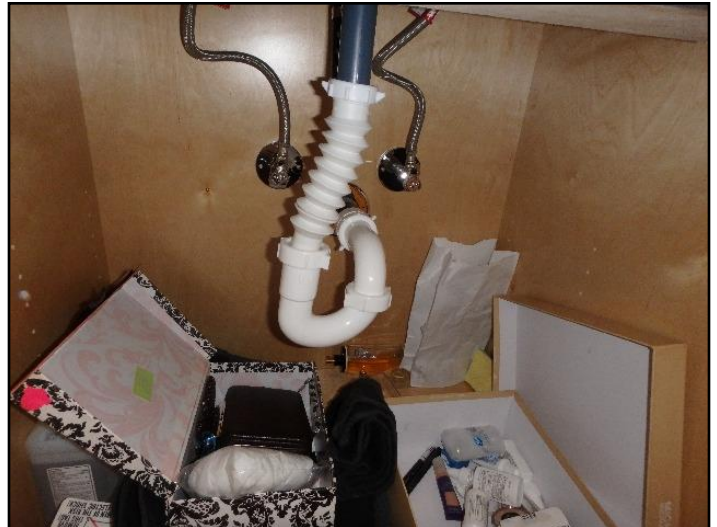
Trap is installed with a flexible corrugated tail piece. This type of drain pipe is prone to frequent clogging and is designed for a temporary repair only.

Location: Master Bathroom

Nonstandard shape or material

Task: Replace with a smooth walled tail piece. This should be done by a licensed plumber.

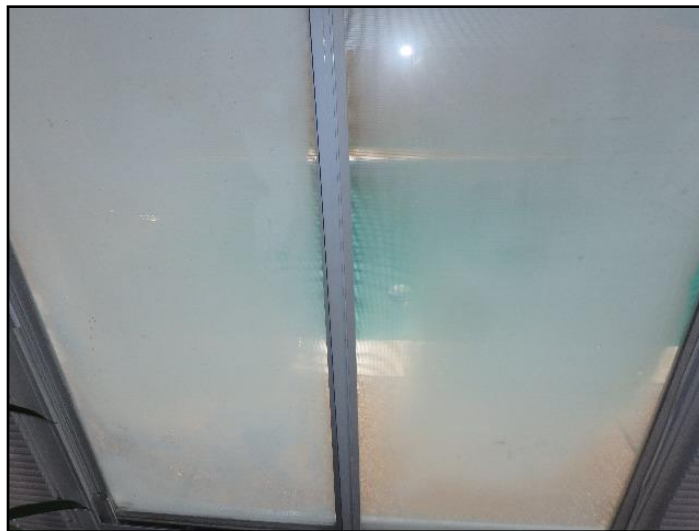
Location: Rear sunroom

Lost seal on double or triple glazing

Task: Replace fogged window(s)

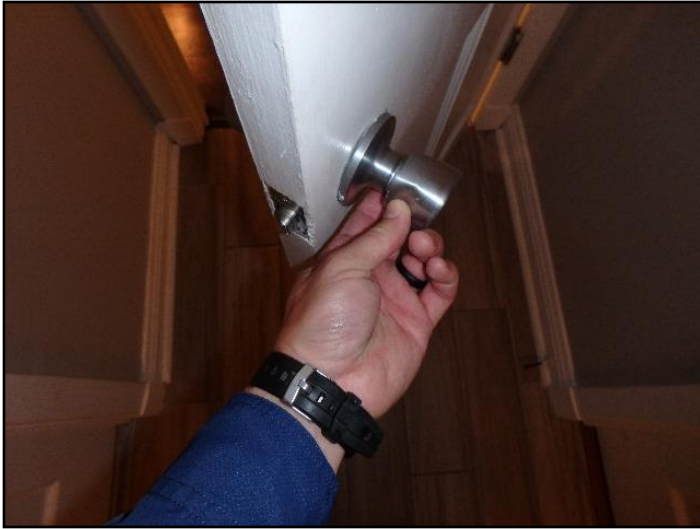
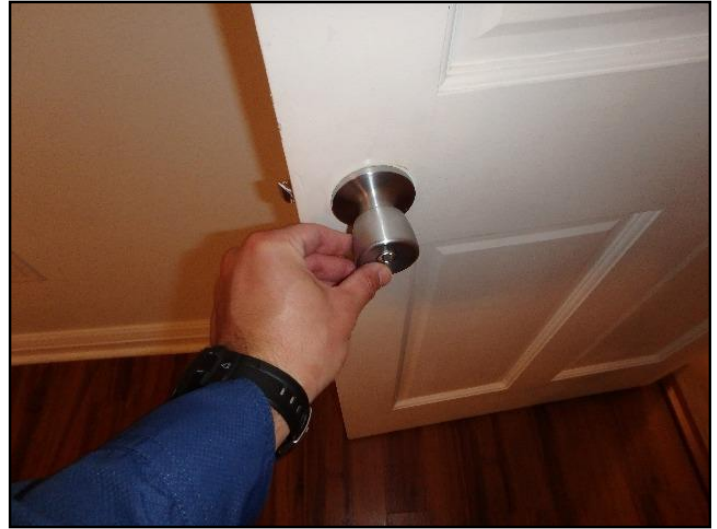
Damaged

Task: Replace.

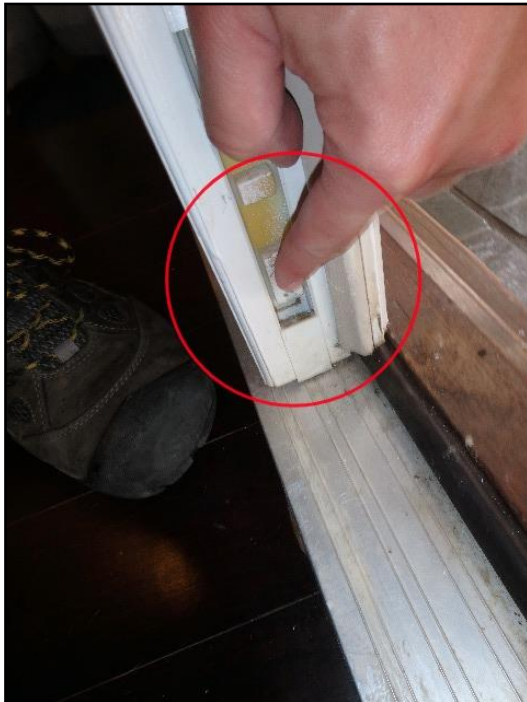
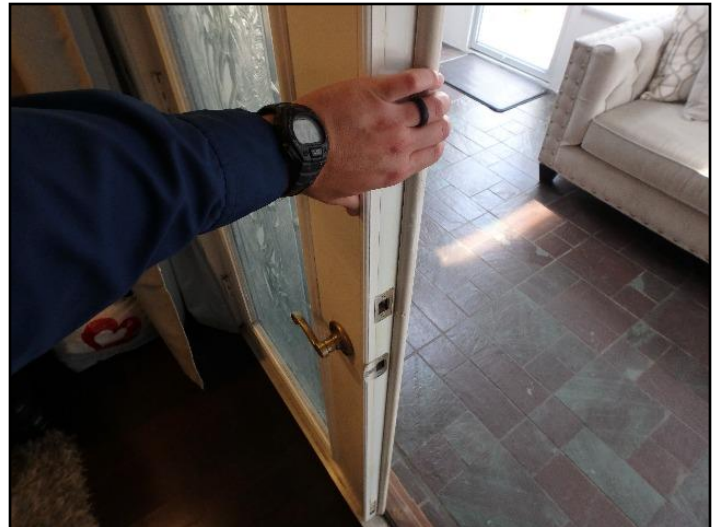
Condition: • [Broken](#)

Location: Master Bedroom

Broken

Task: Replace.

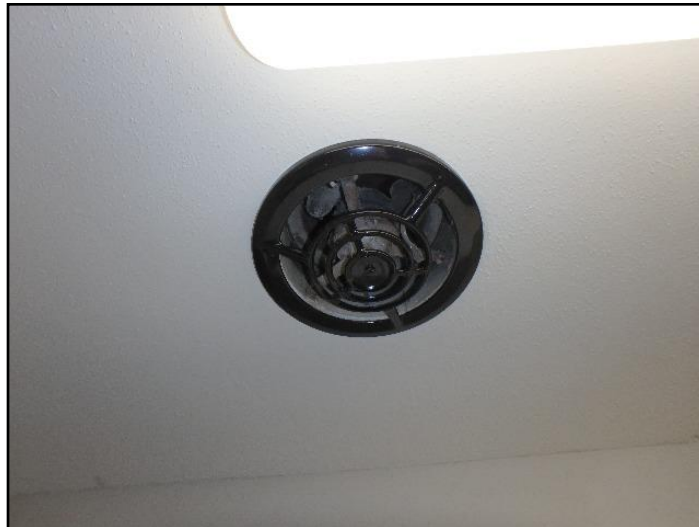
Inoperative

Task: Repair or replace.

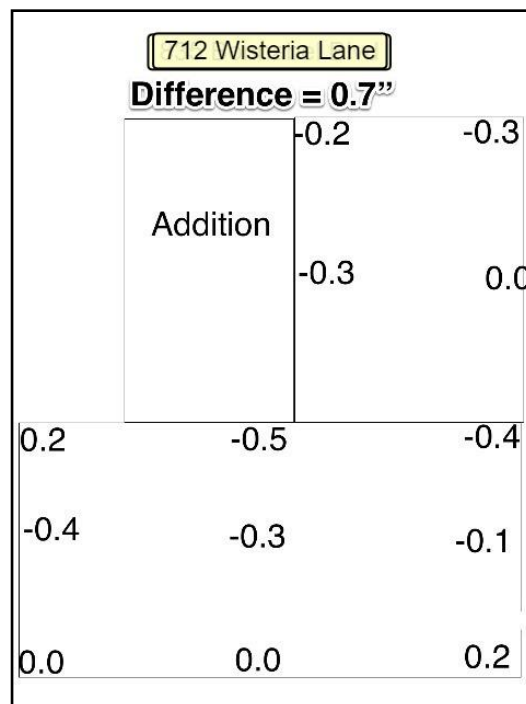
<1.9" Maximum Relative Elevation Differential: • Within acceptable limits for this area

Note: The maximum differential found was 0.7" as shown on the drawing below. According to one of the leading local engineering firms, the average differential for all residential foundations in the New Orleans area is about 3.2". The average for reinforced concrete slabs about 2.9" and for pier and beam foundations about 3.6". Allowances are made for floor coverings and materials. Additions and enclosed areas built with a designed slope are not included. All measurements taken are not shown. The drawing is not to scale and locations are approximate.
