# Inspection Report

1020 - 1022 Sample St  
New Orleans, LA 70115

Inspection Date:  
Monday, January 24, 2022

RE: Report No. 14696, v.2  
1020 - 1022 Sample St  
New Orleans, LA  
70115

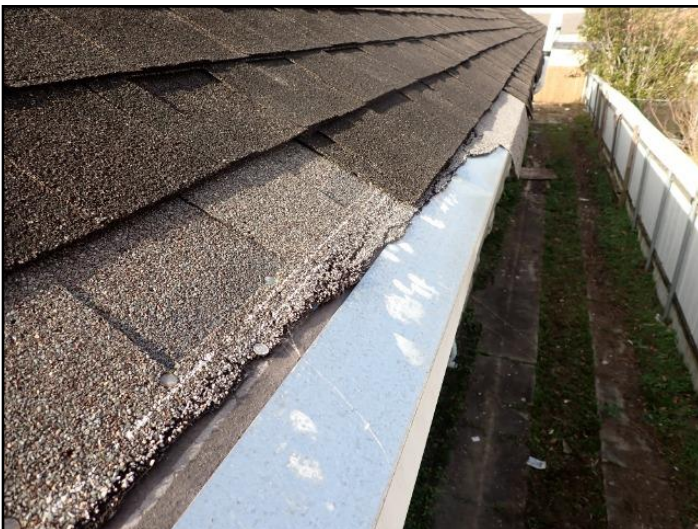
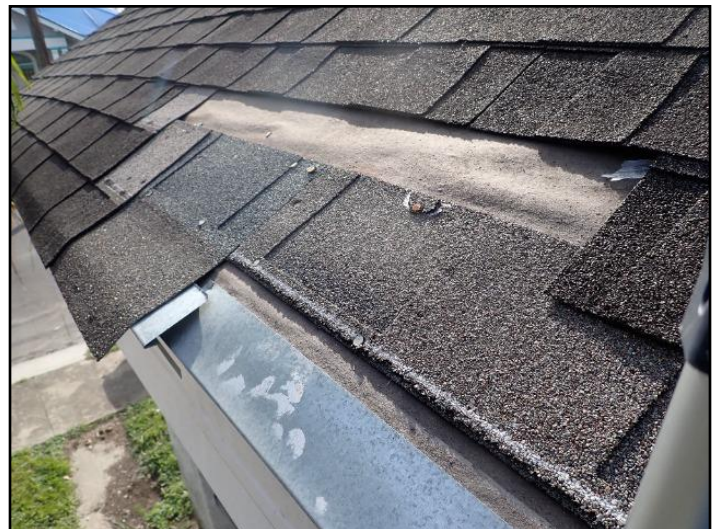
**Location:** Right Front Roof

**Condition:** • [Missing, loose or torn](#)

*Missing, loose or torn*

**Task:** Replace damaged, missing shingles

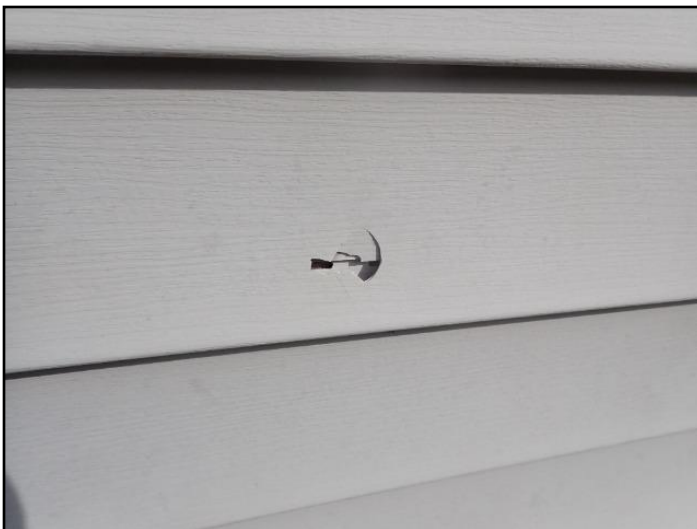
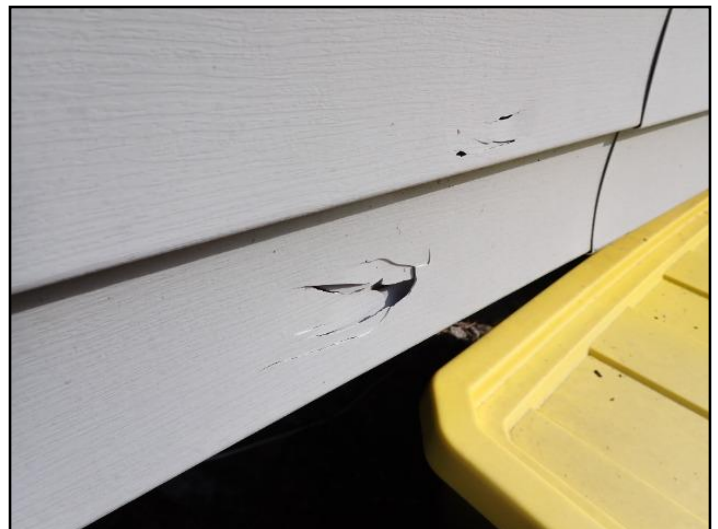
**Location:** Various

**Condition:** • [Mechanical damage](#)

*Mechanical damage*

**Task:** Repair. Replace damaged pieces

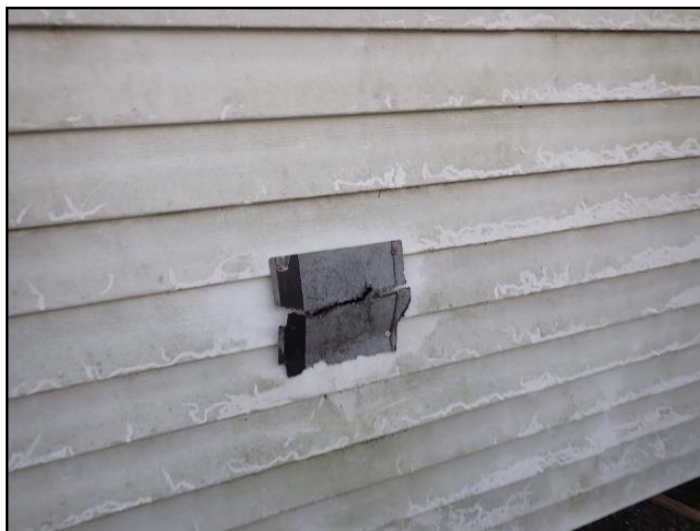
**Location:** Right Side

**Condition:** • Openings in siding

*Openings in siding*

**Task:** Repair.

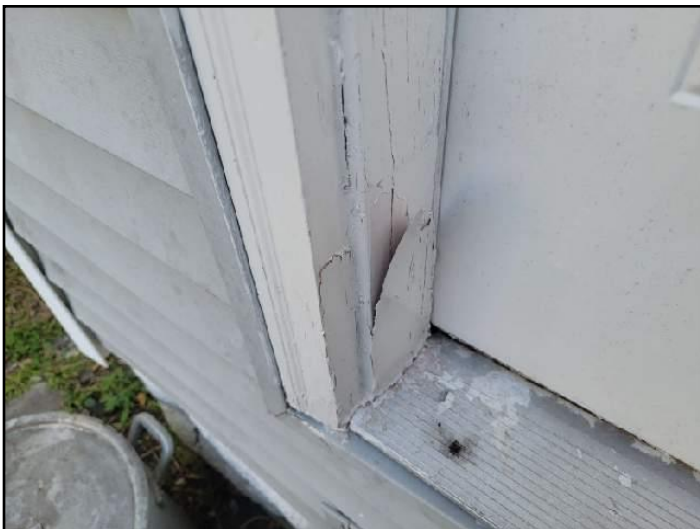
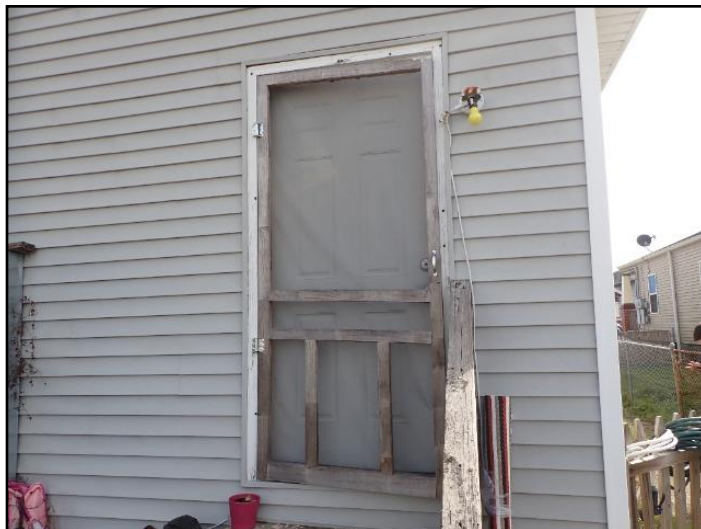
**Location:** Various

**Condition:** • [Paint or stain needed](#)

*Paint or stain needed*

**Task:** Clean. Paint. Monitor

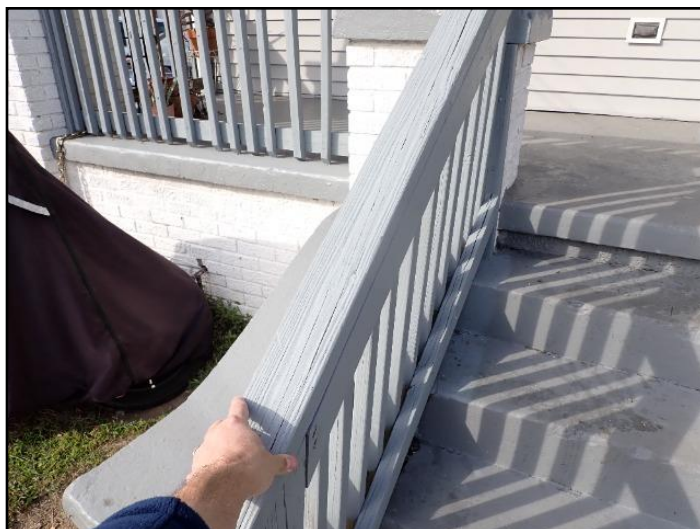
Location: Front Left Railing

Condition: • [Loose](#)

Loose

Task: Repair

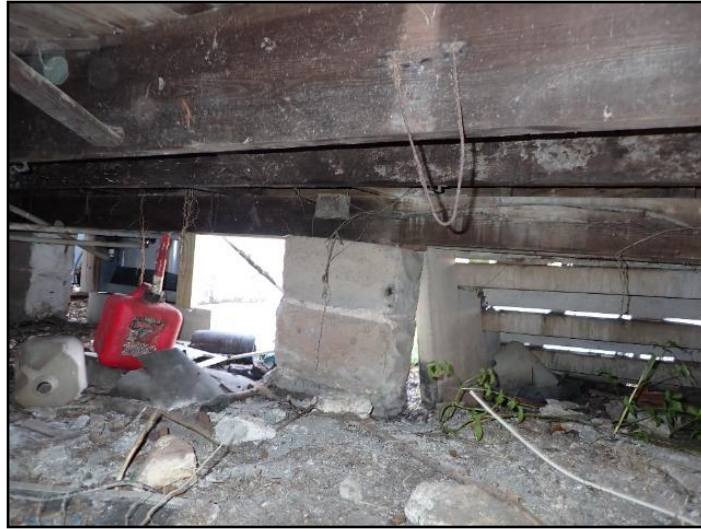
Location: Rear Crawl Space

Condition: • [Leaning](#)

*Leaning*

Task: Monitor.

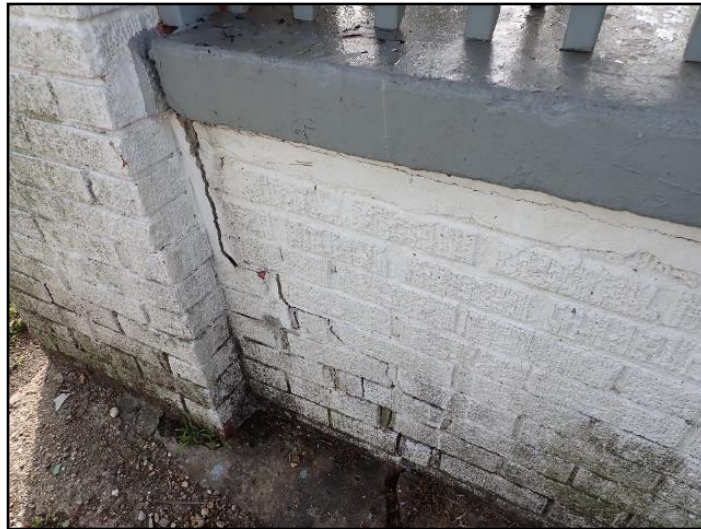
**Location:** Rear Right, Front Right

**Condition:** • Cracked

*Cracked*

**Task:** Repair

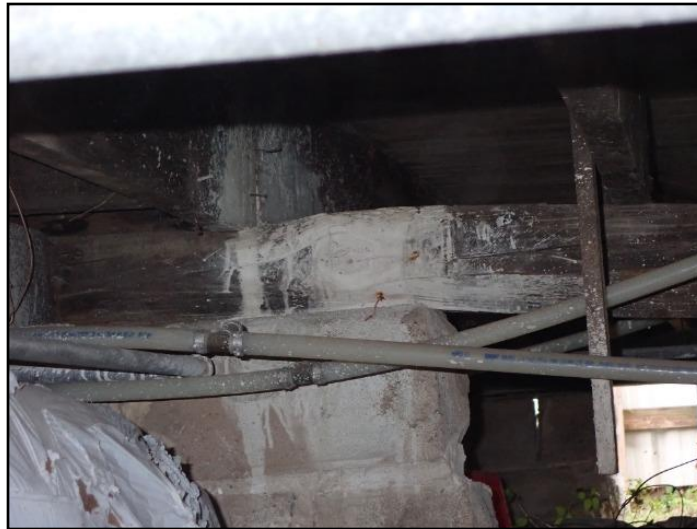
**Location:** Rear center Crawl Space

**Condition:** • Crushed

*Crushed*

**Task:** Replace

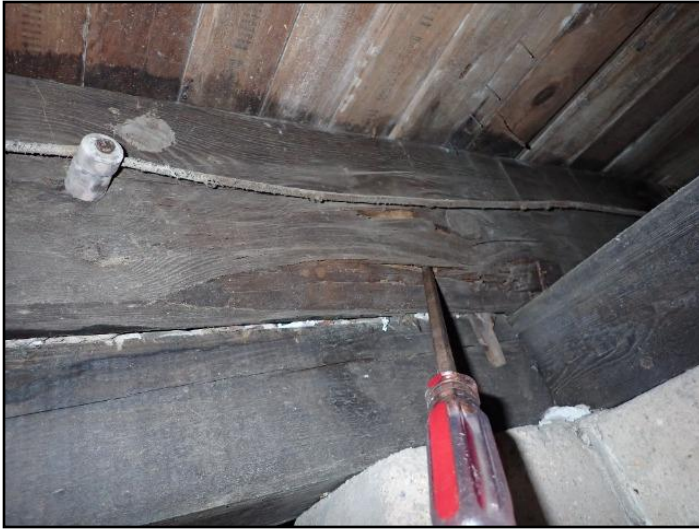
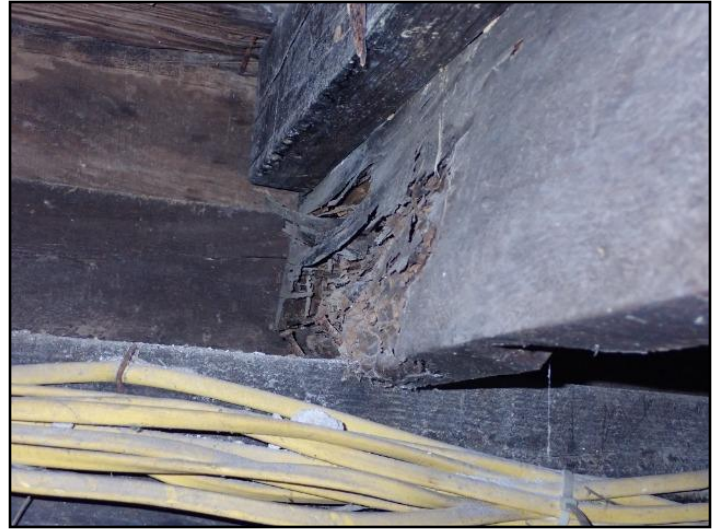
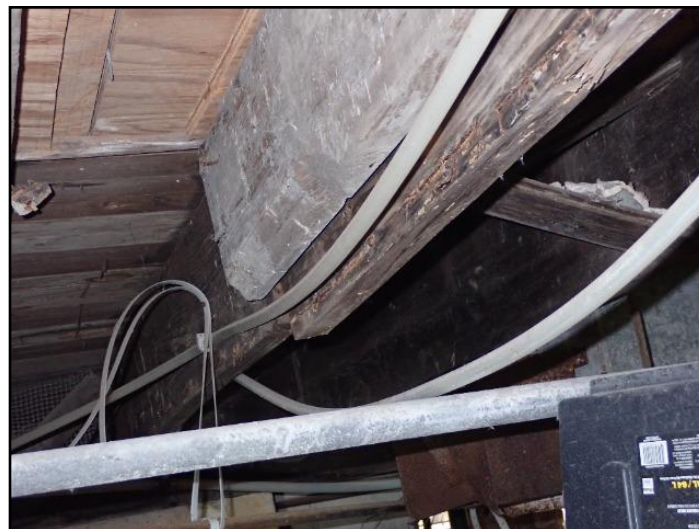
**Condition:** • Rot and/or insect damage

Damaged joists have lost some structural integrity from rot and/or insect damage. Repair by sistering is recommended. Sistering is adding a new joist to the old, attaching the same dimensional member to the damaged one with nails or bolts. The sister member should span the supporting piers if possible and this may require the area to be raised a quarter-inch by jacking, in order to place the new joist into position.

Several joists on the left near the bathroom plumbing have been scabbed, with poor repairs.

*Insect damage*

*Rot and/or insect damage*

**Task:** Repair should be done by a licensed contractor.

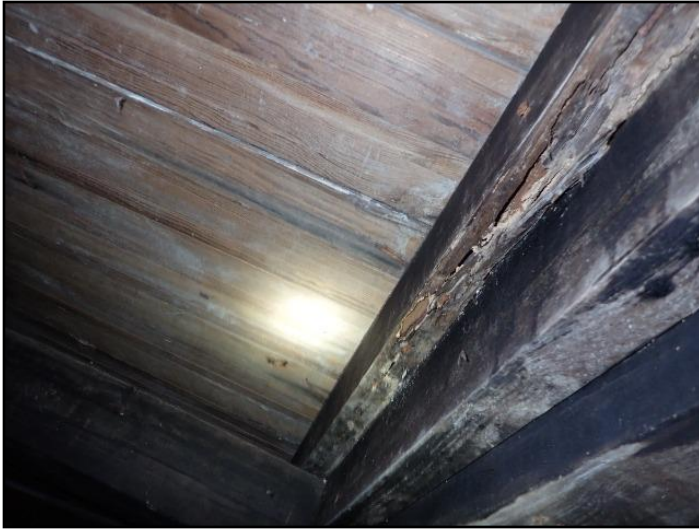
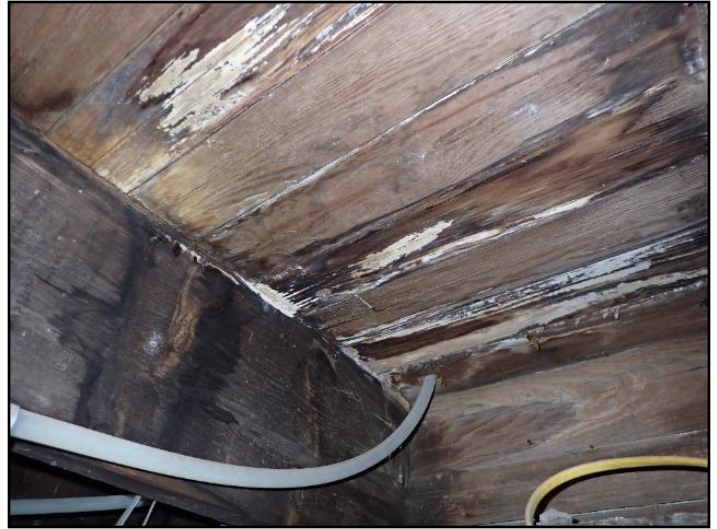
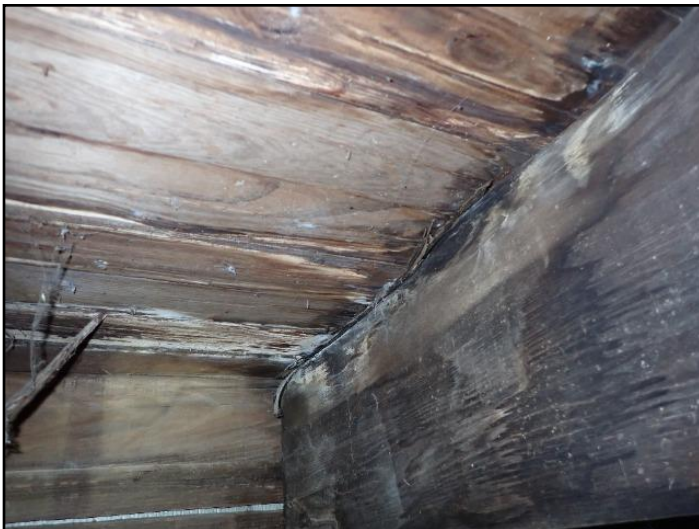
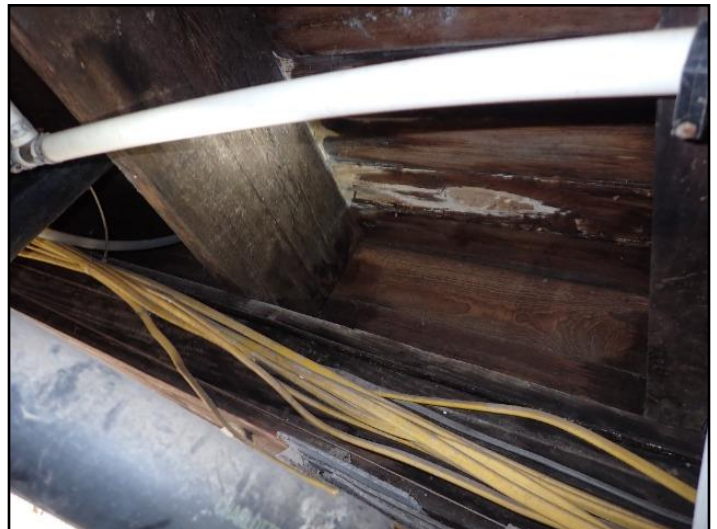
**Condition:** • Water stains

Water stains and the beginnings of rot were noted on the subfloor, It was not determined if this is an active leak.

Water stains

**Task:** Verify and repair as needed

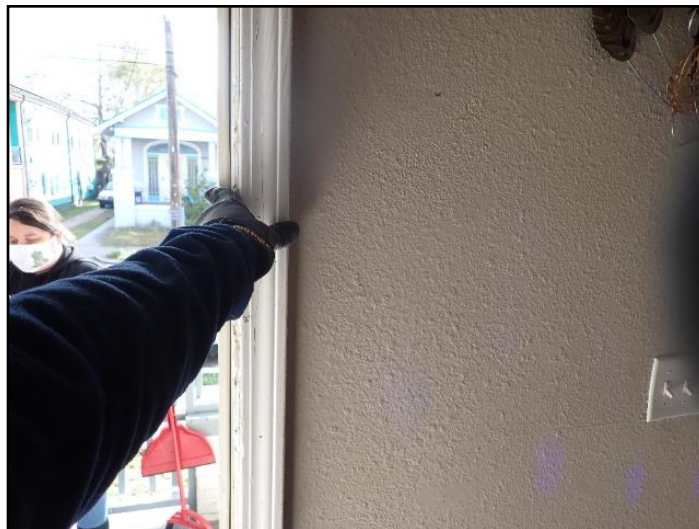
**Location:** 1428 Front Door Opening

**Condition:** • Weak wall

*Weak wall*

**Task:** Further Investigation. Repair as needed

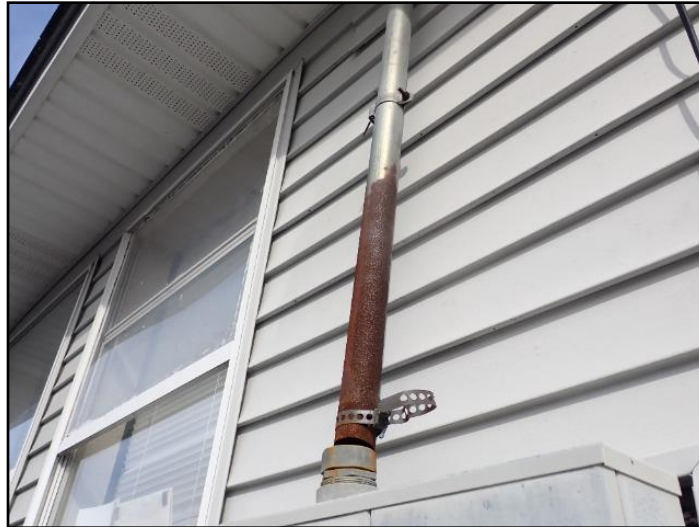
**Location:** Left Front Exterior

**Condition:** • [Mast rust](#)

*Mast rust*

**Task:** Replacement recommended

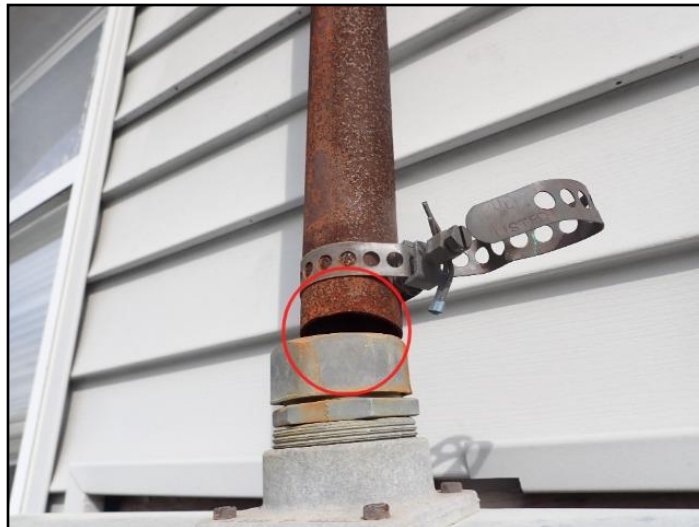
**Location:** Left Front Exterior

**Condition:** • Disconnected service mast

**Implication(s):** Moisture intrusion into panel

*Disconnected*

**Task:** Repair/Correct

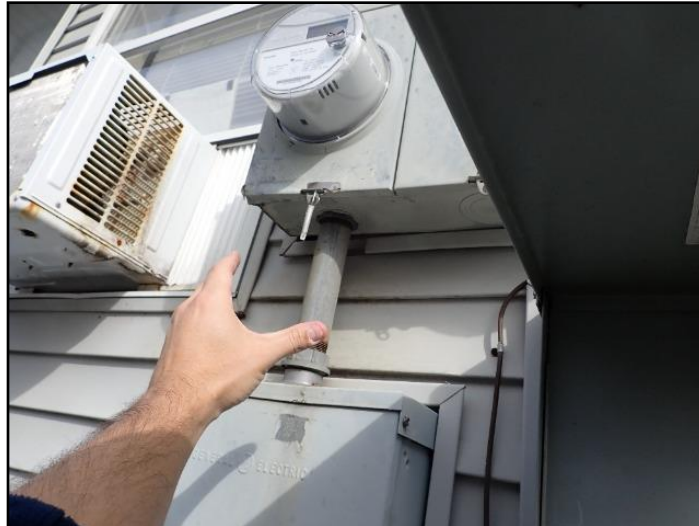
**Location:** Left Front Exterior

**Condition:** • Loose meter boxes

*Loose*

**Task:** Re-secure

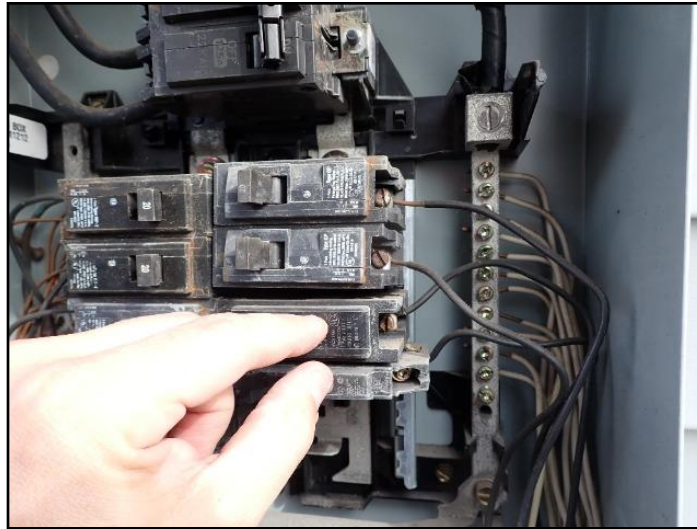
**Location:** Left Front Combination Panel

**Condition:** • [Loose breakers or fuses](#)

*Loose breakers*

**Task:** Correct

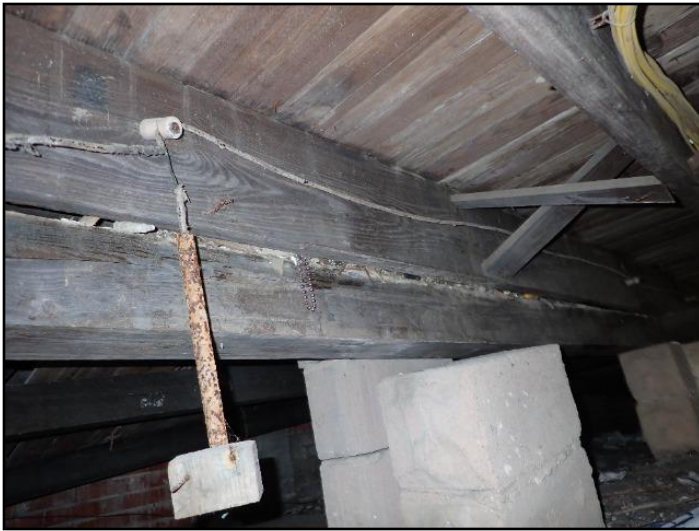
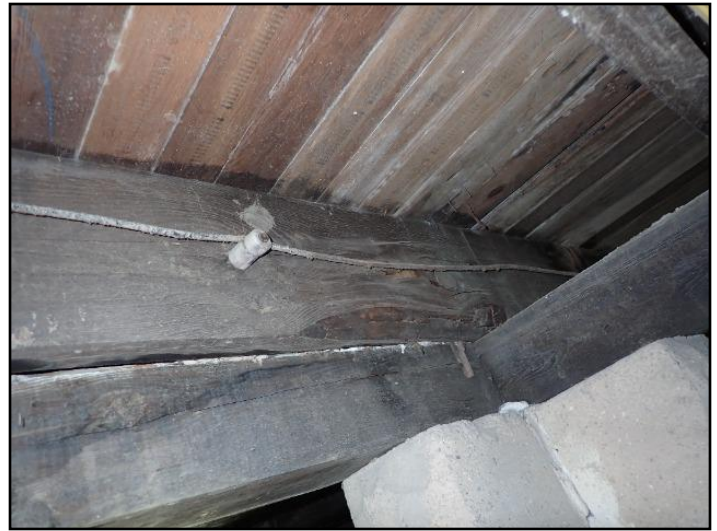
**Location:** Front crawlspace

**Condition:** • Inactive knob and tube wires found

Inactive knob and tube wires found. Though disconnected, all abandoned wires should be completely removed to ensure the wiring is never put back into service.

*Inactive knob and tube wires found*

**Task:** Verify and Remove.

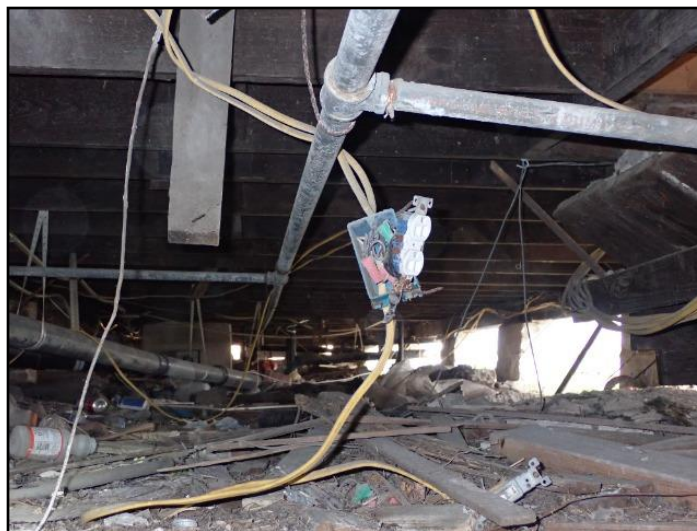
**Location:** Right Side Crawl Space

**Condition:** • [Abandoned wire](#)

*Abandoned wire*

**Task:** Remove

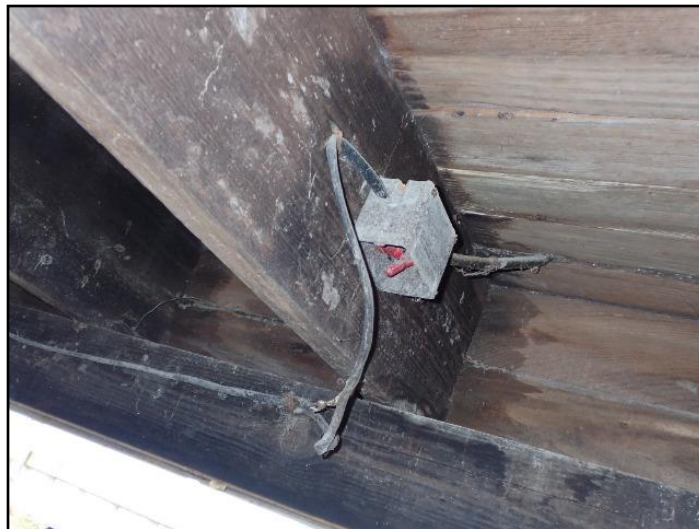
**Condition:** • Cover loose or missing

Cover missing on junction box(s), exposed, live wiring. Electrical connections should be in closed junction boxes.

*Cover loose or missing*

**Task:** Correct.

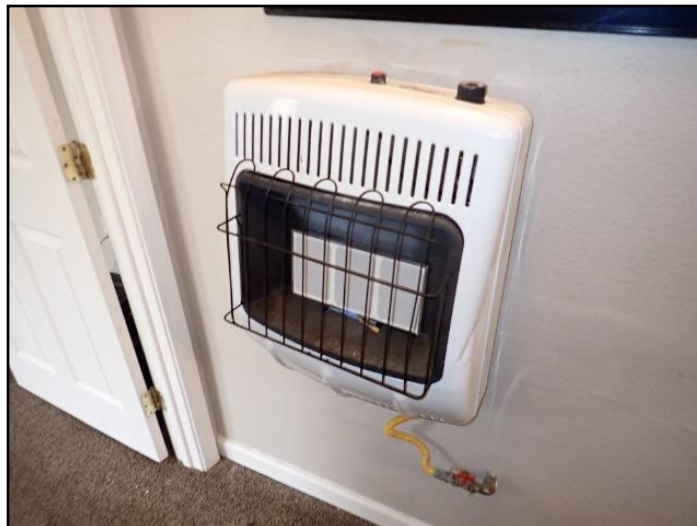
**Location:** Throughout

**Condition:** • [Unvented](#)

Older unvented gas heaters are inherently dangerous with little safety features. They can cause carbon monoxide poisoning or release gas accidentally, and can be a fire hazard. They should never be used in a bedroom or bathroom. They should either be removed or the gas supply capped to each unit. Even the newer ventless gas heaters, although they have some safety features, can fail and be dangerous (Read warning labels). We recommend removal of either type and implementation of a safer heating method.

*Unvented*

**Task:** Removal or disabling is recommended. Consider replacing with heat/cool window units

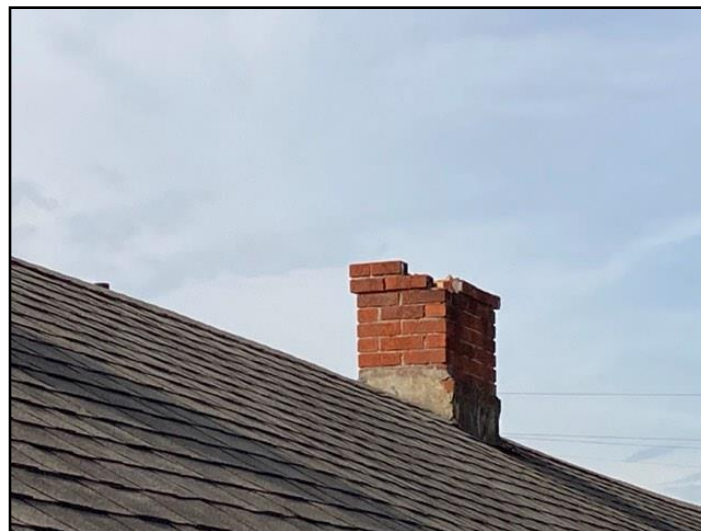
**Condition:** • [Loose, missing or deteriorated masonry](#)

Missing bricks on chimney

*Loose, missing or deteriorated masonry*

**Task:** Repair chimney

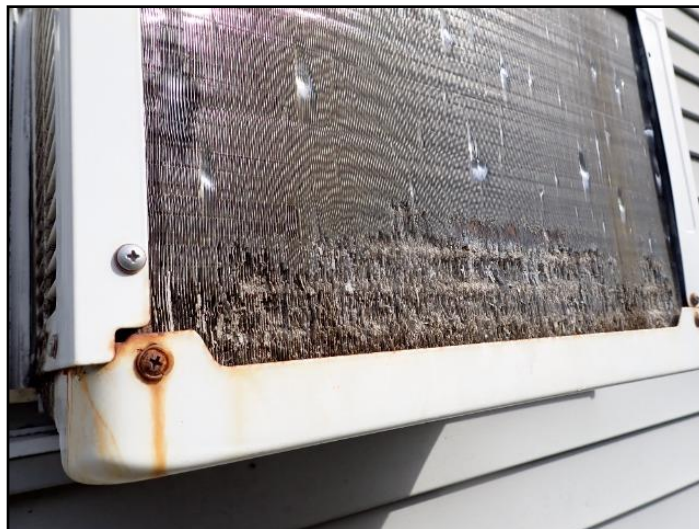
**Location:** Left Rear Exterior

*Damaged fins*

**Task:** Replace as needed

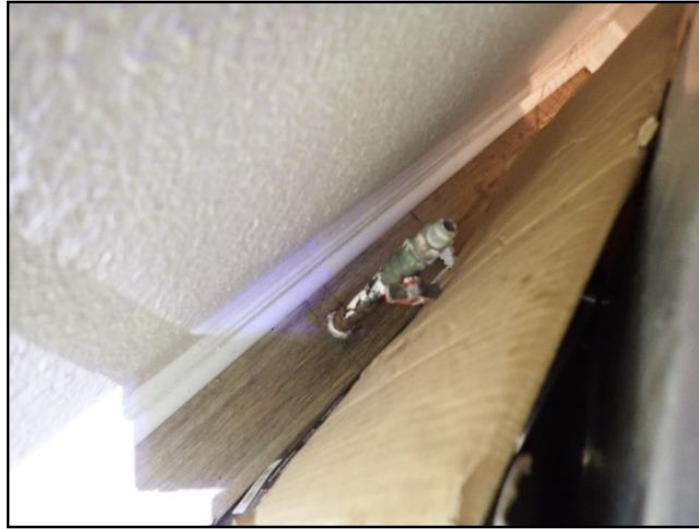
**Location:** 1428 Laundry Room

*Missing end cap.*

**Task:** Correct

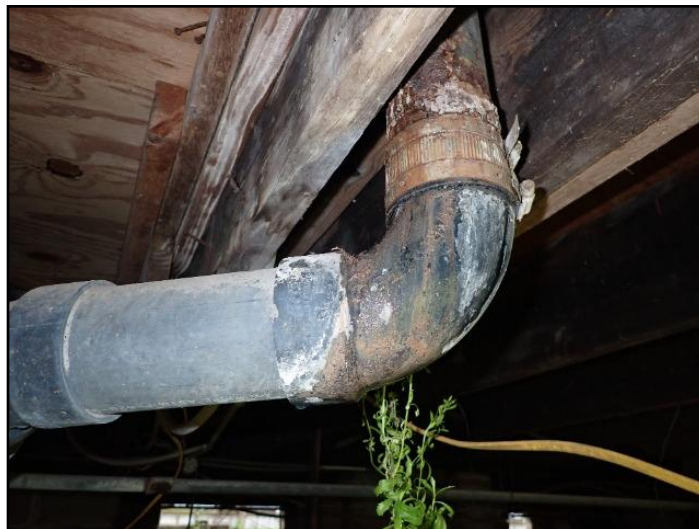
Location: Left Side Middle Crawl Space

Leak

Task: Repair.

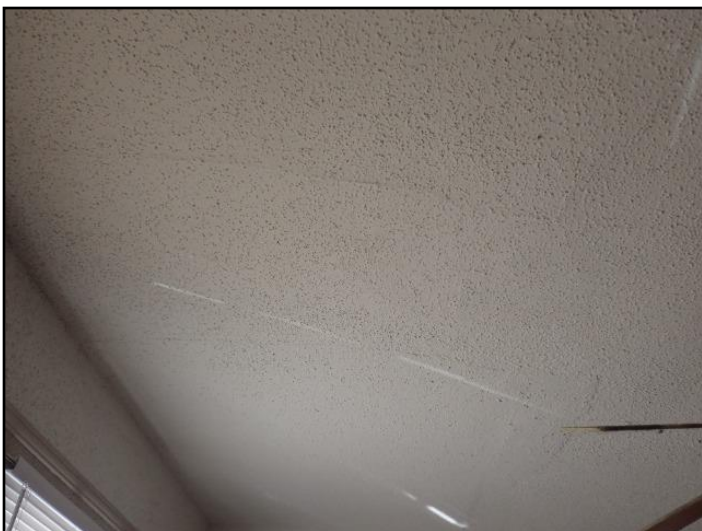
**Location:** 1426 Various

*Patched*

**Task:** Monitor for any re-opening of cracks

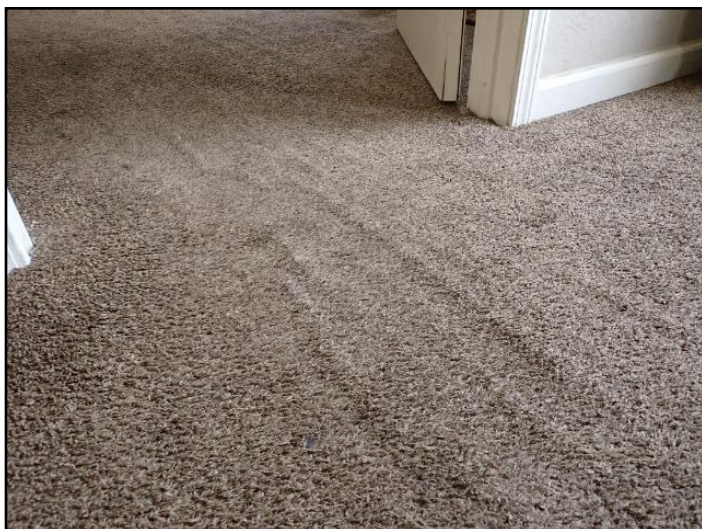
**Location:** Throughout

*Buckled*

**Task:** Re-stretch or Replace

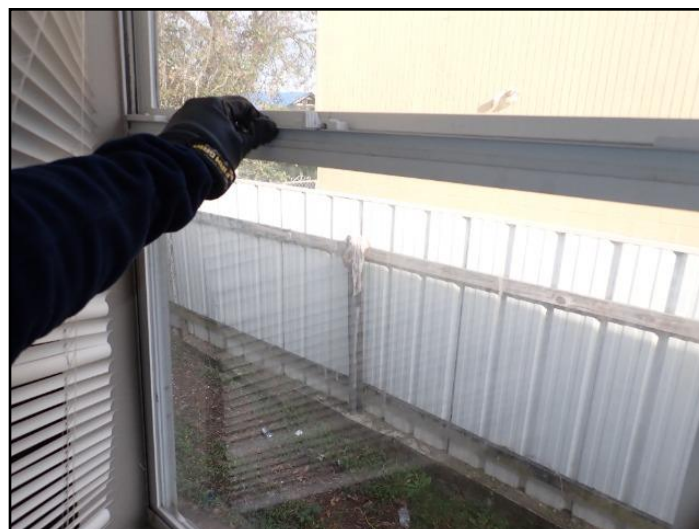
**Location:** 1428 Middle Bedroom

**Condition:** • Inoperable

*Inoperable*

**Task:** Repair. Adjust

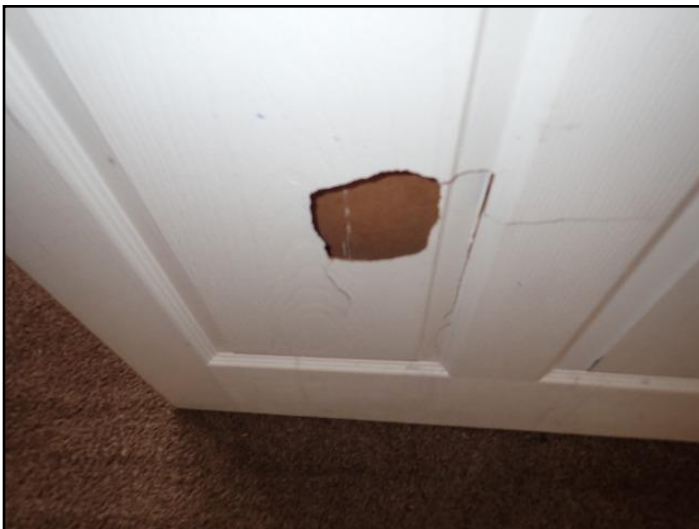
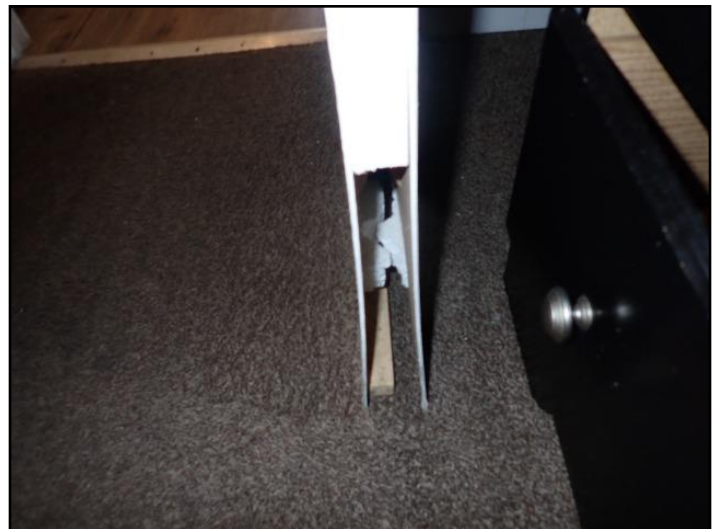
**Location:** 1428 Bedrooms (2 doors)

**Condition:** • [Damage](#)

*Damage*

**Task:** Replace

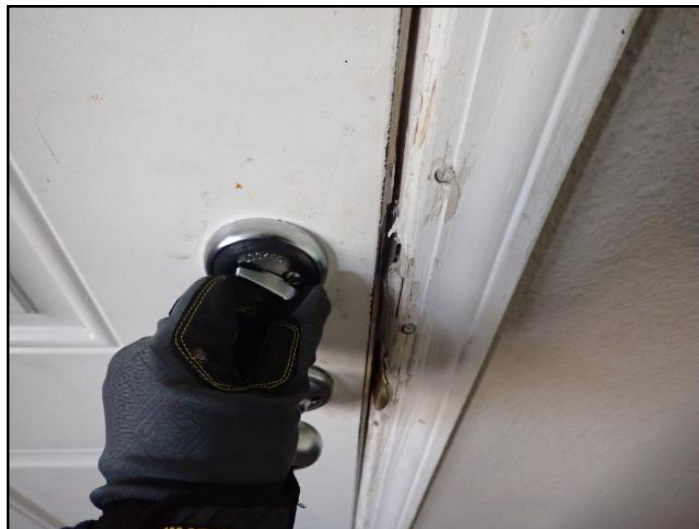
**Location:** 1428 Front Door Deadbolt

*Does not latch properly*

**Task:** Repair. Adjust

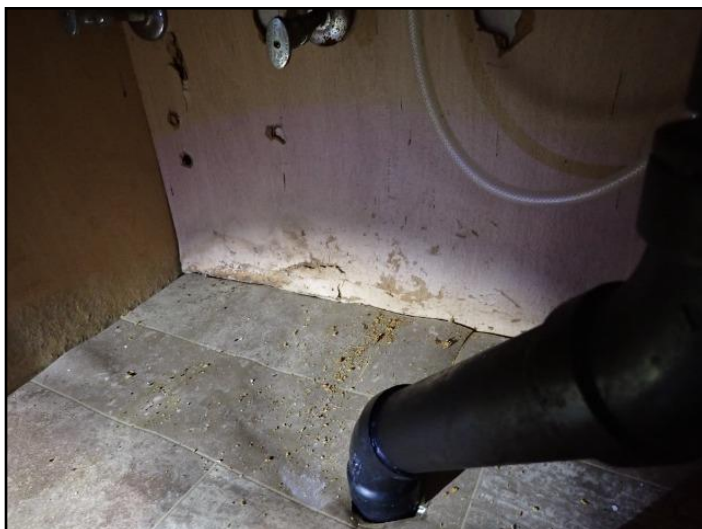
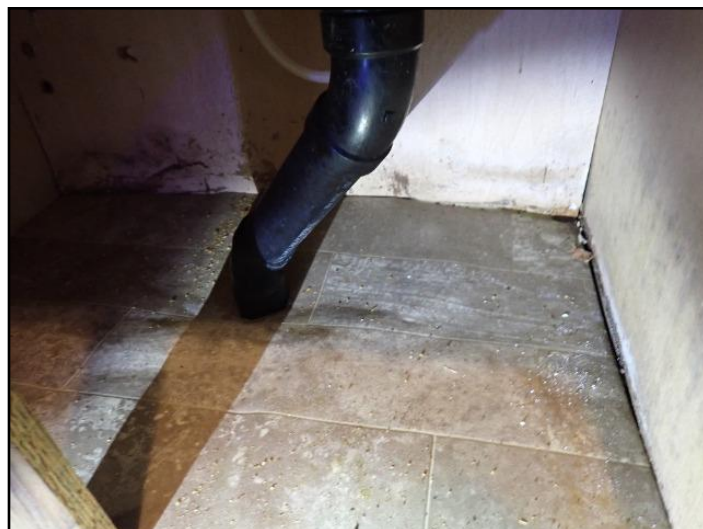
Location: 1428 Kitchen

Water damage

Task: Replacement recommended. Possibility of hidden mold

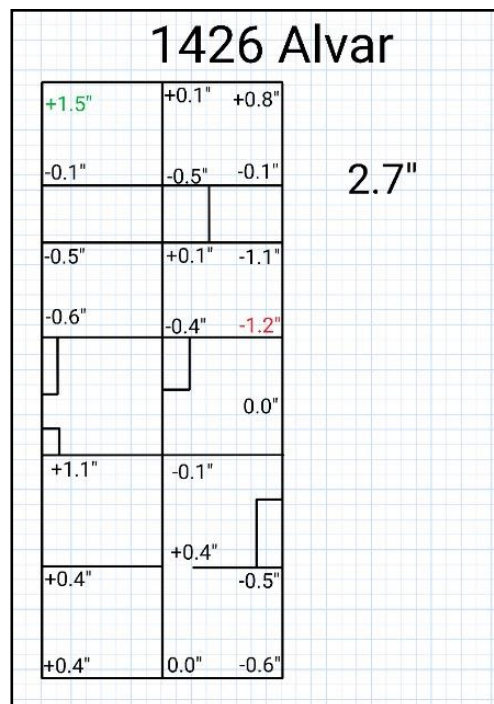
The maximum differential found was 2.7" as shown on the drawing below. According to one of the leading local engineering firms, the average differential for all residential foundations in the New Orleans area is about 3.2". The average for reinforced concrete slabs about 2.9" and for pier and beam foundations about 3.6". Allowances are made for floor coverings and materials. Additions and enclosed areas built with a designed slope are not included. All measurements taken are not shown. The drawing is not to scale and locations are approximate.

*Locations approximate, not to scale*
