INSPECTION REPORT

For the Property at: 4520 BURTHE ST NEW ORLEANS, LA 70118

Prepared for: JOHN BEECHEM Inspection Date: Friday, June 1, 2018 Prepared by: Beau Tanner and Matthew Del Buono

RE: Report No. 8108, v.3 4520 Burthe St New Orleans, LA 70118

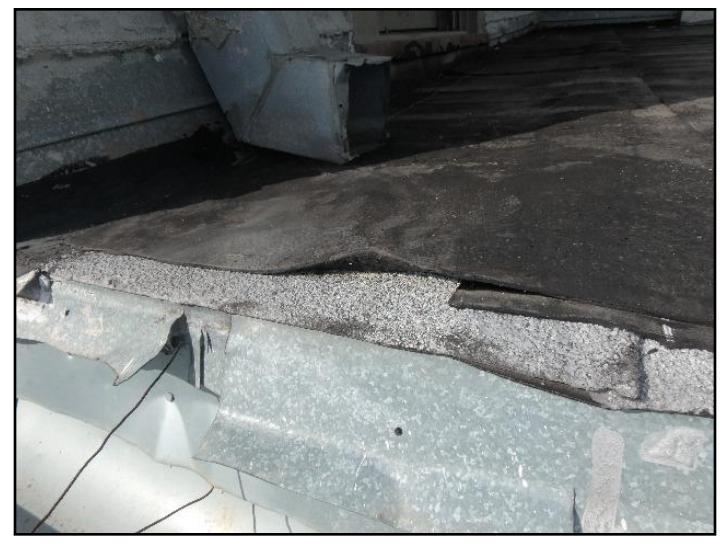
Condition: • Old, worn out Location: Rear Left Flat Roof Task: Replacement recommended

Old, worn out

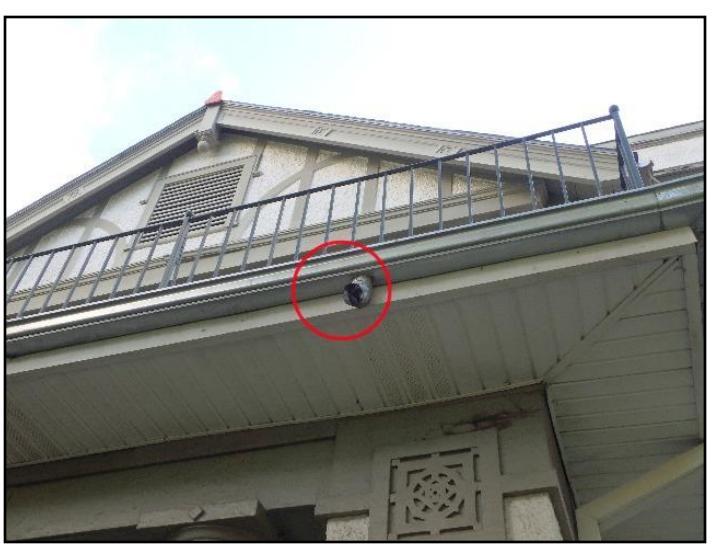
Missing

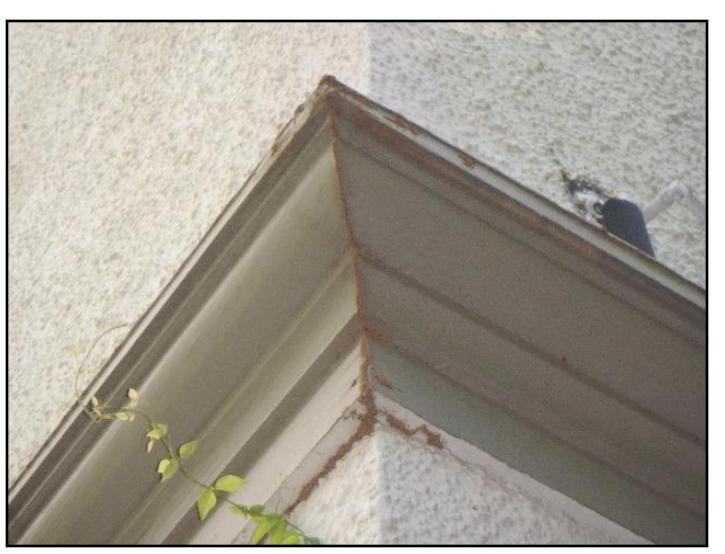
Insect damage

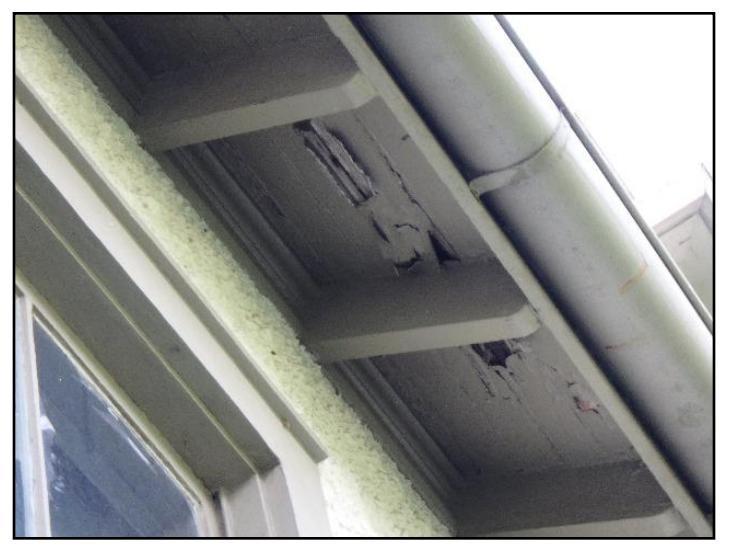
Water Damage/Loose

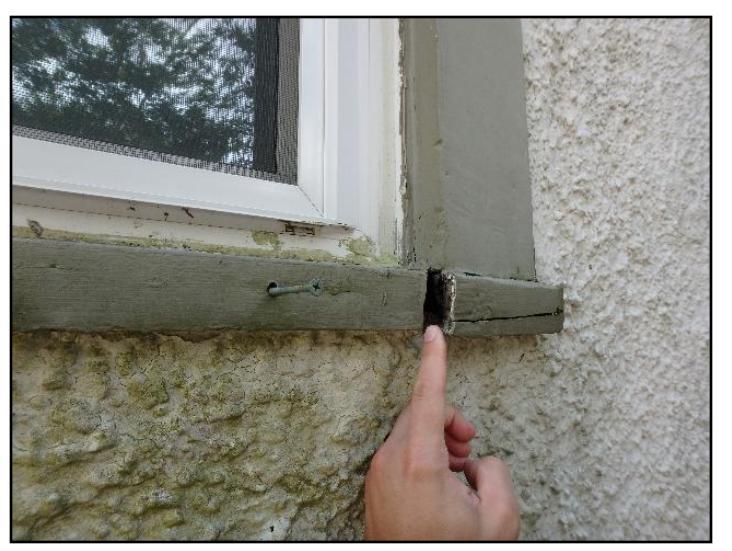
Rot/Peeling Paint

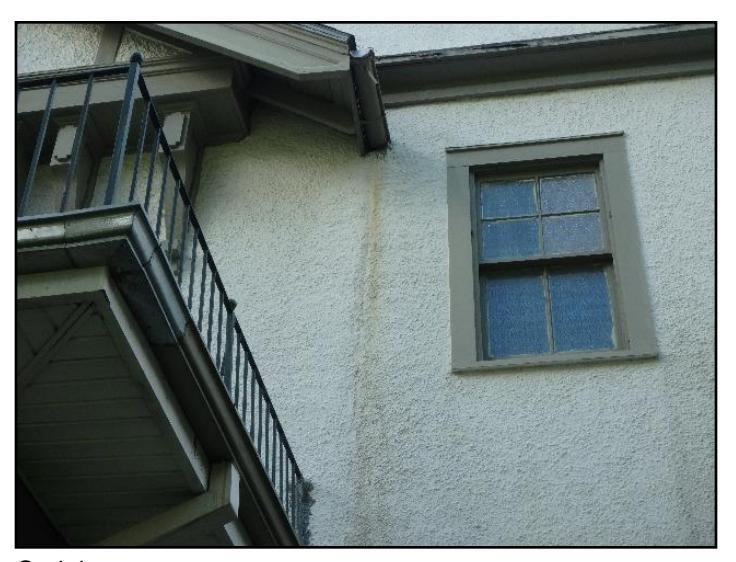
Staining

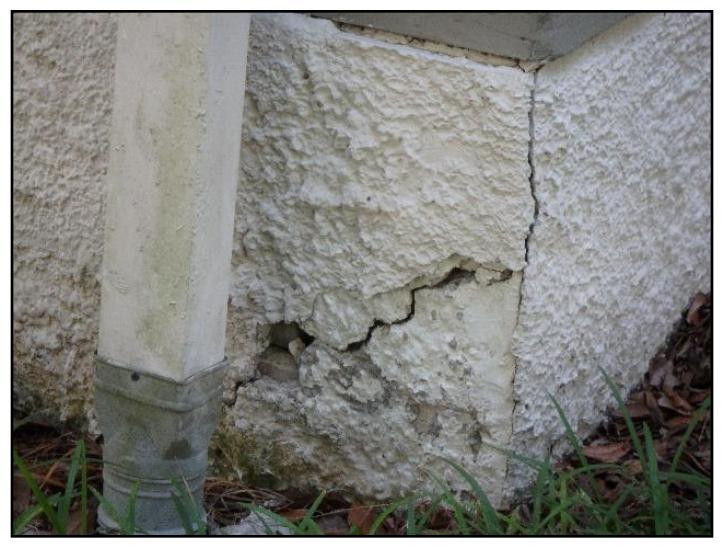
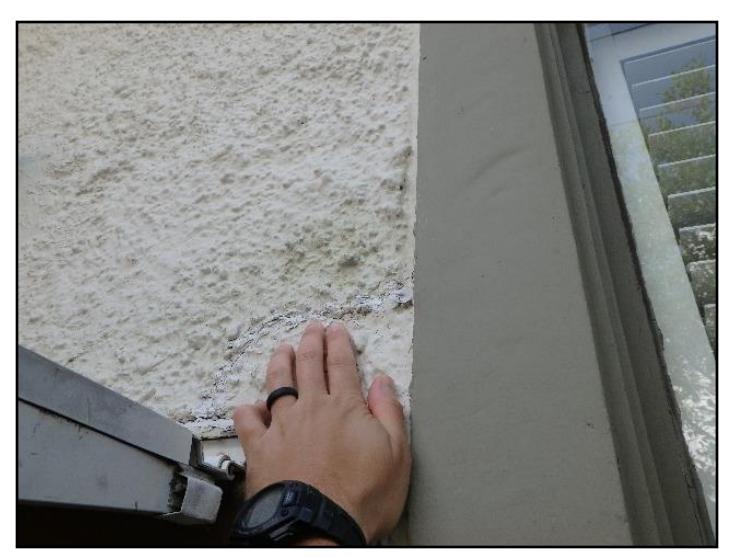
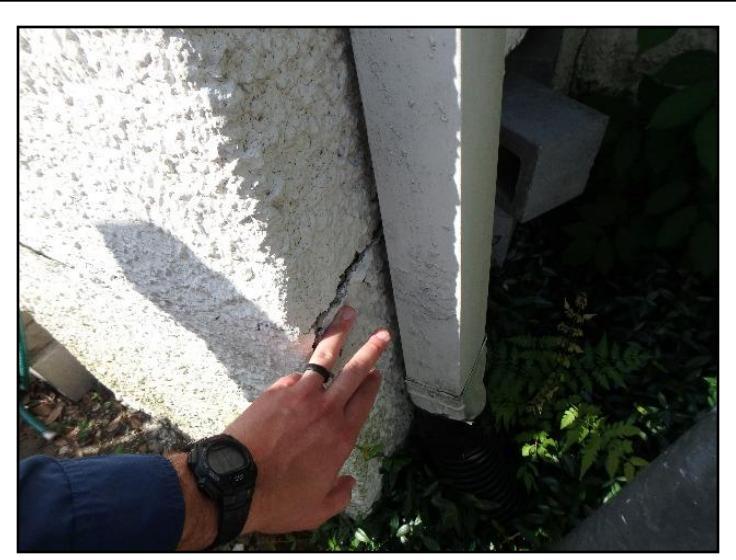
Condition: • Stucco Damage: Cracking, water damage, and other general disrepair was noted to the stucco in various areas. Further evaluation and proper repairs are recommended.

Stucco Damage: Cracking, water damage, and ...

Stucco Damage: Cracking, water damage, and...

Location: Various Exterior Task: Repair or replace

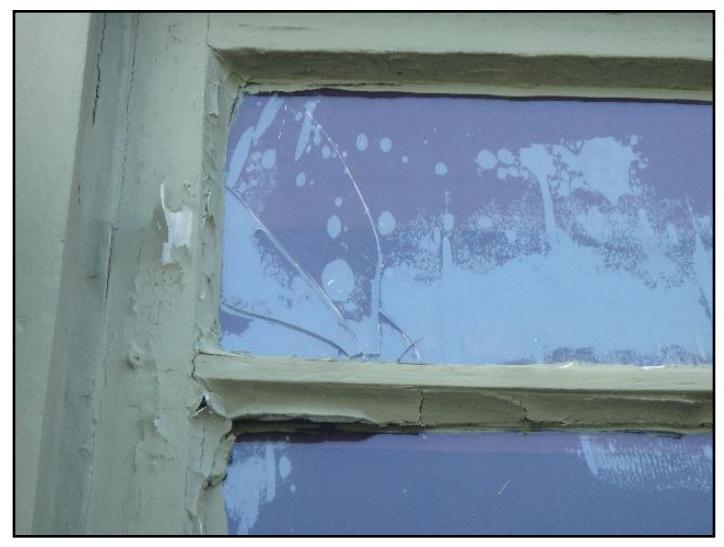
Condition: • <u>Cracked</u> Location: Front Balcony French Doors Task: Replace

Cracked

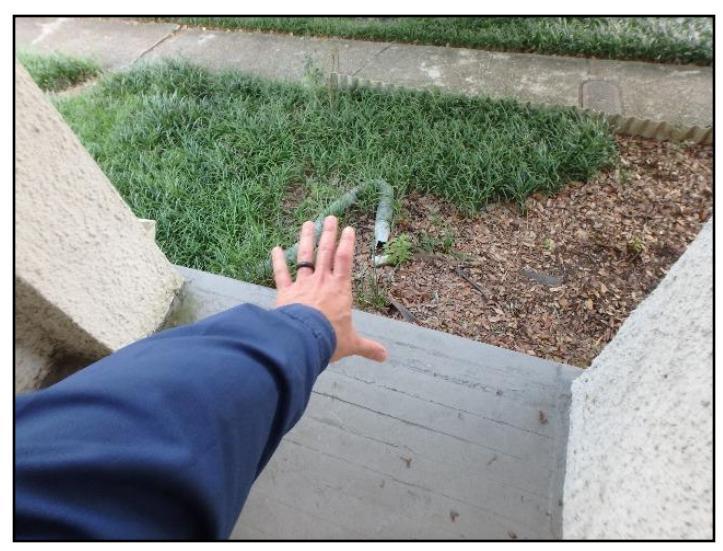
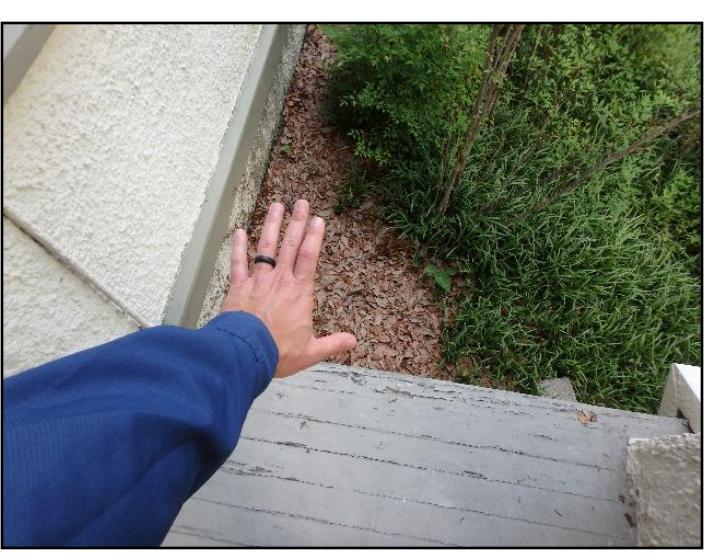
Missing

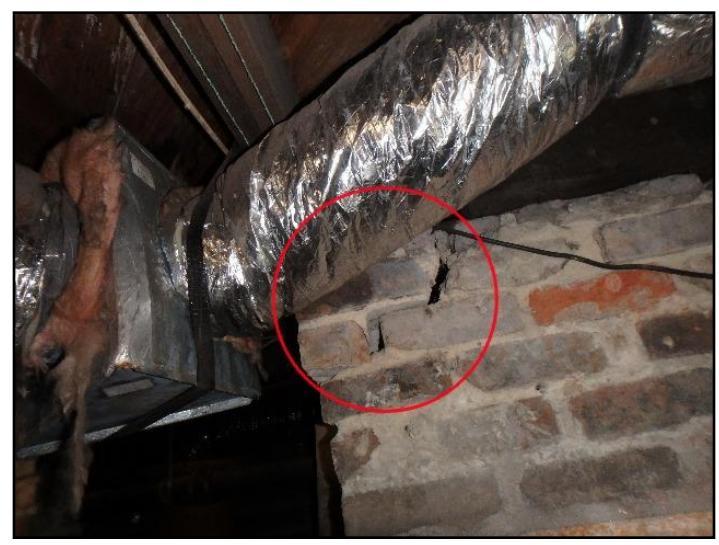
Condition: • Damage Location: Middle Crawl Space Task: Repair or replace.

Damage

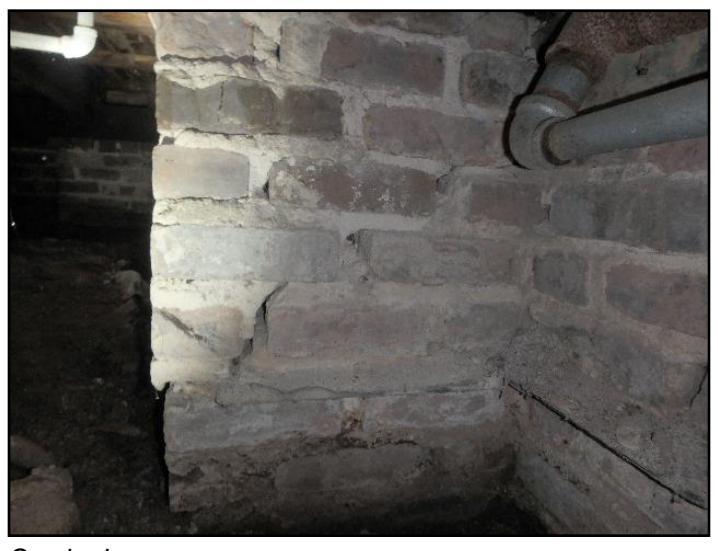
Cracked

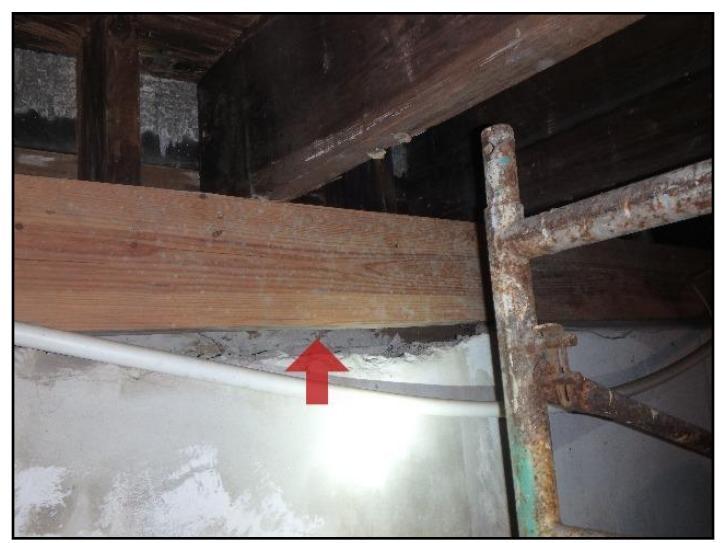
Improper repair

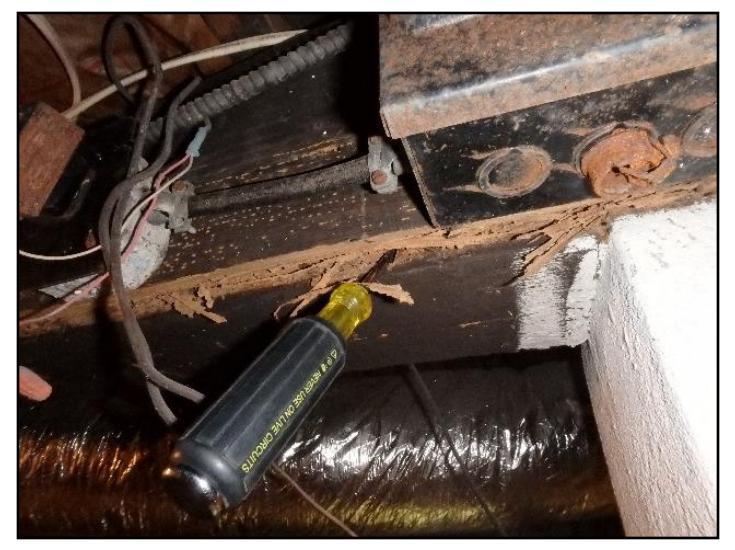
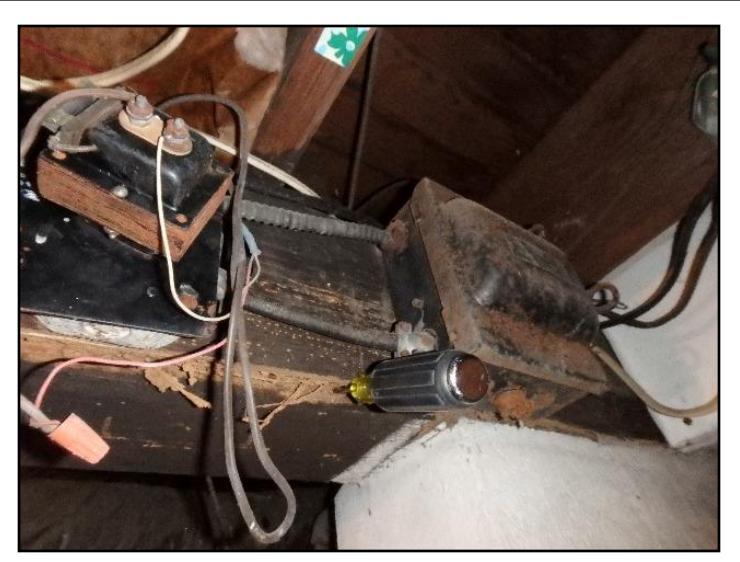
Condition: • <u>Rot or insect damage</u> Approximately 18 feet of sill needs to be replaced in basement. Location: Basement Task: Replace.
4520 Burth	ne St, New C	Drleans, LA	June 1, 201	www.axelradhome.cor					
SUMMARY	ROOFING	EXTERIOR	STRUCTURE	ELECTRICAL	HEATING	COOLING	INSULATION	PLUMBING	INTERIOR
RELATIVE EL	PHOTOS	SITE INFO	APPENDIX	REFERENCE

Rot or insect damage

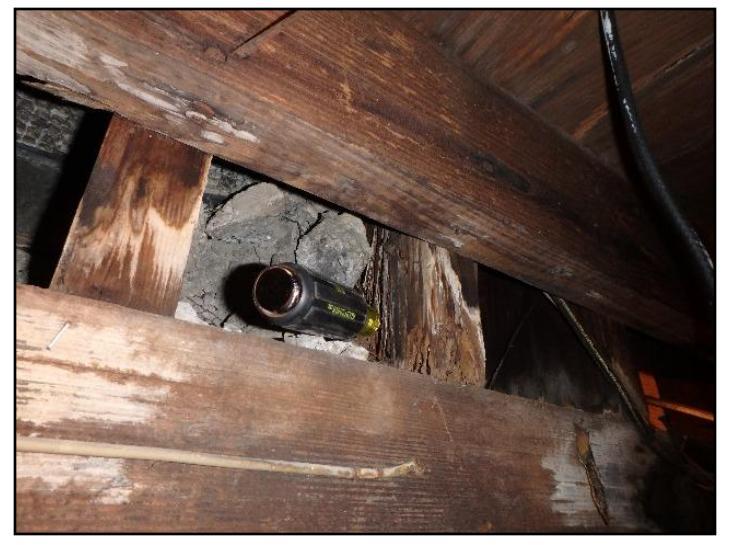
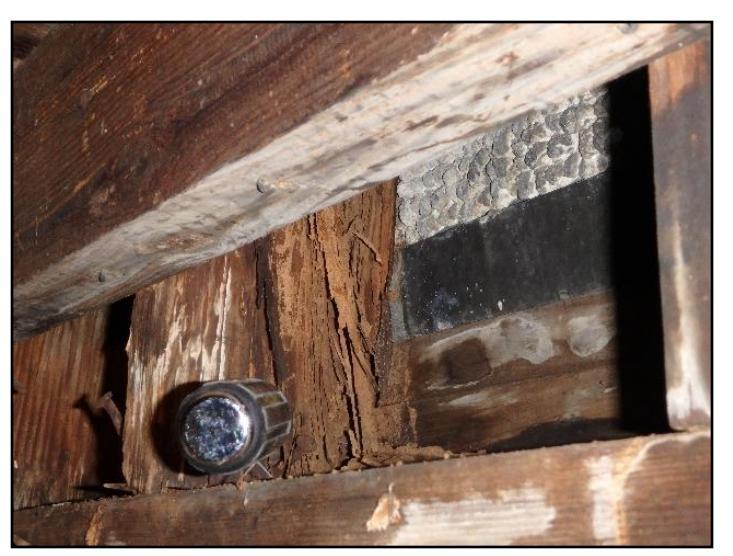
Insect damage

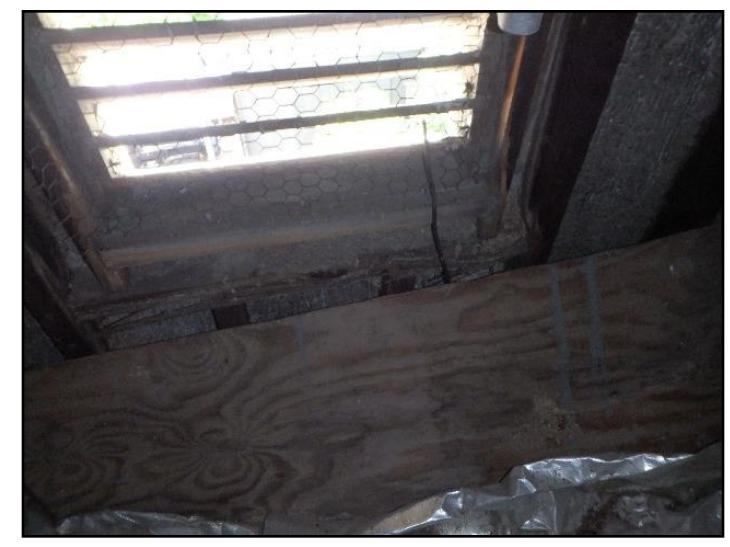
ROOF FRAMING \ Rafters/trusses Condition: • Insect damage Location: Left Middle Attic (at valley jack rafter) Task: Repair

Insect damage

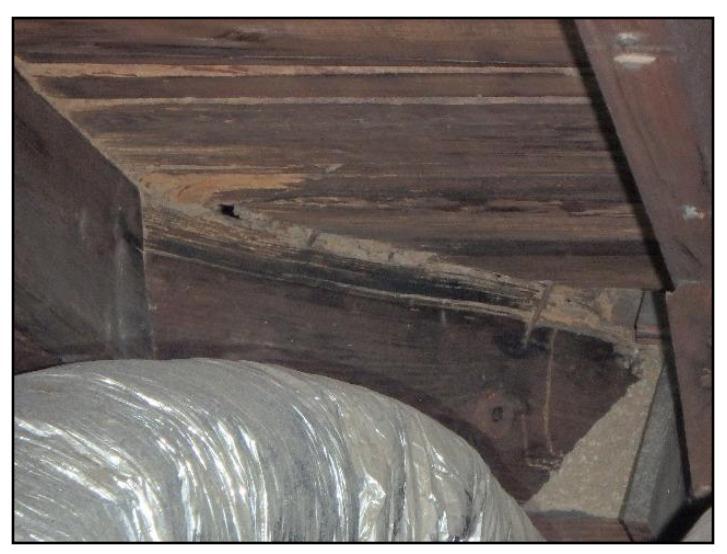
Insect damage

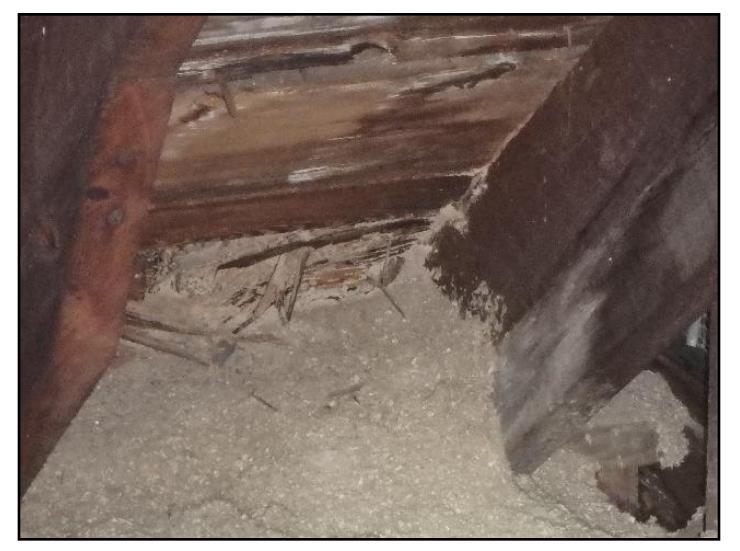
Condition: • Insect damage Location: Rear Left Attic Task: Repair

Insect damage

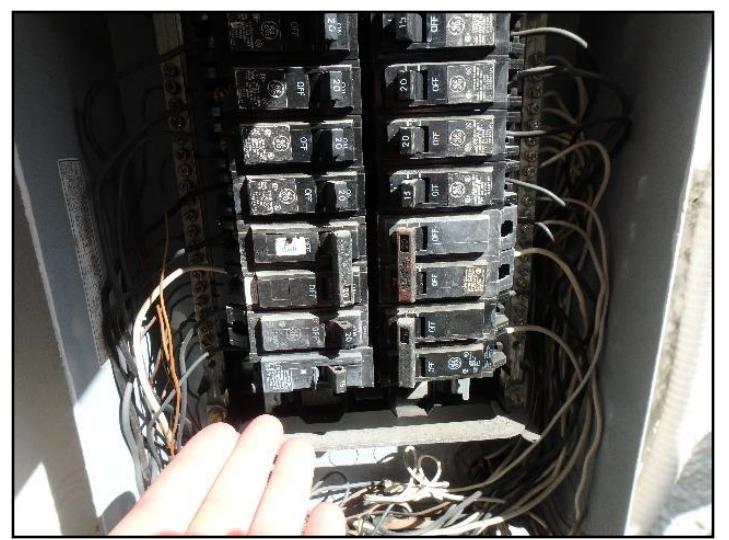
Condition: • <u>No Arc Fault Circuit Interrupter</u> Location: Rear Right Corner Exterior Wall Task: Consider upgrading to current standards

No Arc Fault Circuit Interrupter

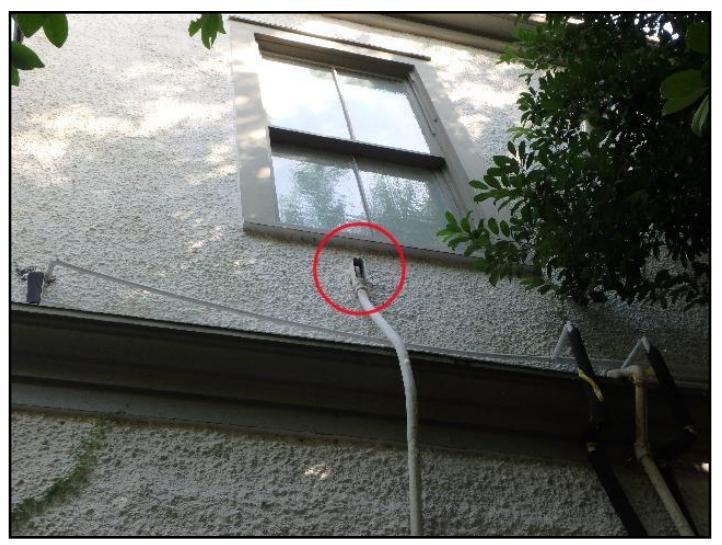
Condition: • Open conduit, exposed wiring Location: Right Side Exterior Wall Task: Correct.

Open conduit, exposed wiring

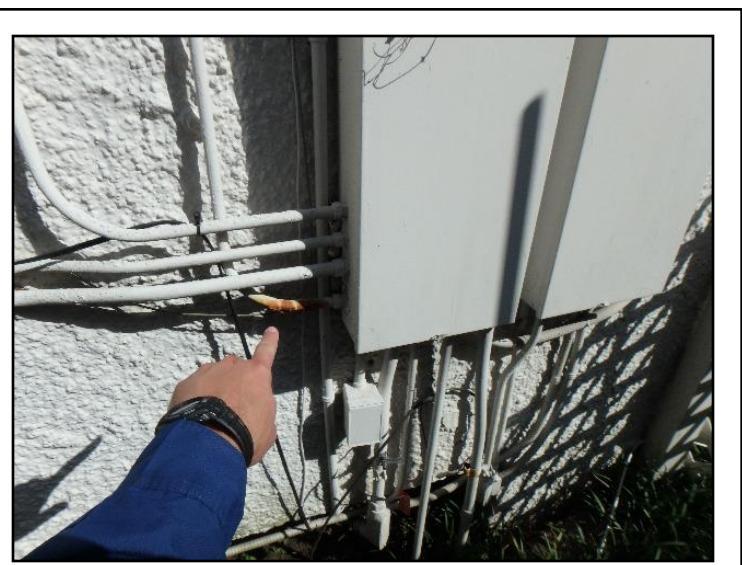
Condition: • Damaged or corroded conduit **Location**: Rear Right Corner Exterior Wall **Task**: Replace.

Damaged or corroded conduit

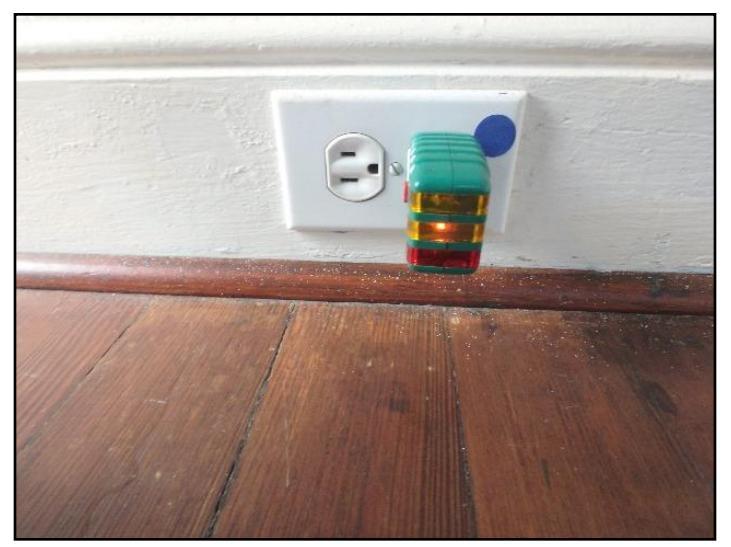
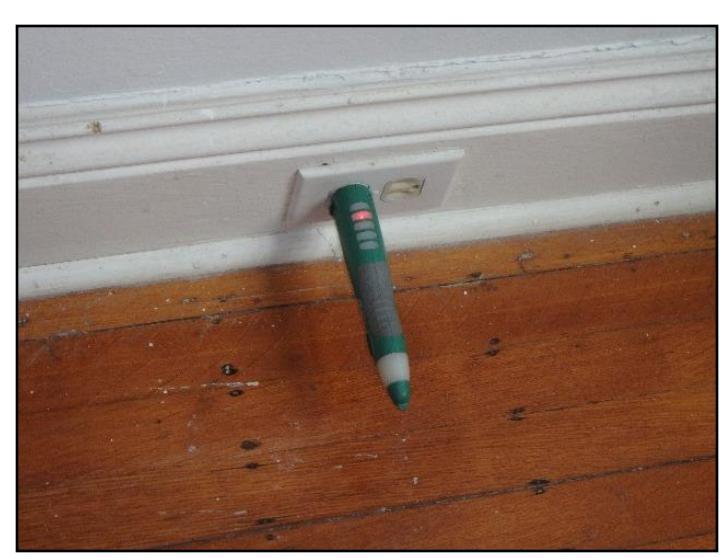
Condition: • Ground needed for 3-slot outlet

Ground needed for 3-slot outlet

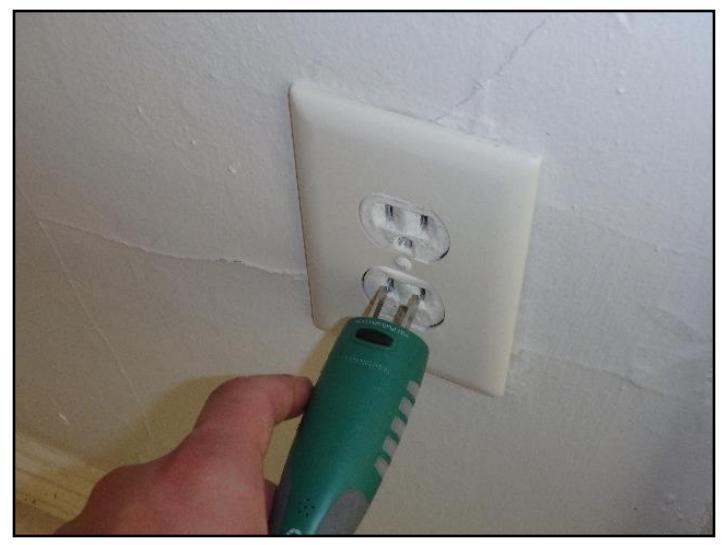
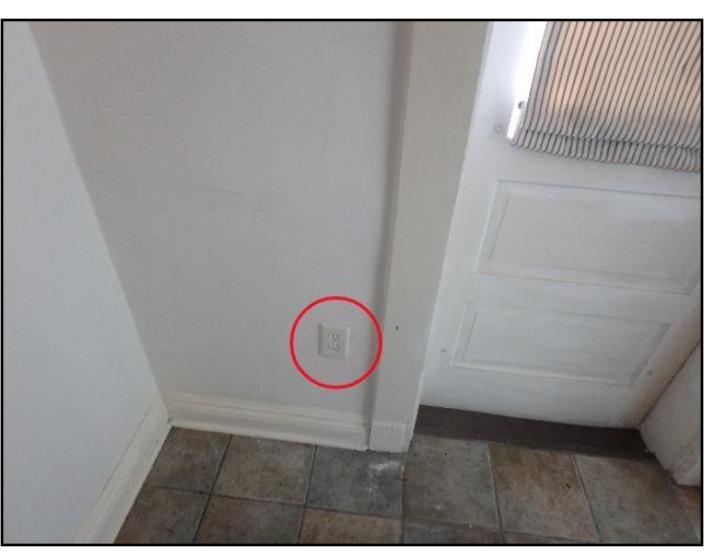
Condition: • Broken pin or blade in slots Location: First Floor Hall By Rear Door Task: Replace.

Broken pin or blade in slots

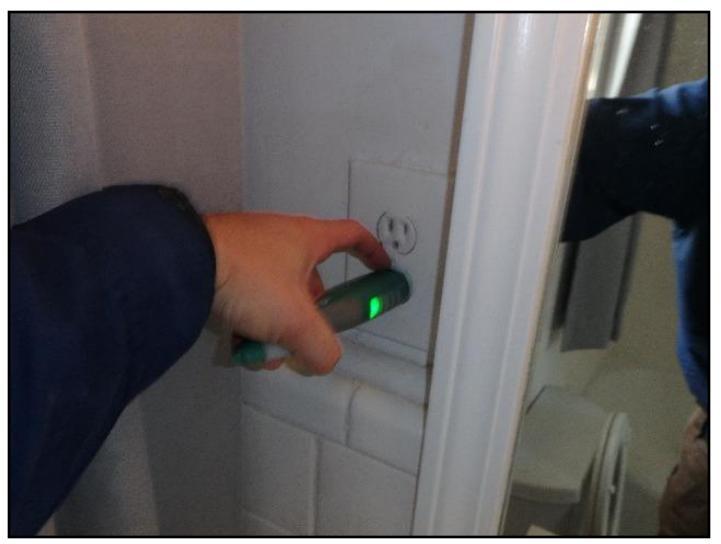
Condition: • <u>GFCI/GFI needed (Ground Fault Circuit Interrupter)</u> Location: First Floor Bathrooms Task: Recommend upgrading to current standard

GFCI/GFI needed (Ground Fault Circuit...

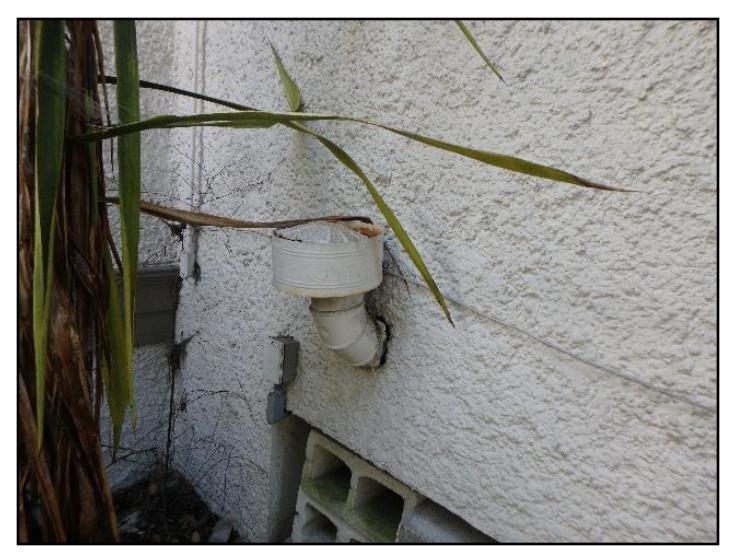
Improper Termination

Task: Correct.

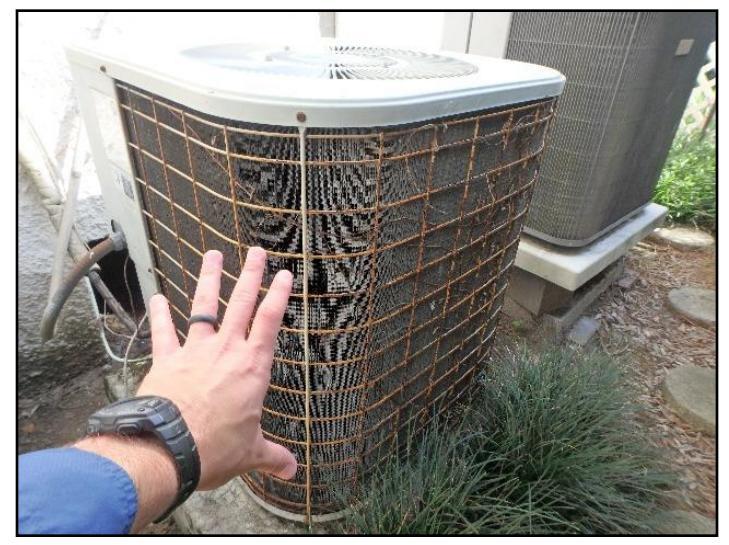
Condition: • <u>Damage</u> Unable to determine extent of damage. Location: Right Side Exterior

Damage

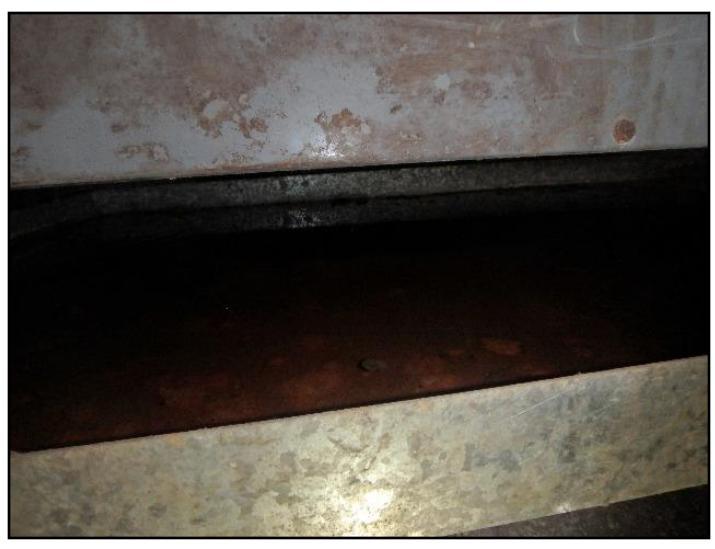
Water in pan

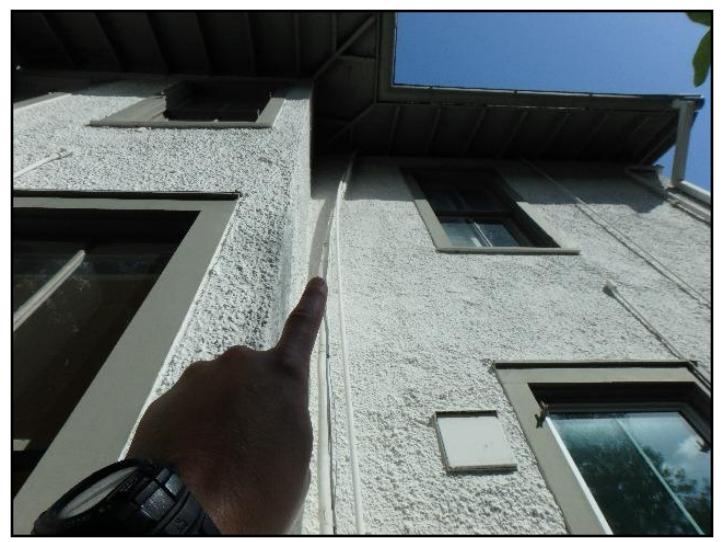
Condition: • Improper discharge point Location: Right Side Exterior Wall Task: Correct.

Improper discharge point

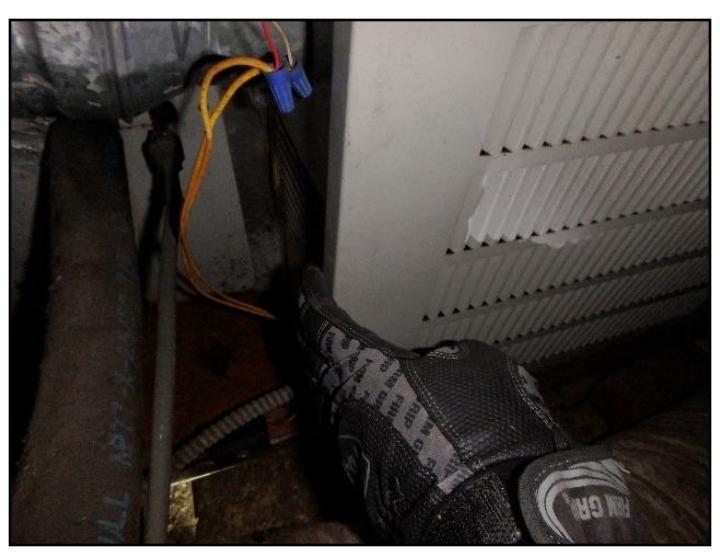
AIR CONDITIONING \ Ducts, registers and grilles Condition: • Disconnected or leaking Location: Attic Next to Unit

Disconnected or leaking

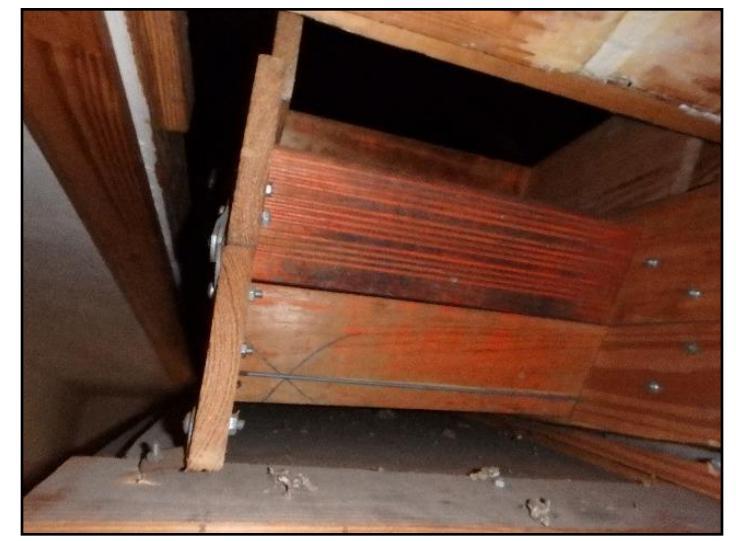
Condition: • Attic pull down ladder was cut too short and difficult close. Location: Second Floor Hall Task: Repair or replace.

Difficult to Close

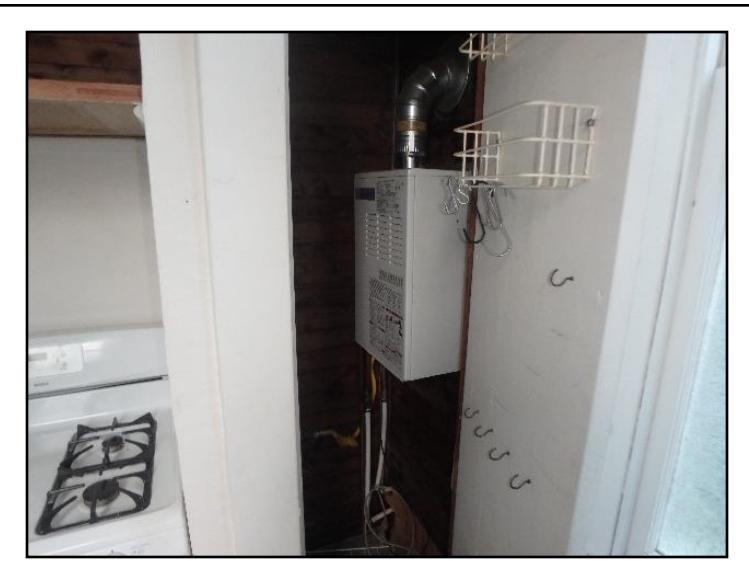
Inadequate combustion air

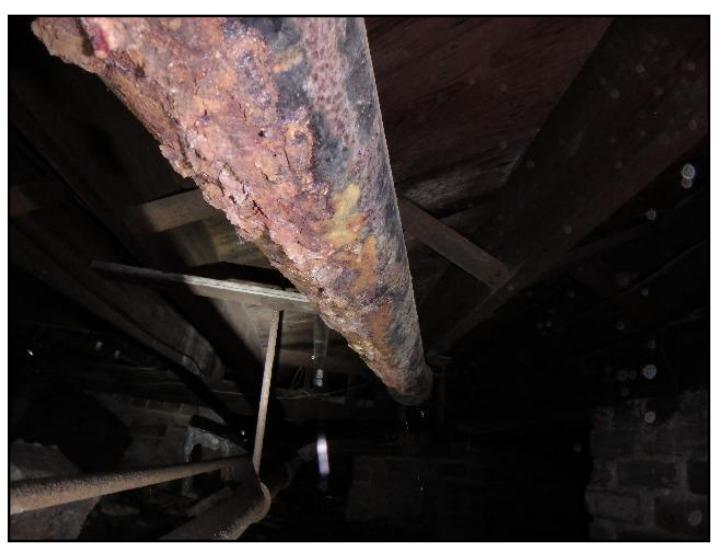
Rust

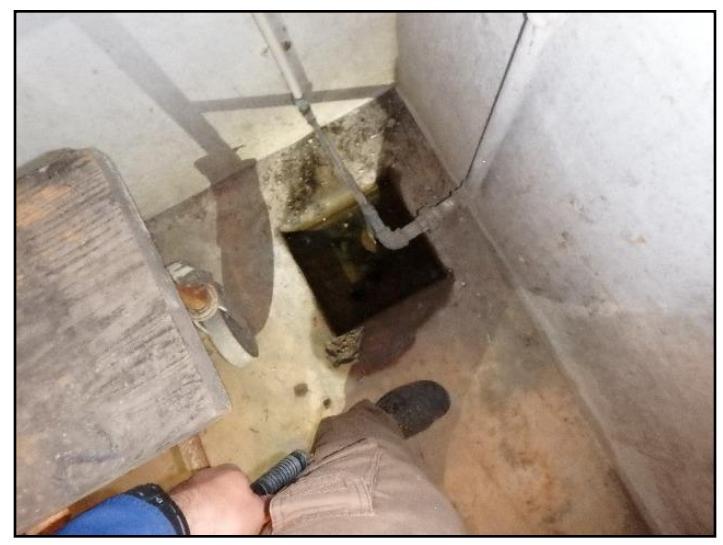
Possible Sump Pump Issue

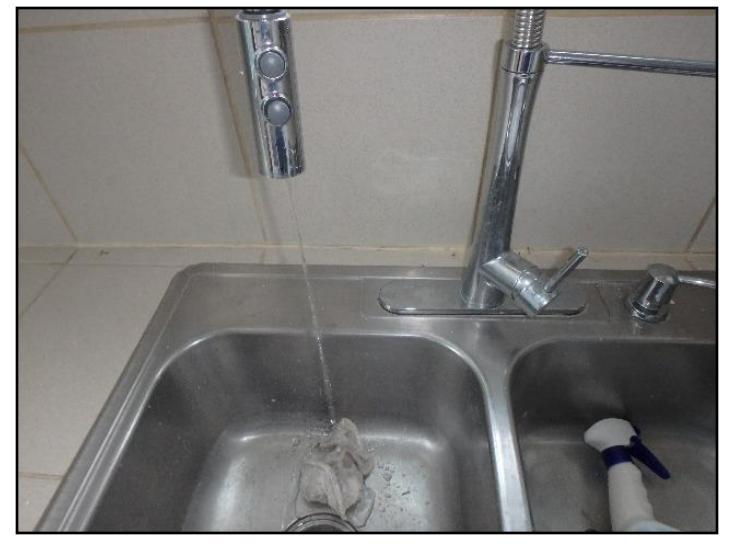
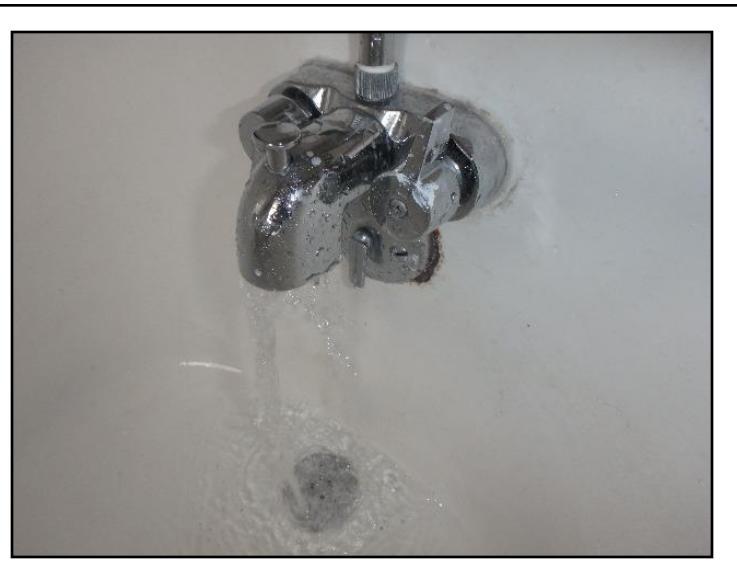
Condition: • Weak pressure or flow **Location**: Second Floor Kitchen and Bathroom Fixtures **Task**: Further Investigation. Repair

Weak pressure or flow

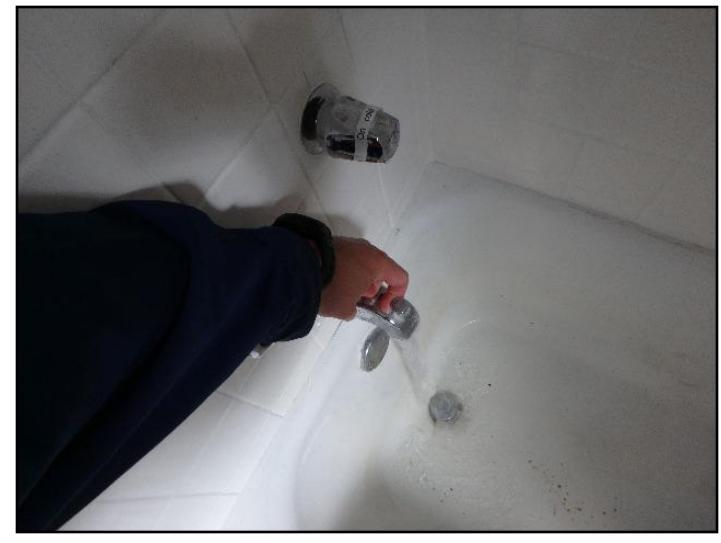
Condition: • <u>Shower diverter inoperative or defective</u> Location: First Floor Bathroom Task: Correct. Adjust.

Shower diverter inoperative or defective

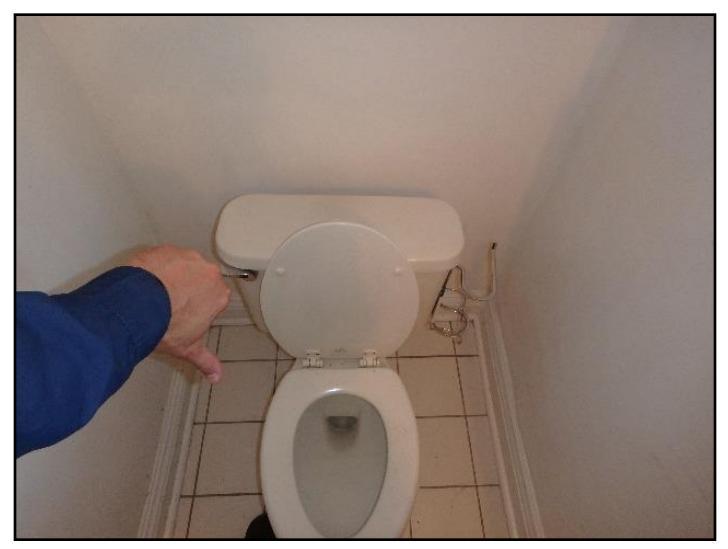
Flush mechanism inoperative

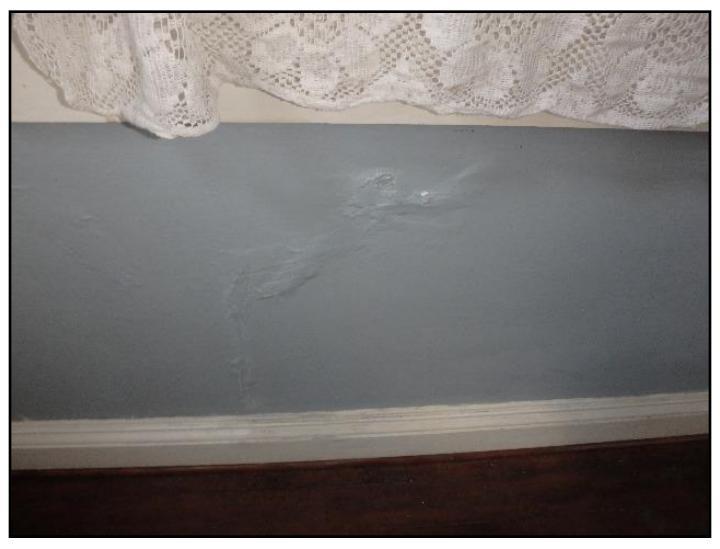
Water damage

Task: Repair

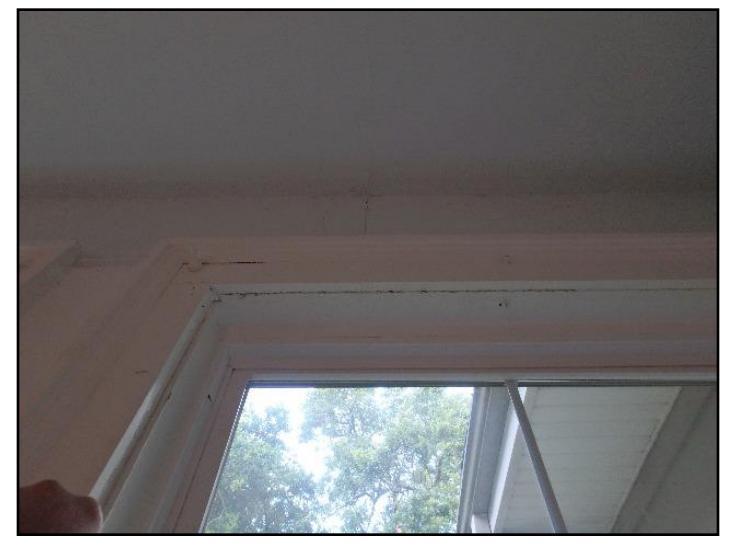
Prior Water Damage

Task: Possibility of hidden mold growth - See Appendix

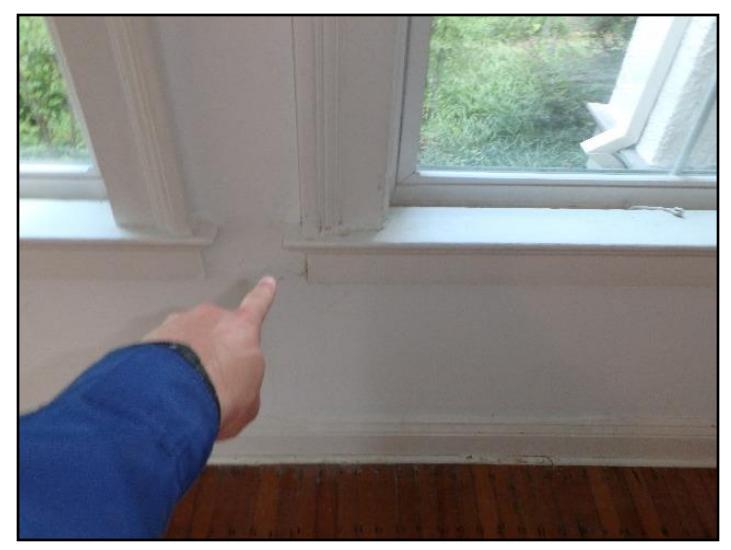
Prior Moisture Damage

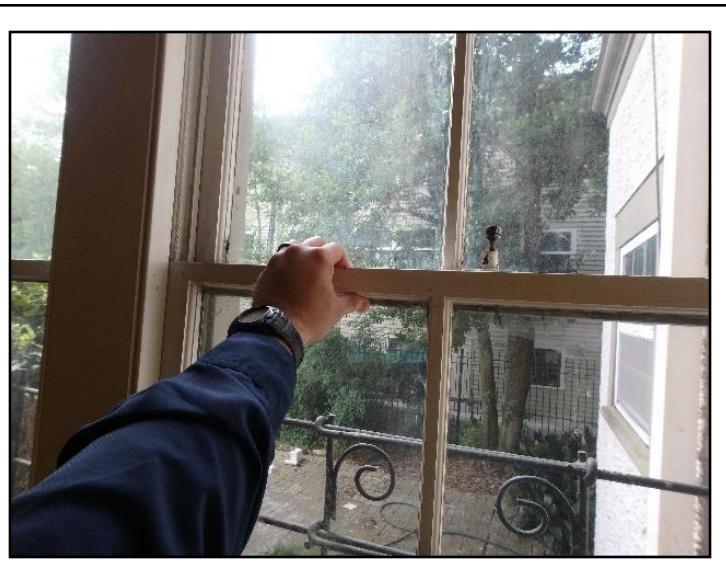
Painted/Sealed Shut

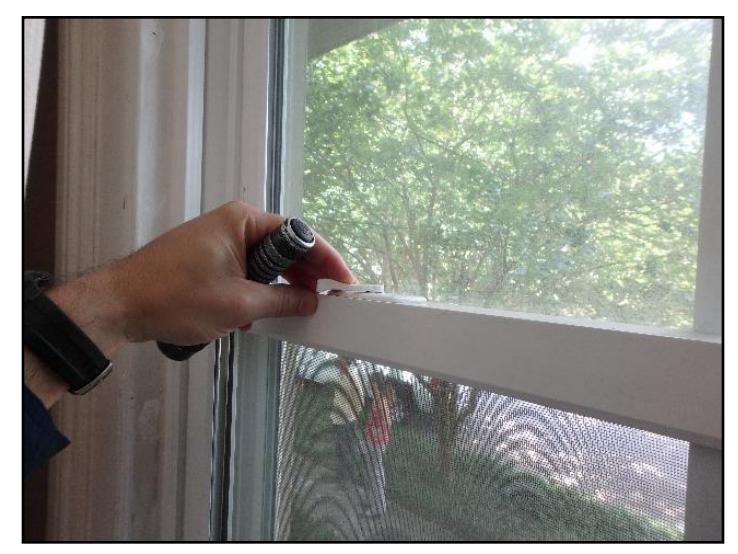
Cracked

Latch Broken

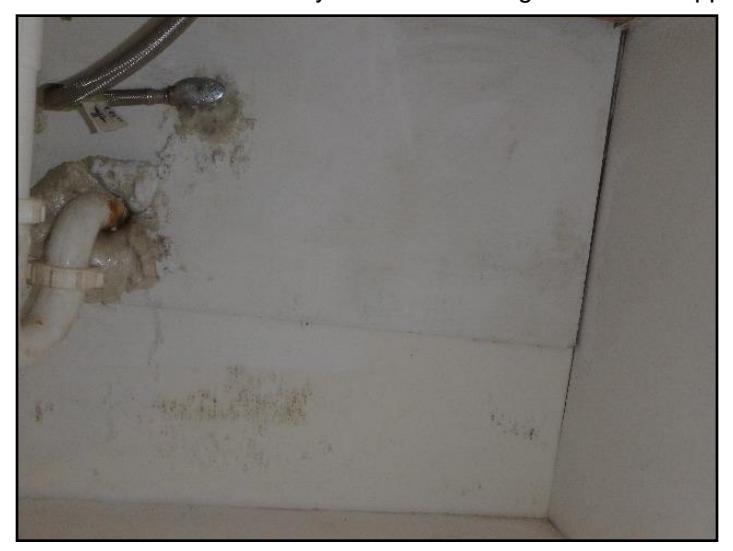
Condition: • Surface mold. Location: First Floor Front Bathroom Task: Remove. Possibility of hidden mold growth - See Appendix

Surface mold.

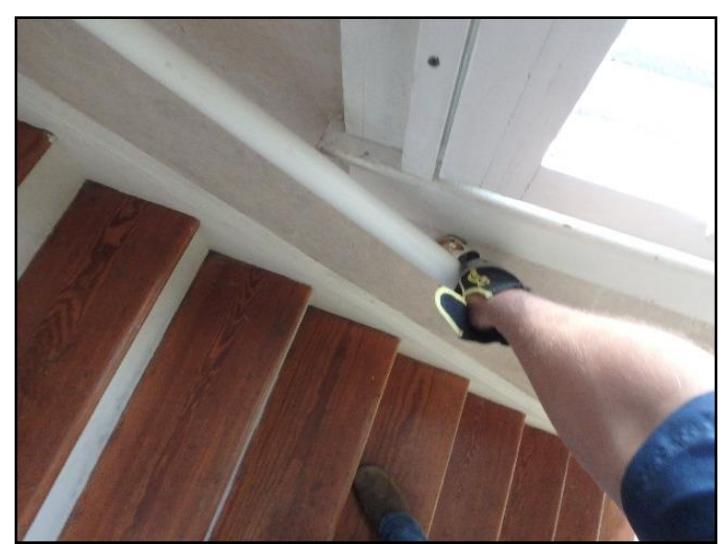
Loose

Task: Tighten

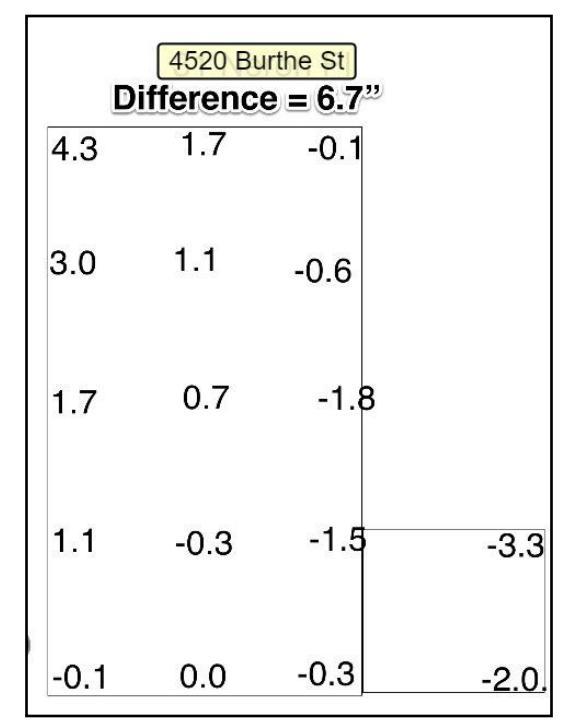
Drawing not scale; Locations approximate

Note: The maximum differential found was 6.7" as shown on the drawing below. According to one of the leading local engineering firms, the average differential for all residential foundations in the New Orleans area is about 3.2". The average for reinforced concrete slabs about 2.9" and for pier and beam foundations about 3.6". Allowances are made for floor coverings and materials. Additions and enclosed areas built with a designed slope are not included. All measurements taken are not shown. The drawing is not to scale and locations are approximate.
