Inspection Report

1431 N. Holland St New Orleans, LA 70119

Inspection Date: Wednesday, May 2, 2018

RE: Report No. 7957, v.8 1431 N. Holland St New Orleans, LA 70119

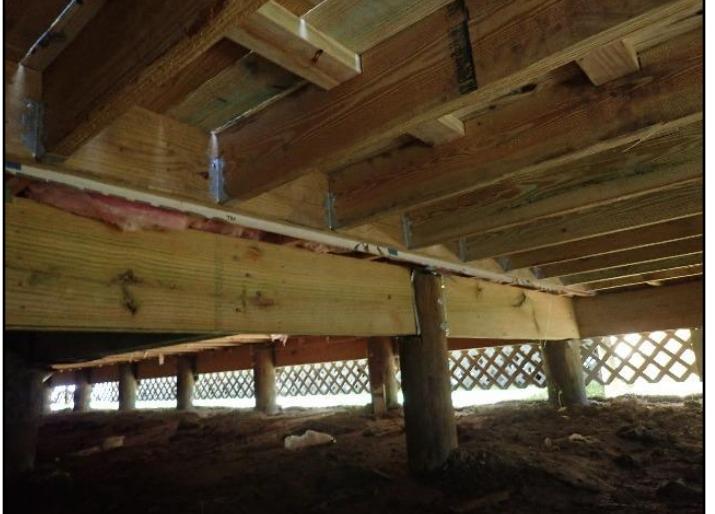
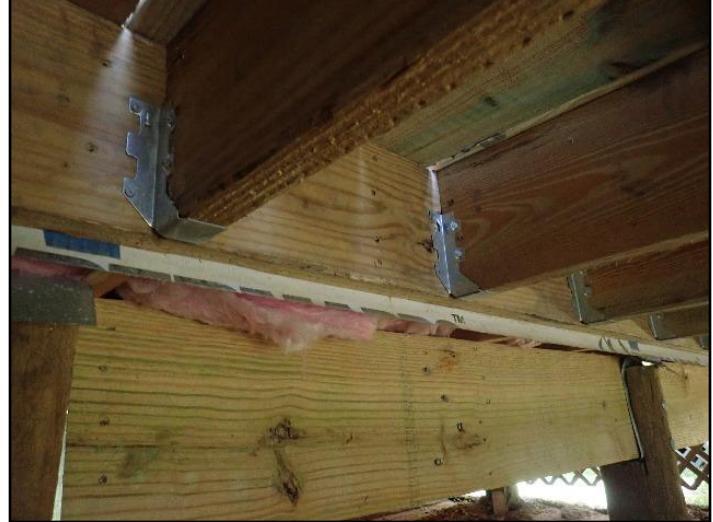
Condition: • Ledgerboard problems

Front and rear decks did not have lag bolts running through the ledgerboards. Recommend installing for additional support.

Ledgerboard problems

Task: Improve.

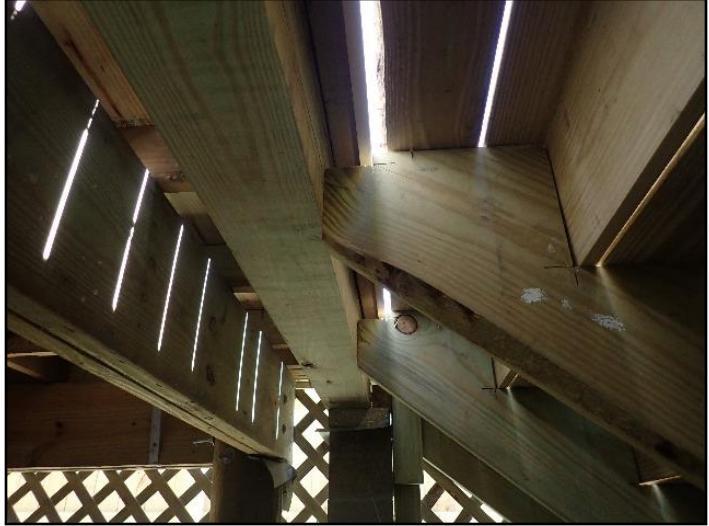
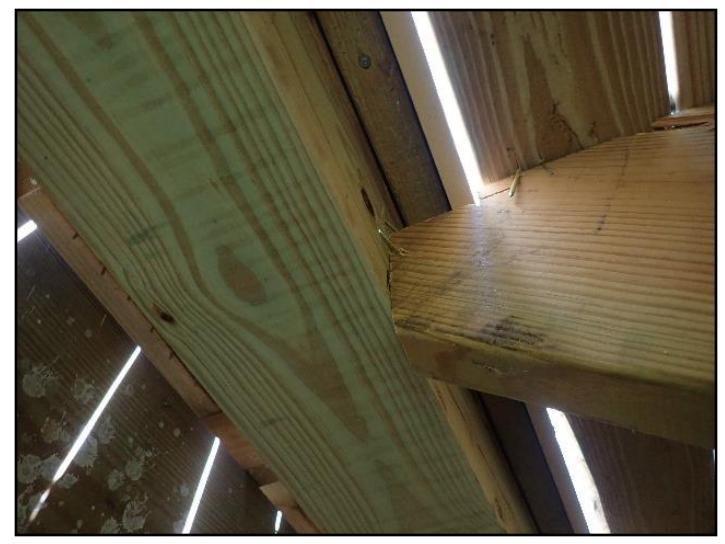
Condition: • Stringers - Poor end bearing

Stringers - Poor end bearing

Task: Correct.

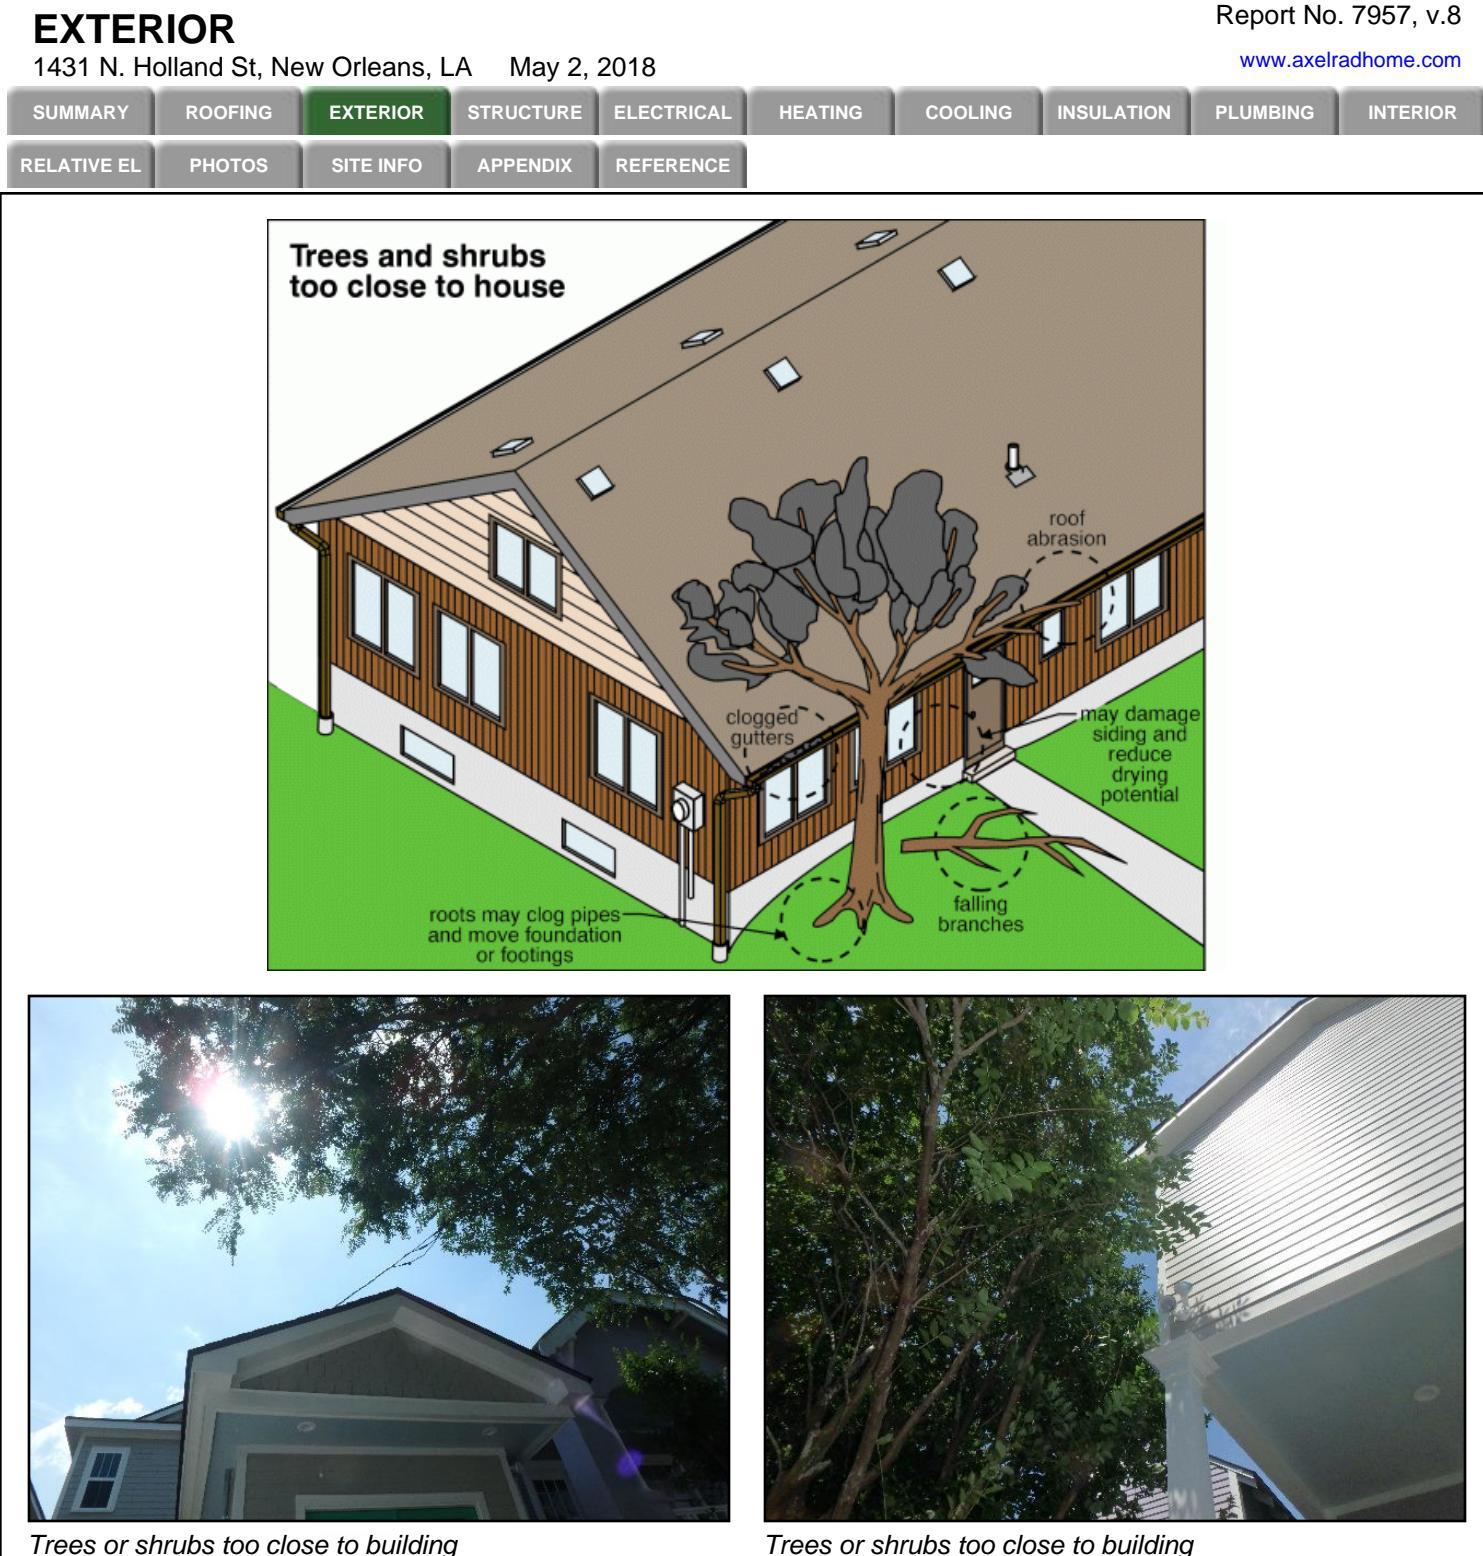
Condition: • Trees or shrubs too close to building

Trees and branches overhang or touch roof and prevent proper drying, increases the chance of moisture damage. Branches can also damage siding and provide an access point for pests.

Trees or shrubs too close to building

Task: Trim back trees from over roof and walls.

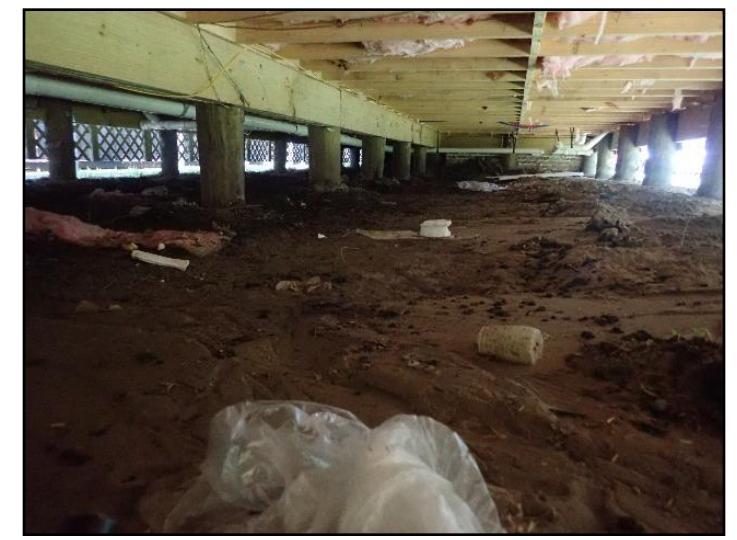
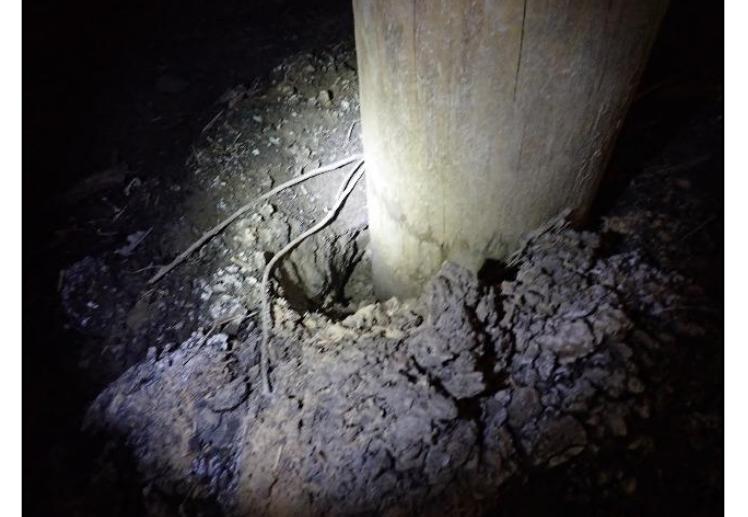
Condition: • Ground that slopes toward the house can funnel surface water from rain against the foundation slab or piers. This can lead to undermining of the foundation, sinkholes and/or standing water. The ground should slope down away from the building.

The crawlspace was very damp and muddy. The grading sloped towards the center of the crawlspace. Additionally, various pilings had holes around them that should be filled to prevent moisture from ponding. Recommend improving the grading throughout to shed water away from the foundation.

Ground that slopes toward the house can...

Task: Improve.

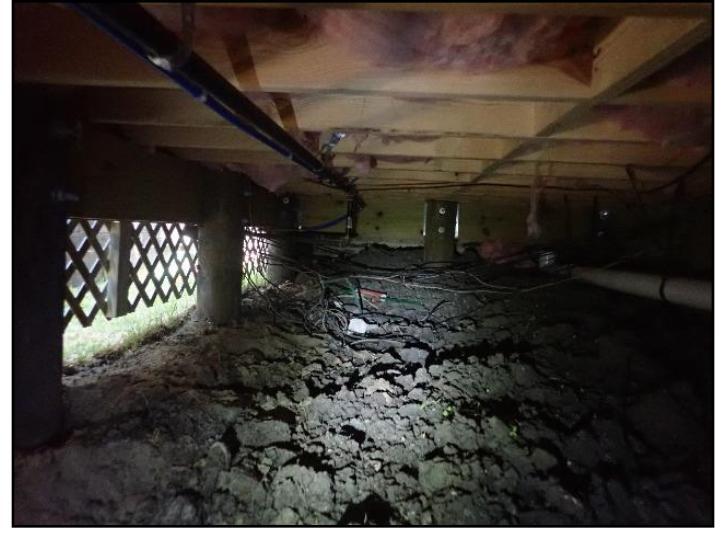
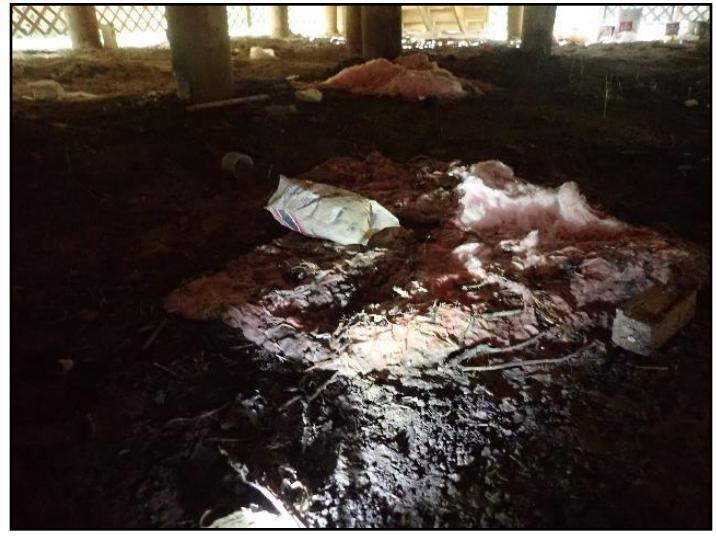
Condition: • Crawlspace debris

Various bits of trash and insulation were noted throughout the crawlspace. Wiring was also hanging onto the ground at the front of the crawlspace.

Crawlspace debris

Task: Clean.

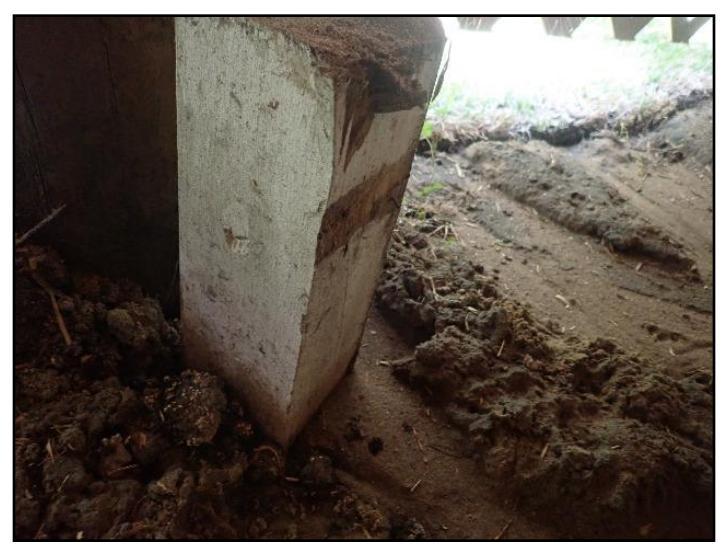
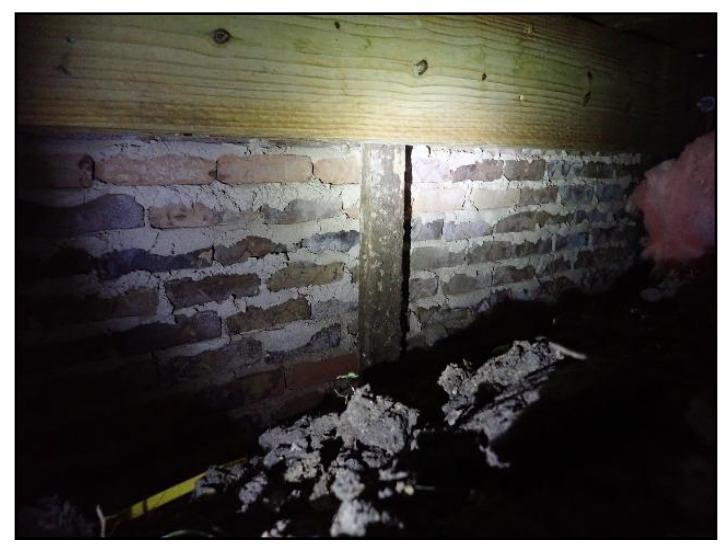
Condition: • <u>Wood/soil contact</u> Location: Various Throughout Crawl Space Task: Remove.

Wood/soil contact

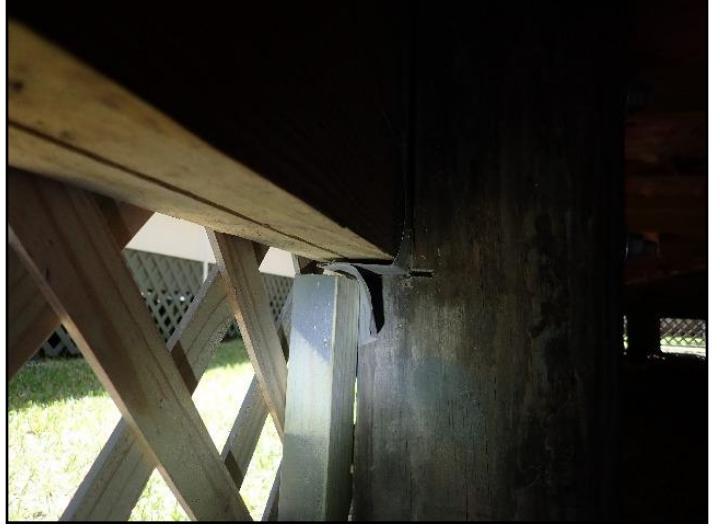
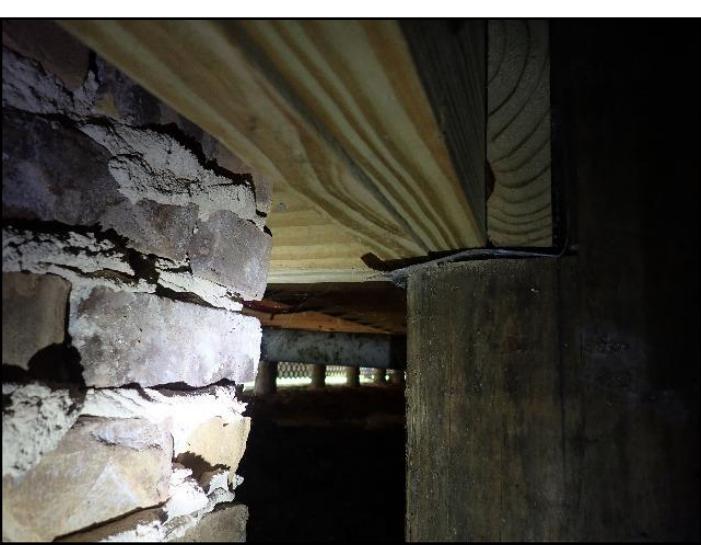
Condition: • Poor end bearing on pier. Various joists/sills did not have full bearing on the pilings. **Location**: Various Throughout Crawl Space

Poor end bearing.

Task: Verify. Correct as needed.

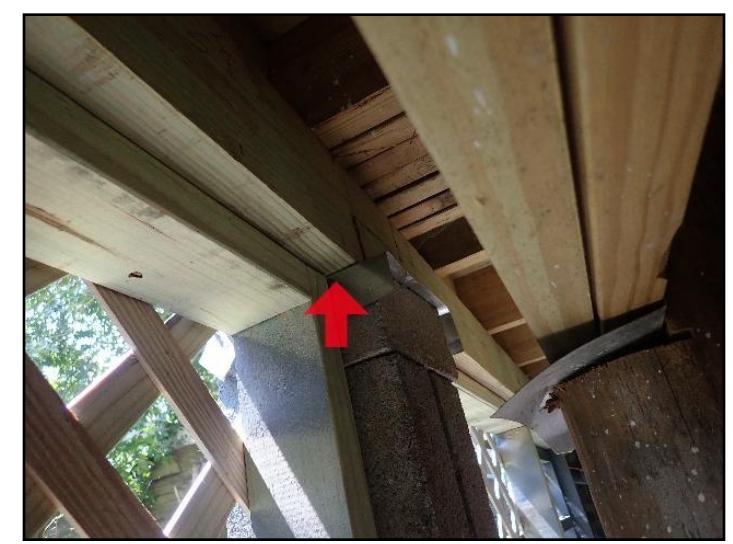
Condition: • Additional support needed Location: Rear Crawl Space Task: Correct.

Additional support needed

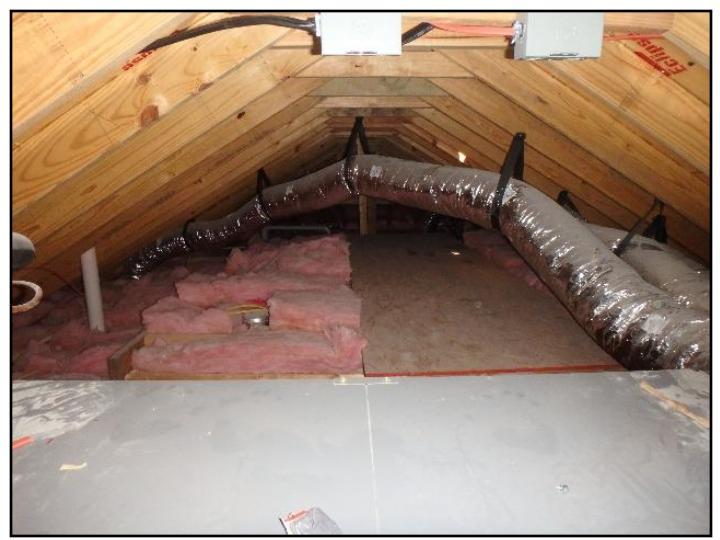
Furnace blocked access to front of attic

Restricted access

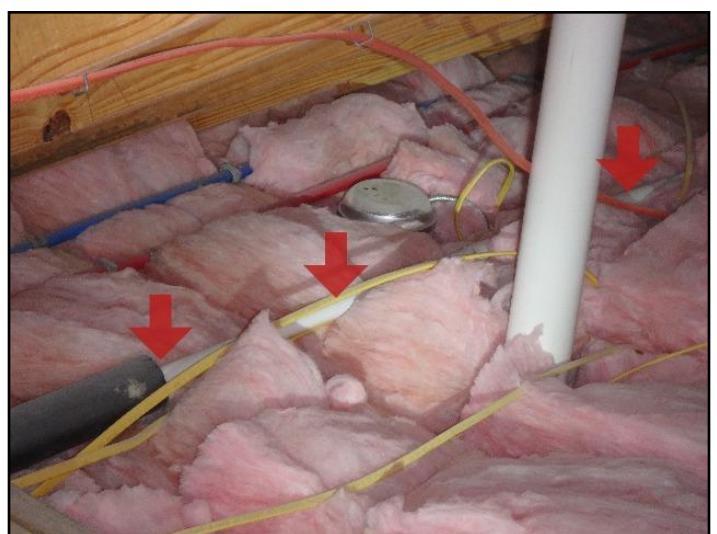
Condition: • Line not insulated

Missing insulation

Task: Include in recommended servicing

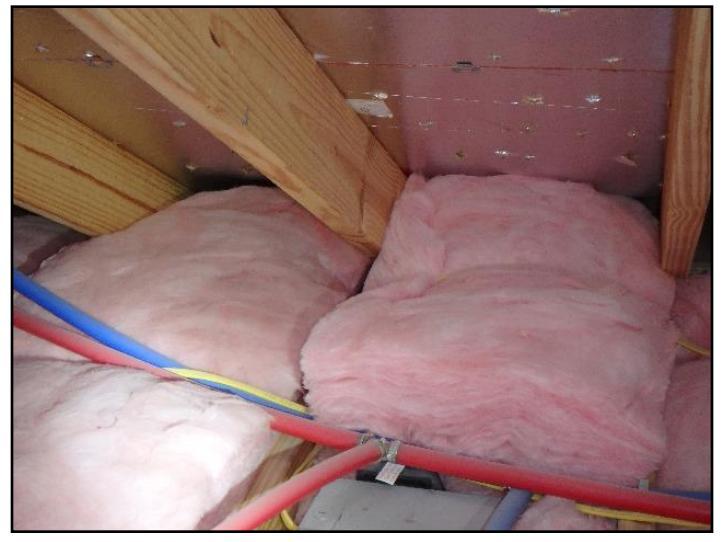
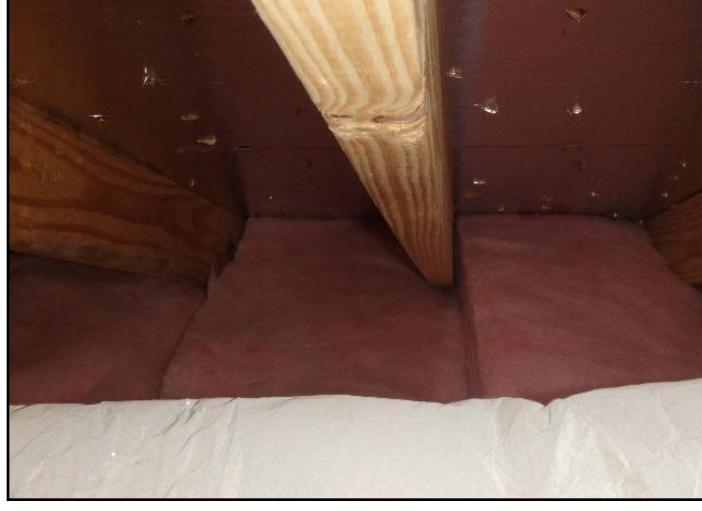
Condition: • Obstructed

Attic rafter insulation extends too far to the eaves and covers the soffit vents. Inadequate attic ventilation. This can lead to attic moisture, mold, wood rot and metal corrosion as well as reduced roof life. Lack of adequate soffit venting can also create low pressure in the attic, bringing in conditioned air and house moisture through the ceiling gaps and into the attic. **Location**: Attic

Obstructed

Task: Recommend installing rafter baffle vents or pulling back insulation from over soffit vents

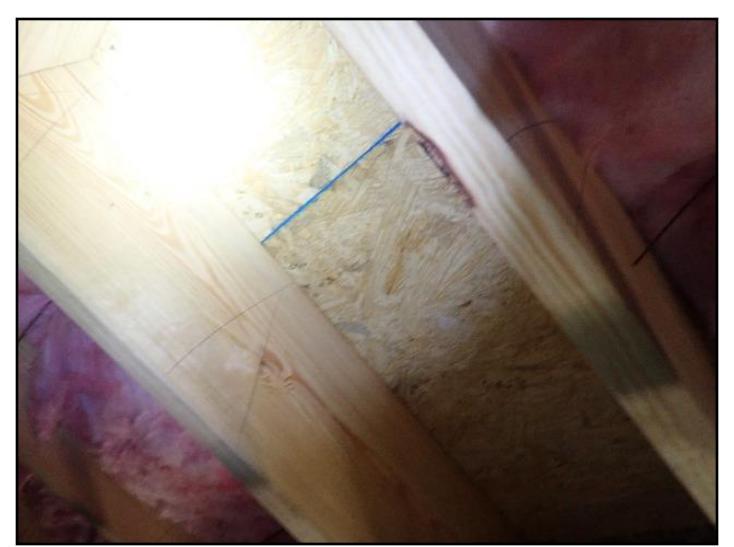
Condition: • Gaps or voids Location: Center Crawl Space Task: Correct.

Gaps or voids

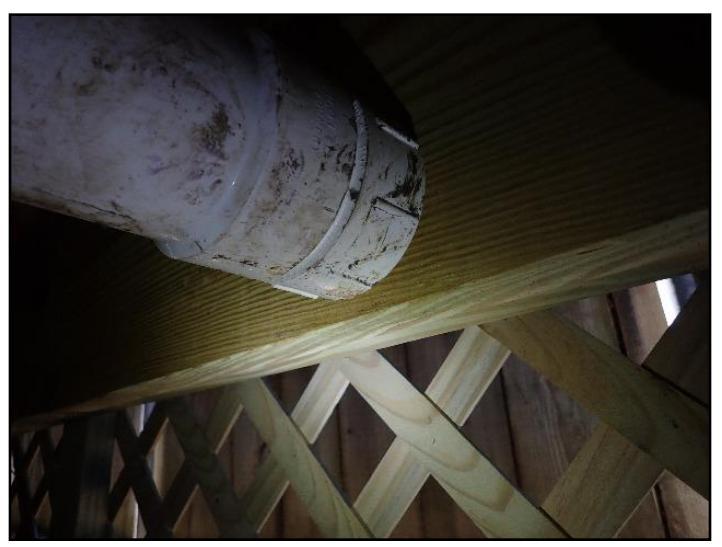
Condition: • Clean out - poorly located Cleanout butts up to the framing so access is difficult. Location: Right Side Crawl Space Task: Correct.

Clean out - poorly located

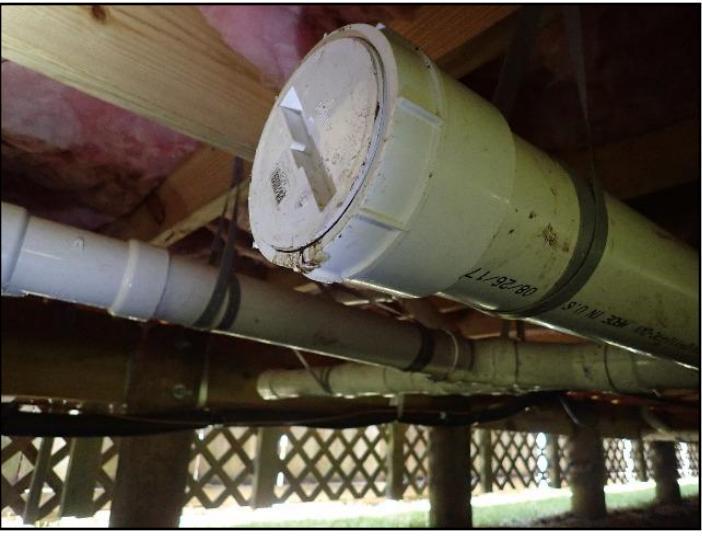
Condition: • Leak Slow drips noted at both cleanouts in the right side of the crawlspace. Location: Various Crawl Space Task: Repair.

Leak

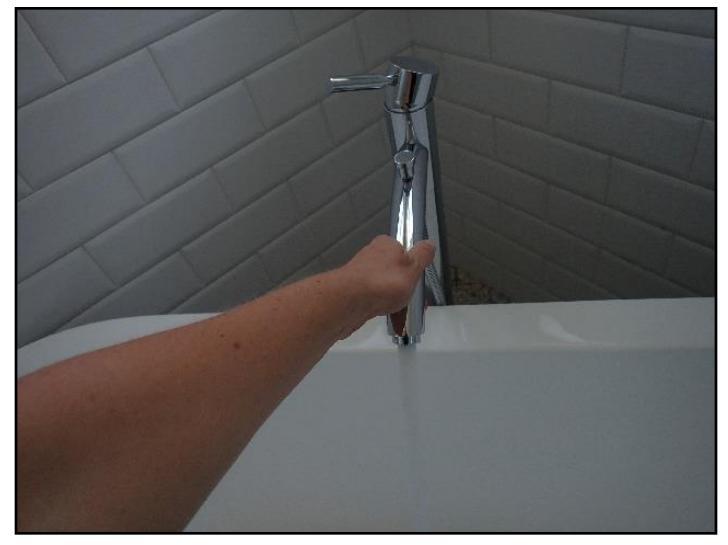
Condition: • Loose Location: First Floor Bathroom Task: Repair.

Loose

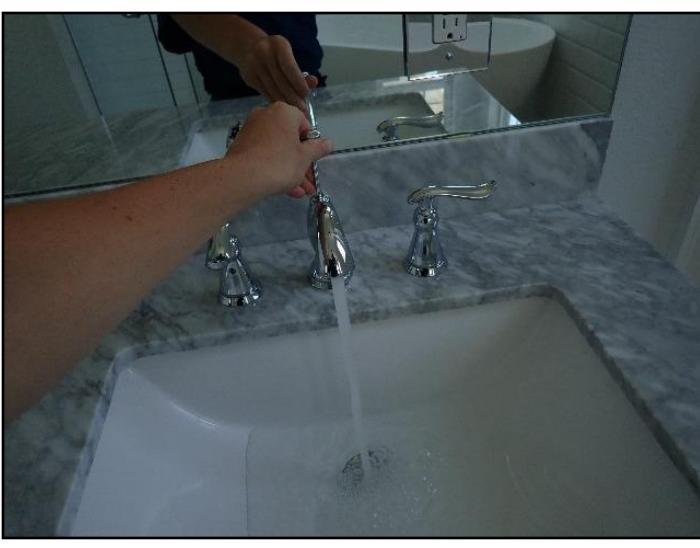
FIXTURES AND FAUCETS \ Basin, sink and laundry tub Condition: • Drain stop ineffective Location: First Floor Bathroom

Drain stop ineffective

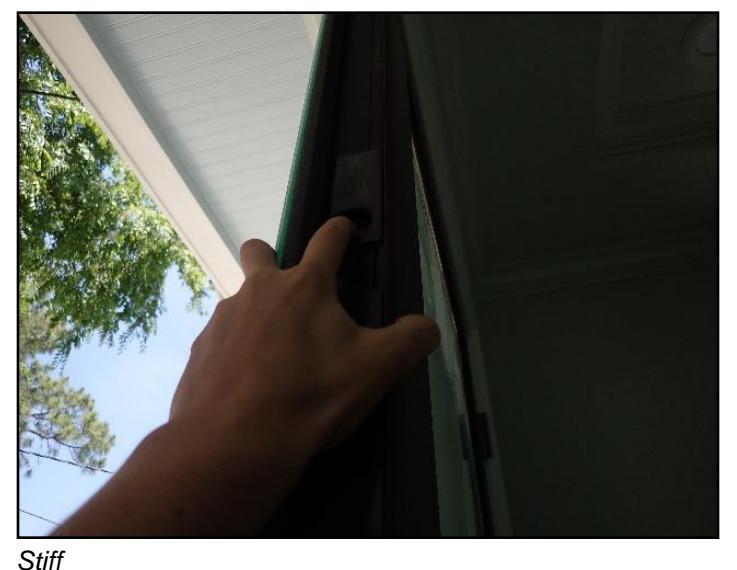
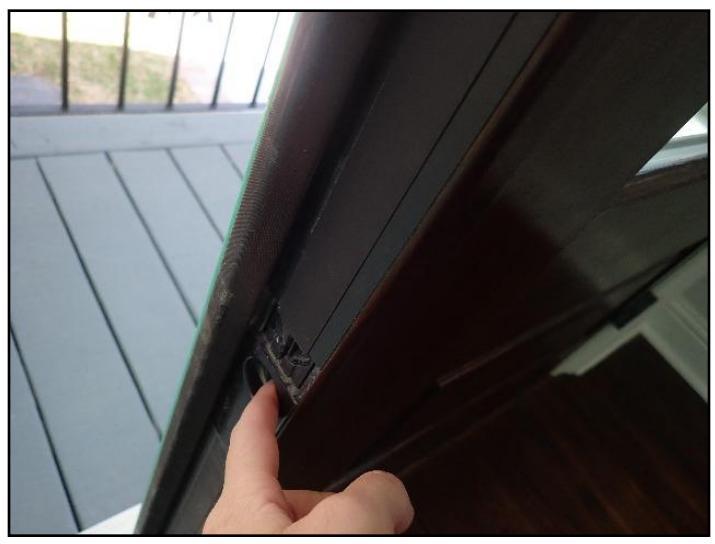
Condition: • Stiff Location: Rear Exterior Task: Repair.

Stiff

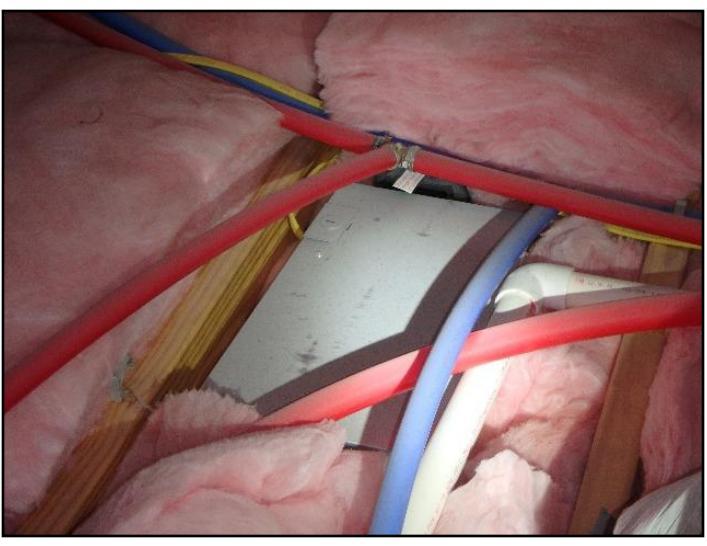
Condition: • Not vented to exterior

Bathroom exhaust fans should vent to the exterior to keep moisture from entering attic.

Excess moisture in the attic can cause rot and corrosion. This is a common problem and found in many homes. Broan, one of the largest manufacturers of vent fans advises on their web site, "Never exhaust air into spaces within walls, ceilings, attics, crawl spaces or garages. The humidity may damage the structure and insulation." Location: Rear Attic

Not vented to exterior

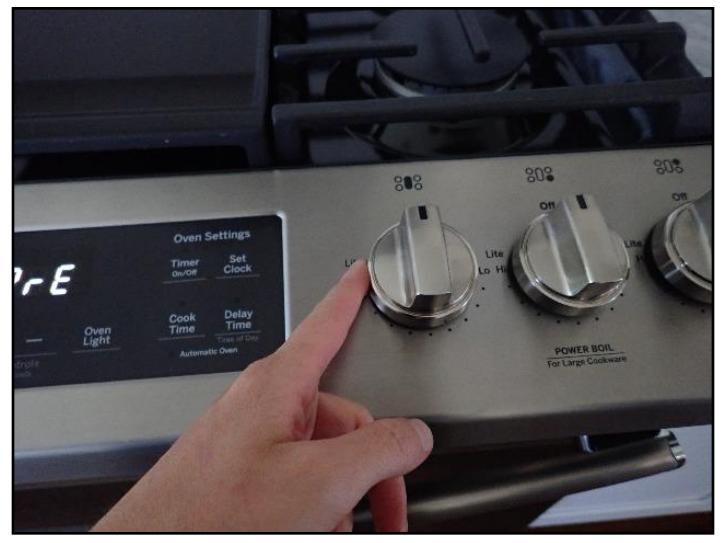
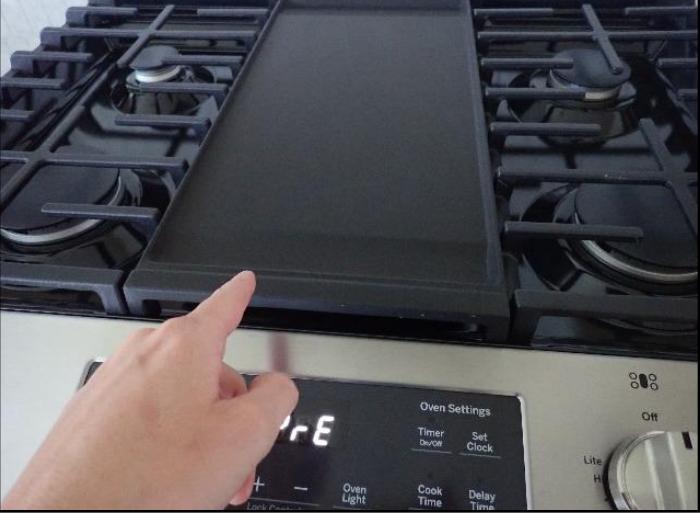
Condition: • Burner inoperative Location: Kitchen Task: Repair.

Burner inoperative

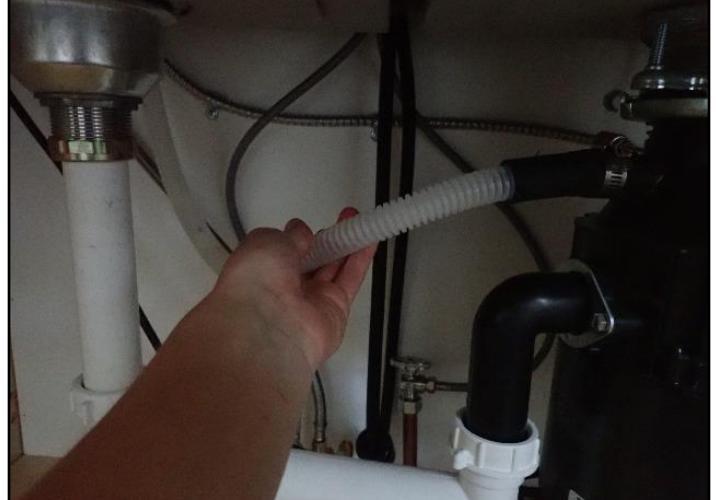
Backflow prevention missing

Task: Correct.
