Inspection Report

1333 SAMPLE FRONT ST New Orleans, LA 70130

Inspection Date: Monday, November 26, 2018

RE: Report No. 8921, v.3 1333 SAMPLE FRONT ST New Orleans, LA 70130

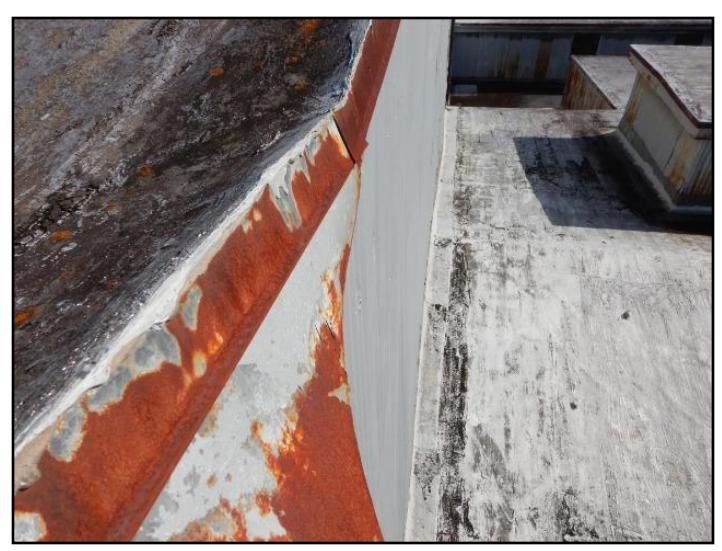
Condition: • Rust Location: Various Task: Replace.

Rust

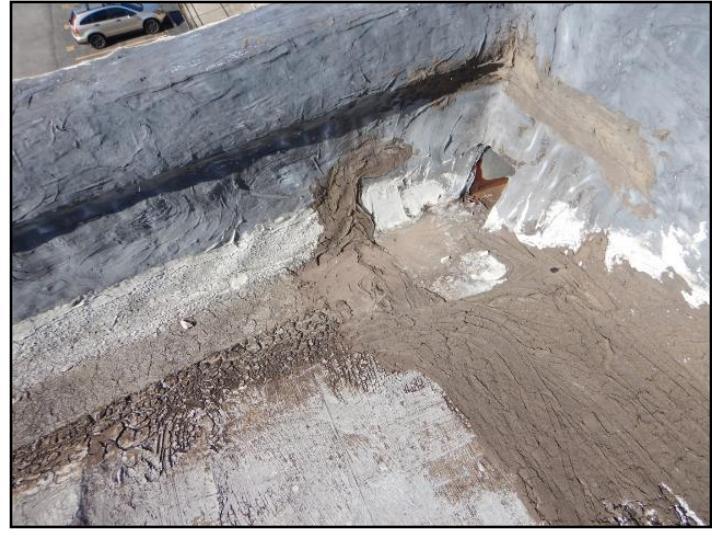
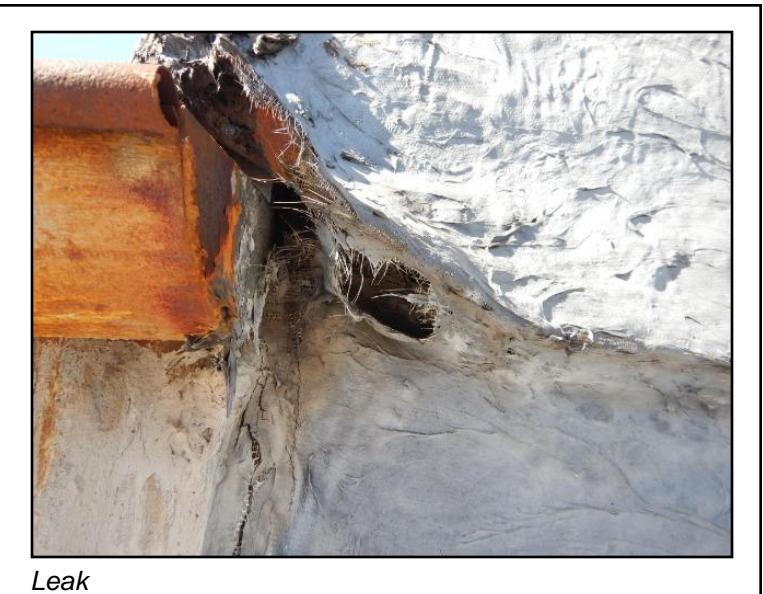
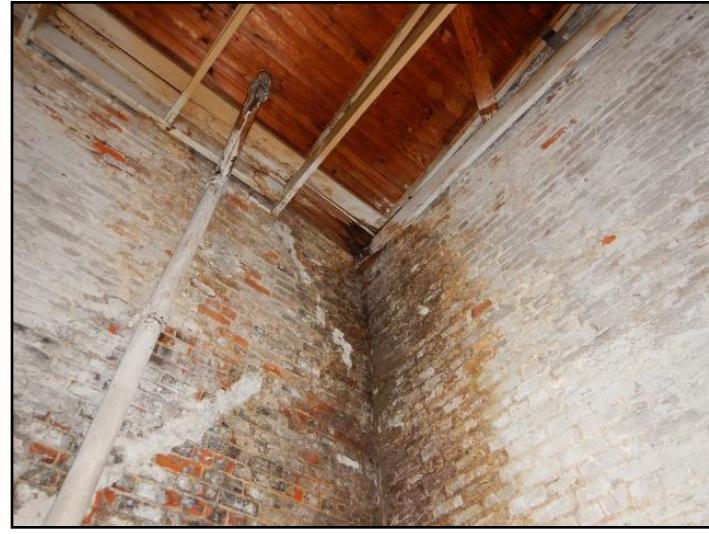
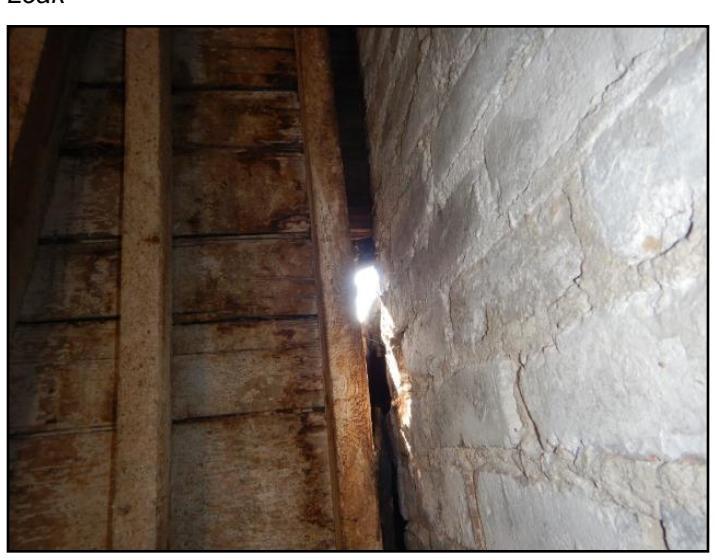
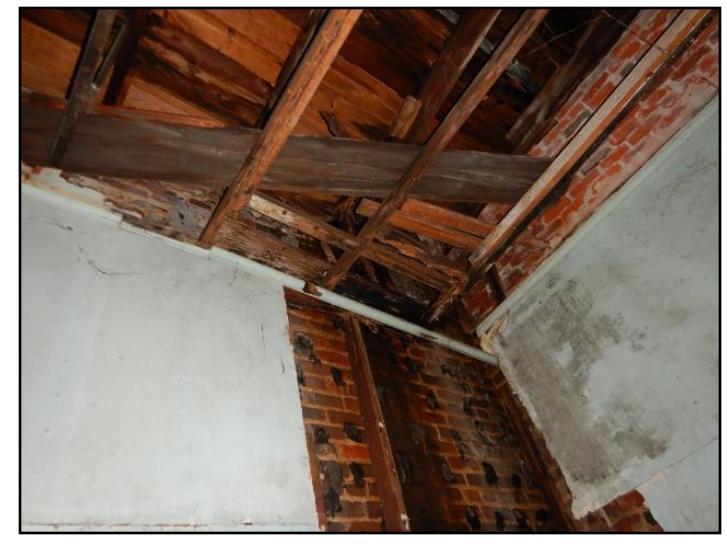
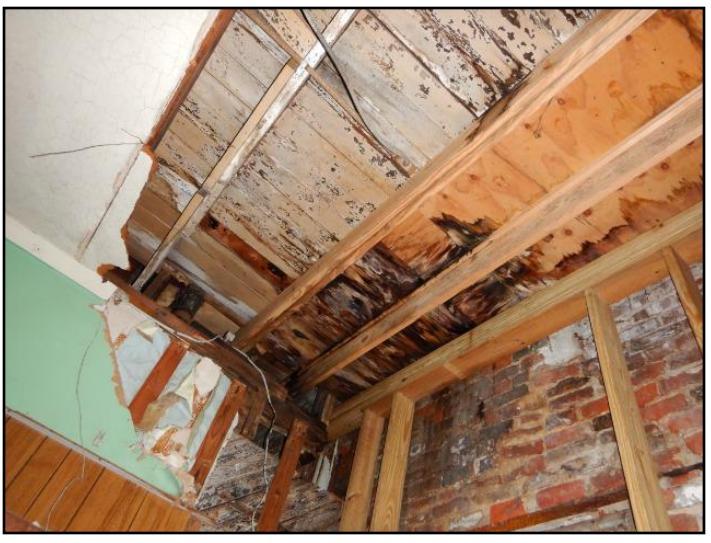
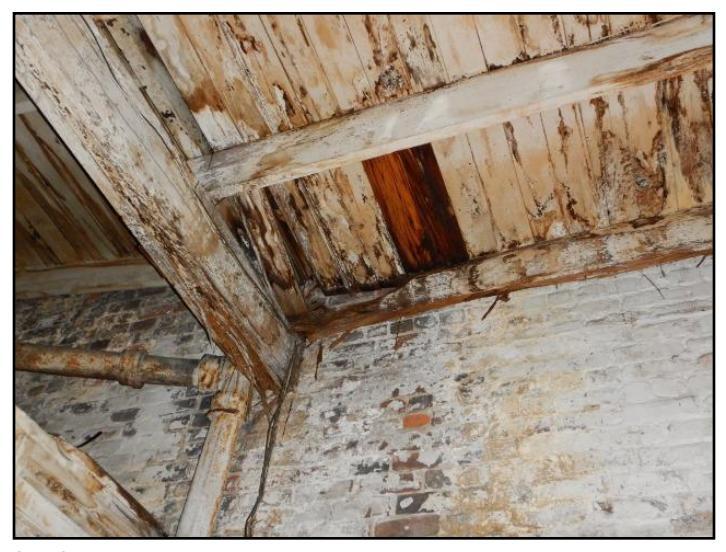
Various openings and 3 major leaks noted. Location: Various, Rear Left, Front Right Task: Repair or replace.

Condition: • Leak

Leak

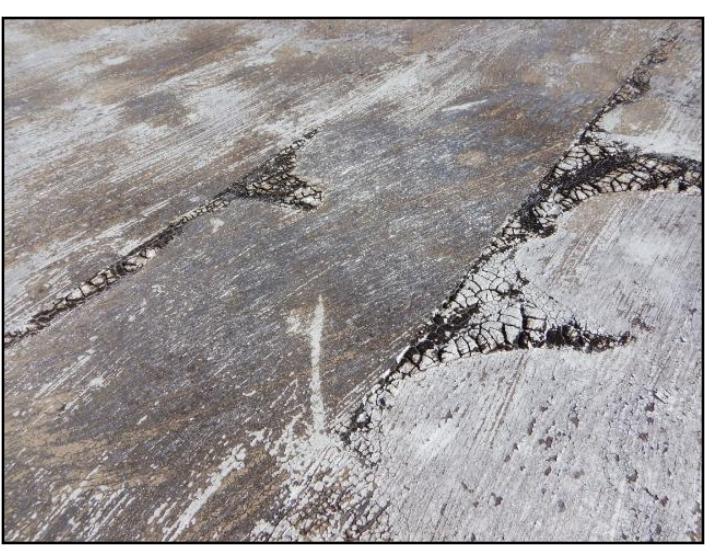
Exposed membrane throughout most of roof. Near end of life expectancy. Resurfacing or replacement likely needed. **Location**: Throughout **Task**: Further evaluation.

Condition: • Old, worn out

Old, worn out

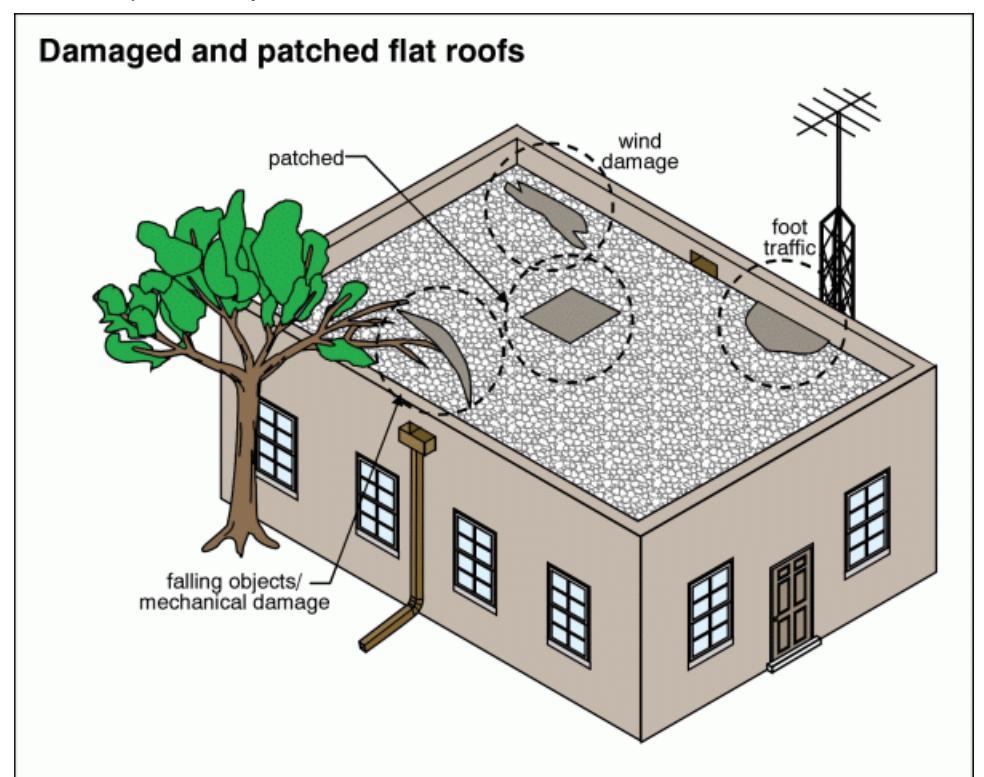
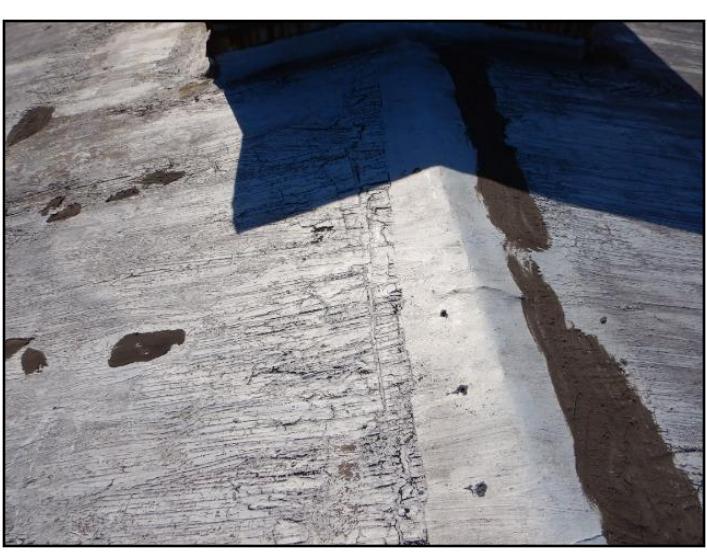
Condition: • Patched

Location: Various

Patched

Task: Prior repairs should be periodically monitored.

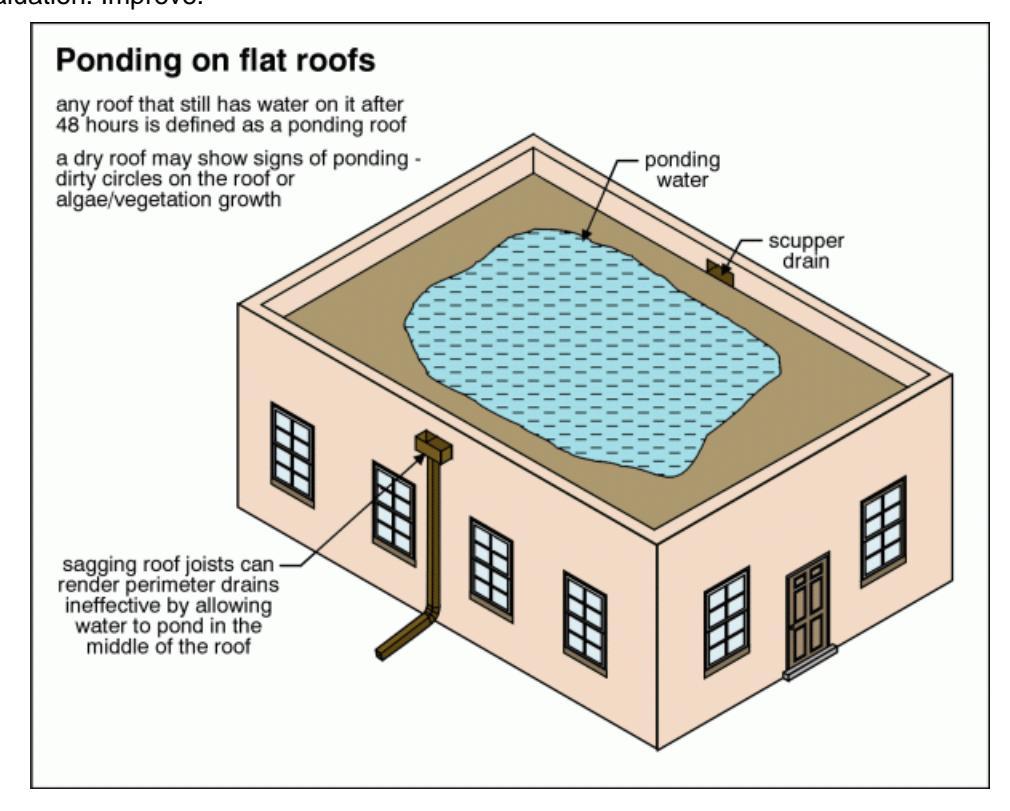
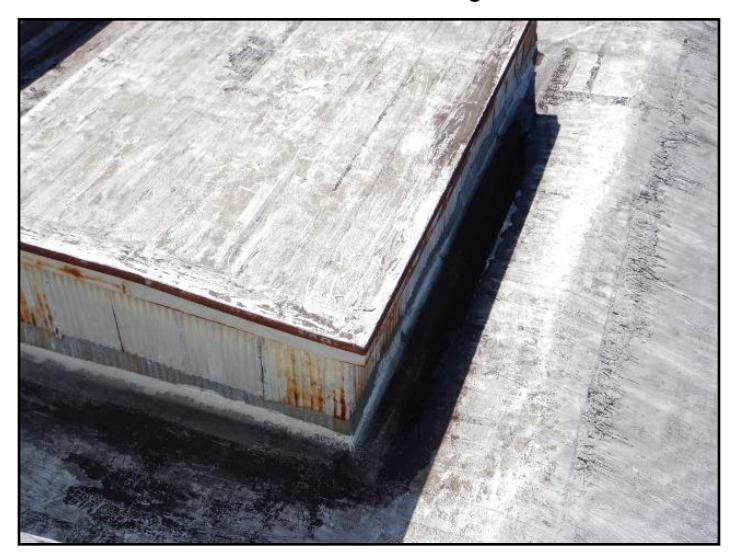
Condition: • Ponding

Low areas also noted Location: Various Task: Further evaluation. Improve.

Ponding

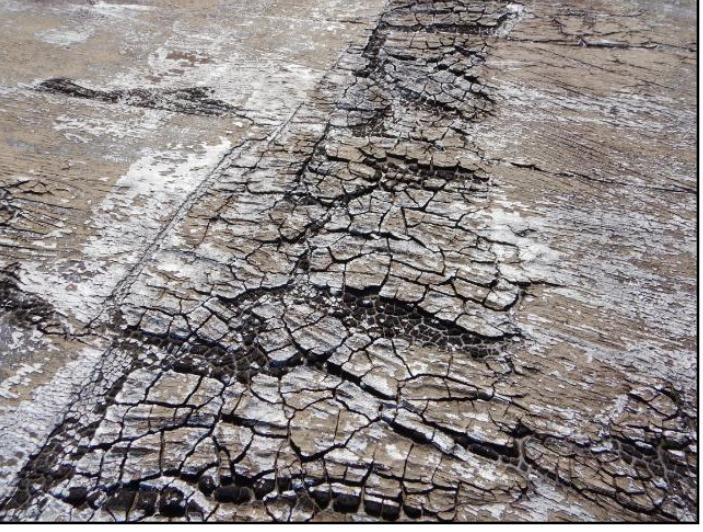
Condition: • Alligatoring

This random cracking of the surface, which looks similar to alligator skin, is the result of the sun making the unprotected top surface of the asphalt brittle. This occurs when there is surface granule loss (UV protection). The volatiles are boiled off, and the asphalt is no longer flexible. Over time, these cracks can deepen and leaks can occur. This is one of the aging signs of an asphalt based flat roof. Maintenance/further evaluation is recommended. **Location**: Various

Alligatoring

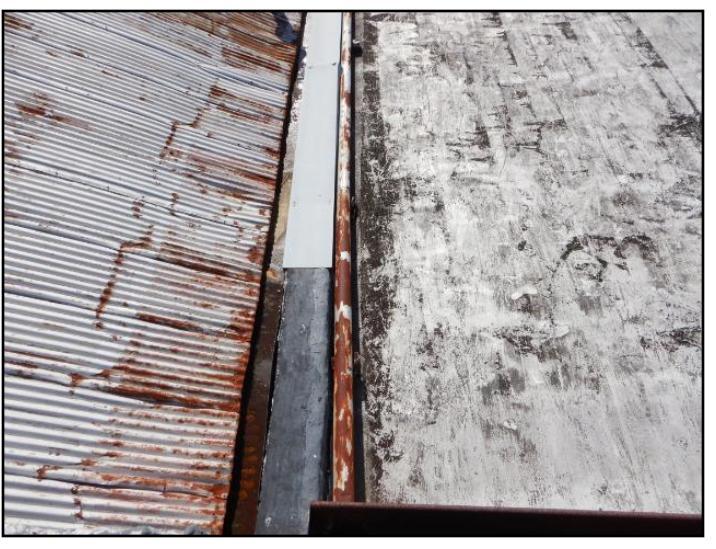
Condition: • Rust Location: Throughout Task: Repair or replace.

Rust

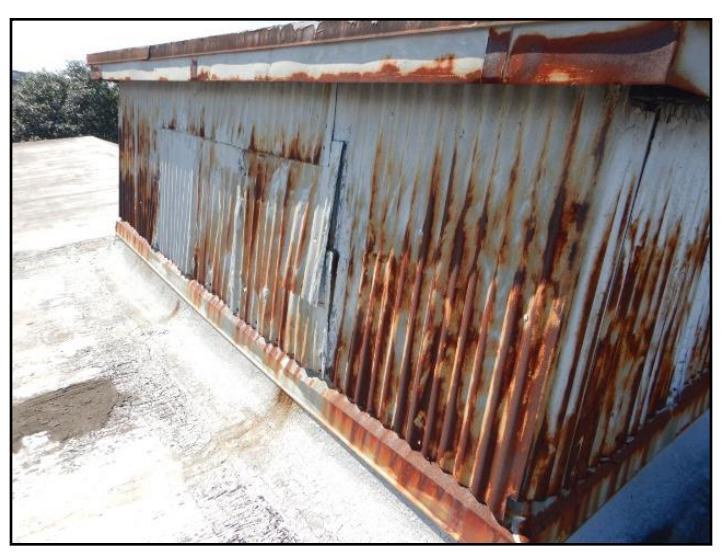
Condition: • <u>Rust</u> Location: Roof Task: Repair or replace.

Rust

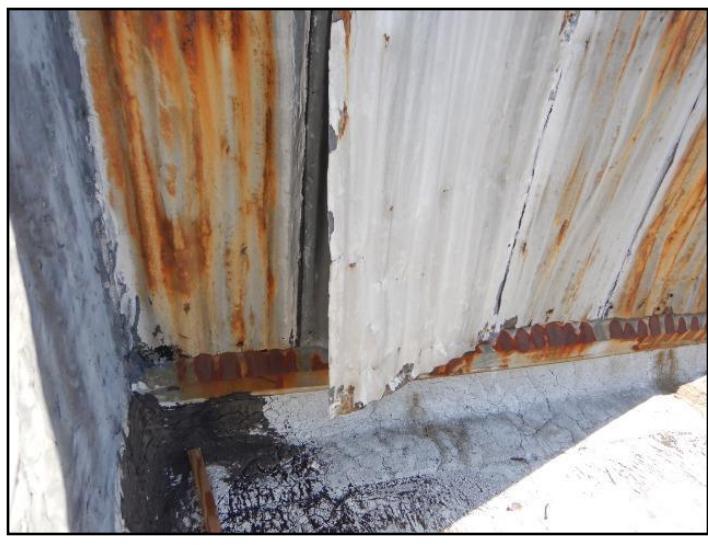
Condition: • Loose or missing pieces Location: Roof Task: Repair or replace.

Loose or missing pieces

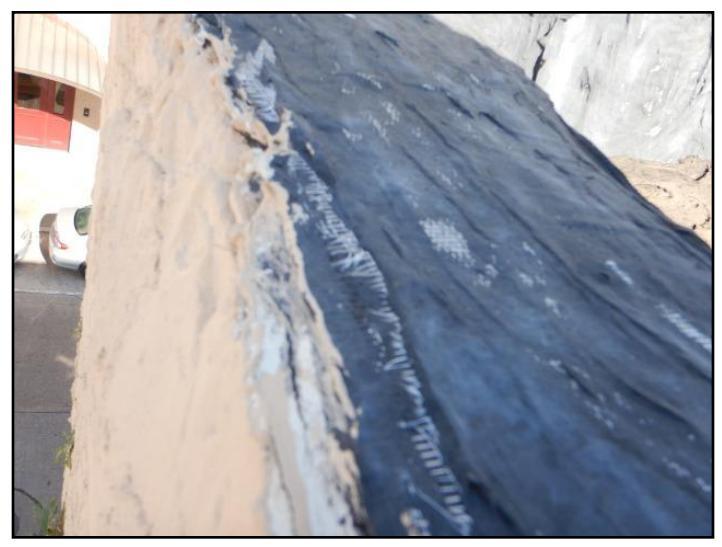
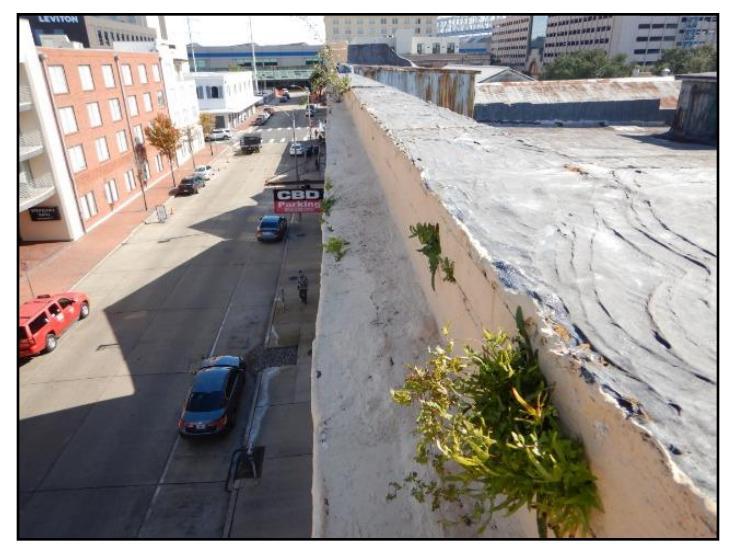
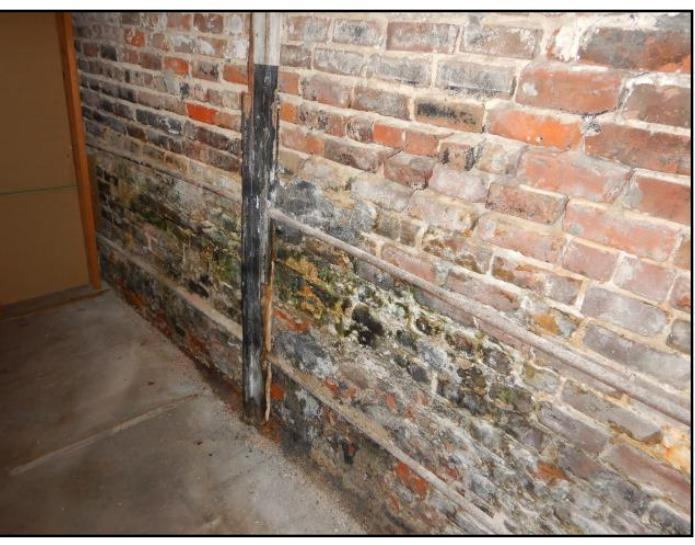
Condition: • <u>Moisture penetration</u> Location: Roof, Front Right First Floor Task: Repair.

Moisture penetration

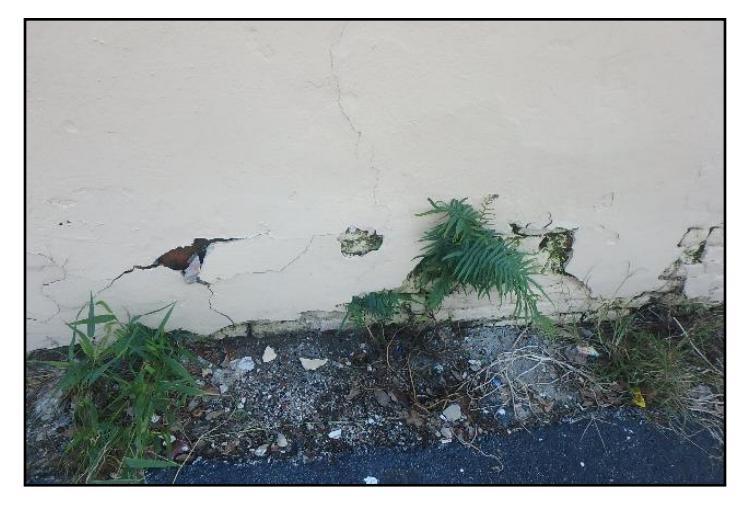
Condition: • The overall condition of the stucco warrants further evaluation from a qualified stucco contractor. Issues noted included: Cracking, open seams and prior repair t
 Location: Throughout Exterior
 Task: Repair.

Stucco repairs needed

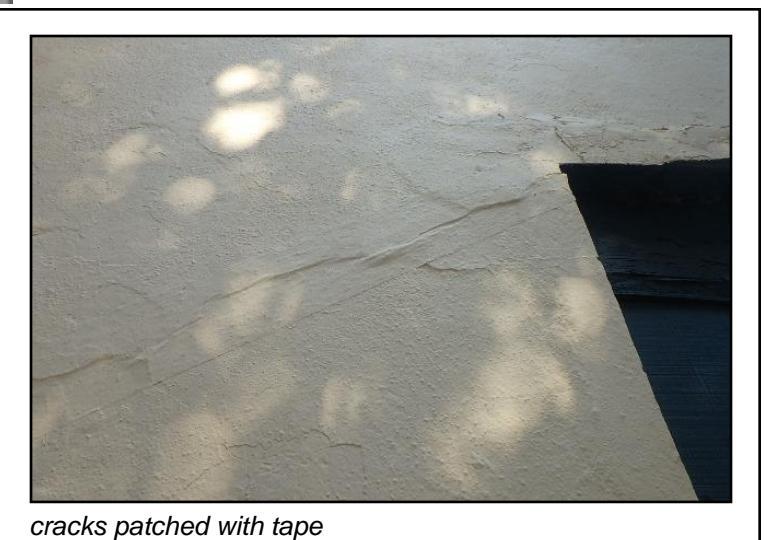
Condition: • Poor repairs Location: Front Task: Correct.

cracks patched with tape

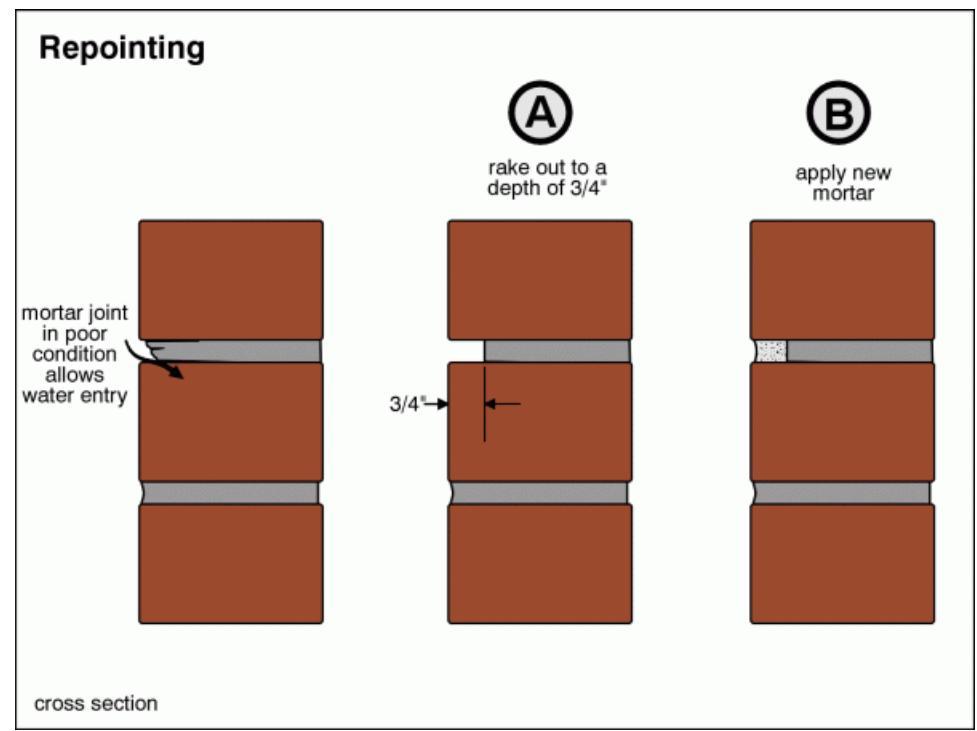
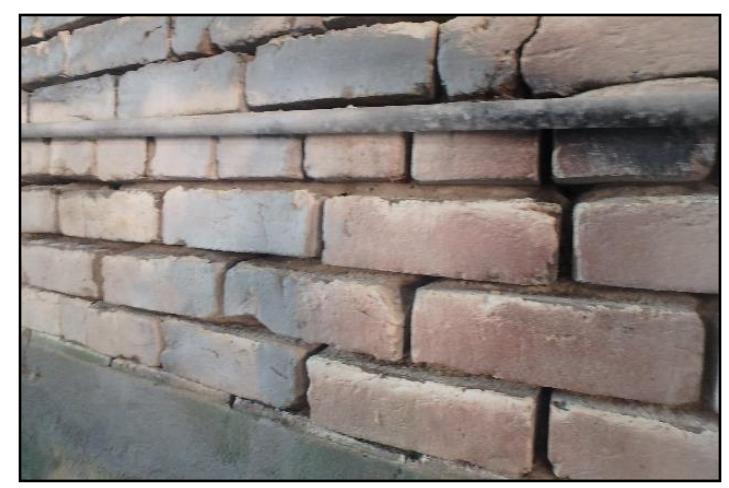
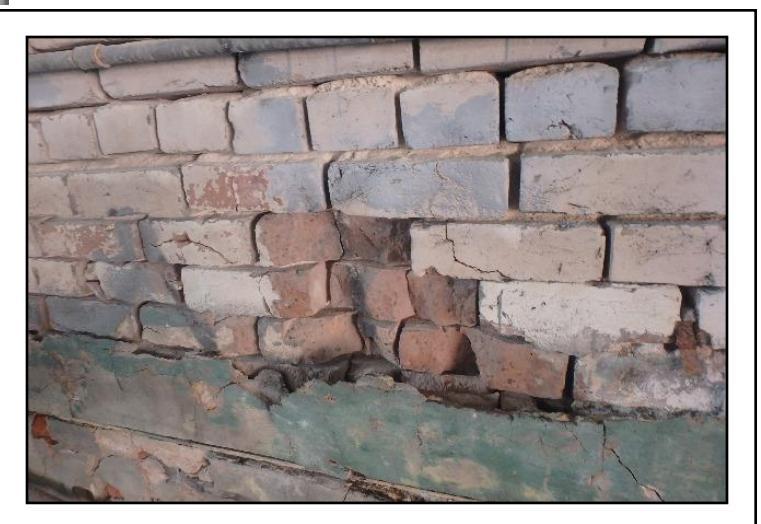
Condition: • Masonry/mortar deterioration **Location**: Throughout Left Side and Right Side Exterior **Task**: Repair.

Mortar deterioration

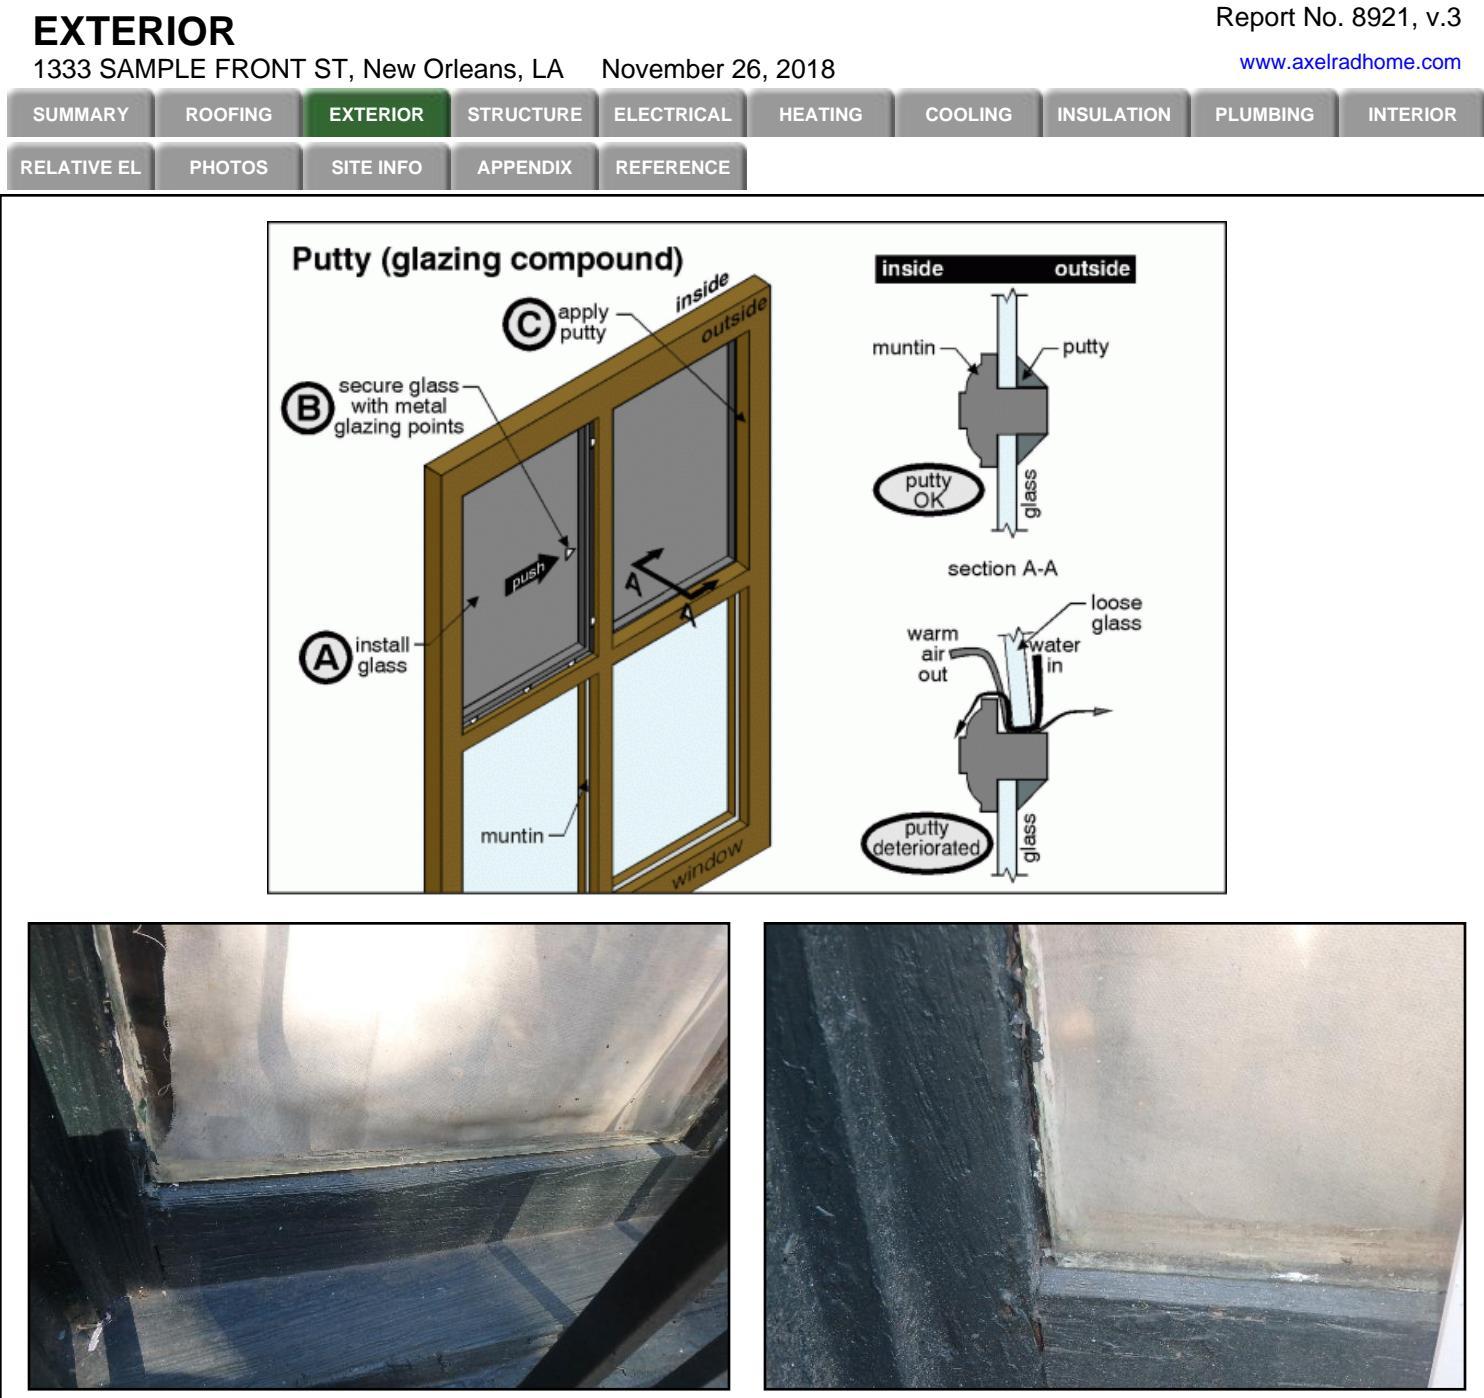
Putty missing, cracked or deteriorated

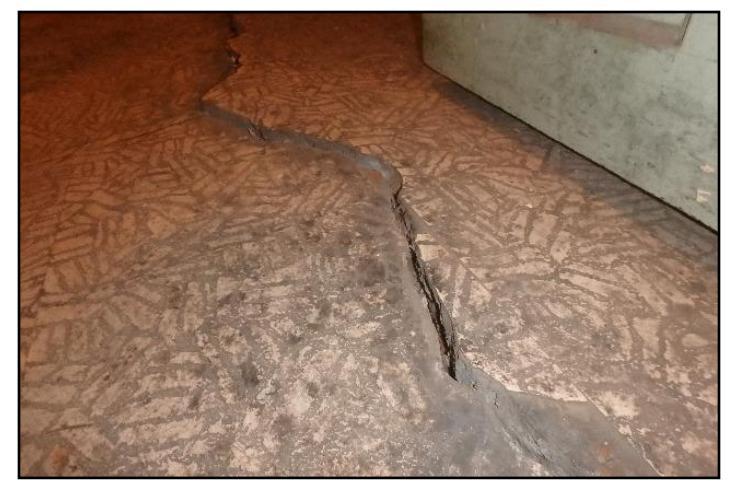
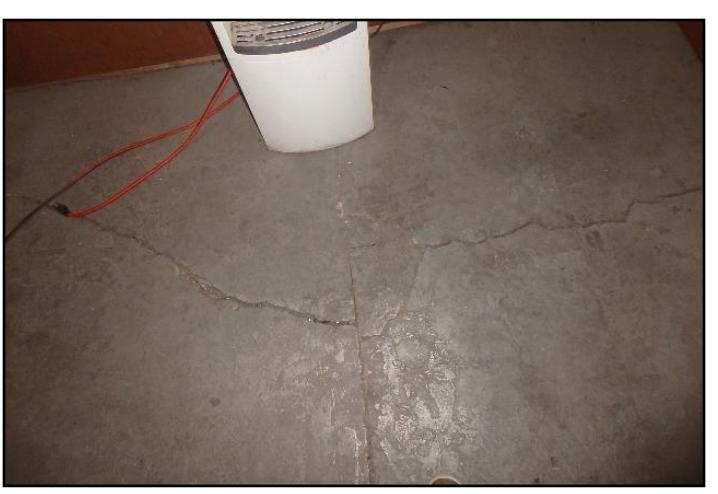
Condition: • <u>Cracked</u> Cracking was noted in various areas in the floating concrete slab. Location: Various Throughout interior Task: Repair. Further evaluation.

Cracked

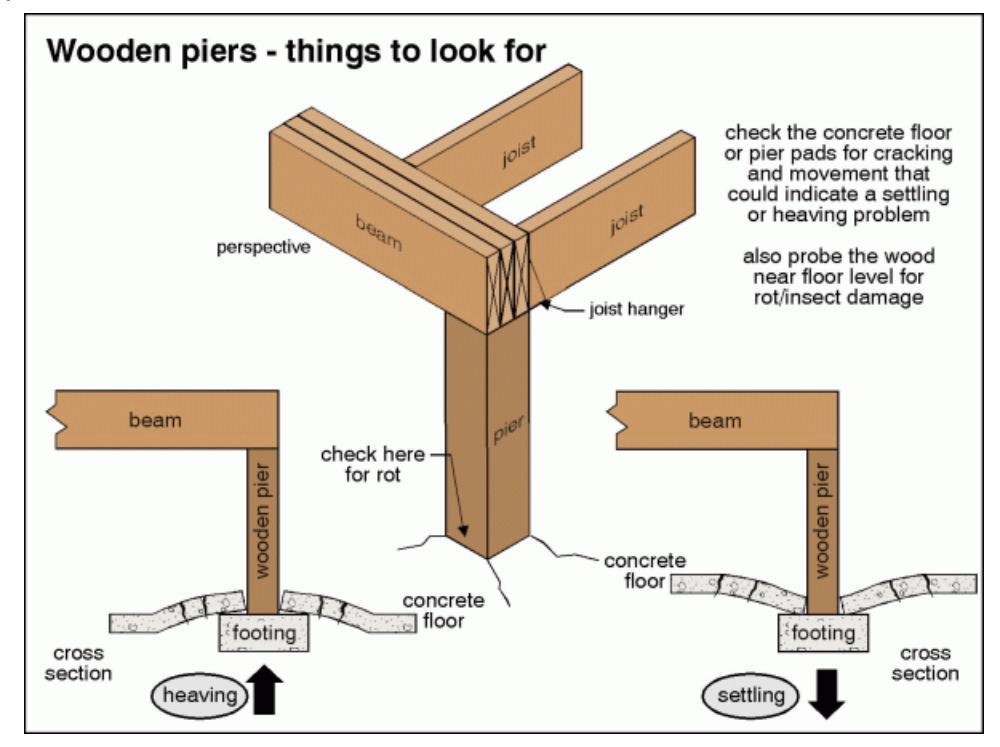
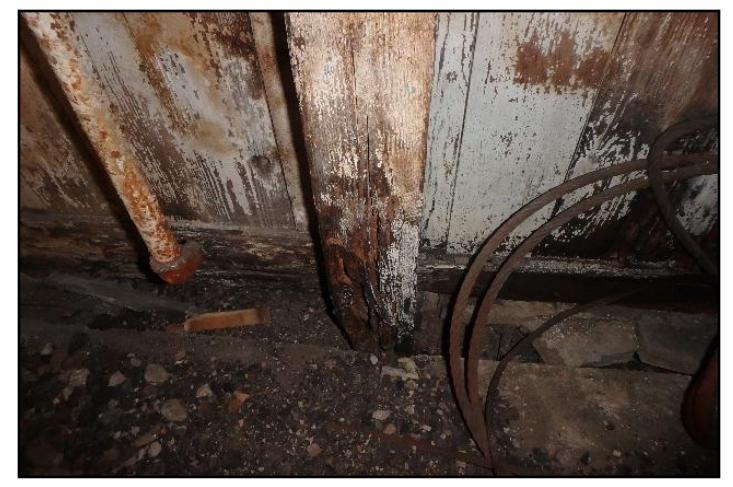
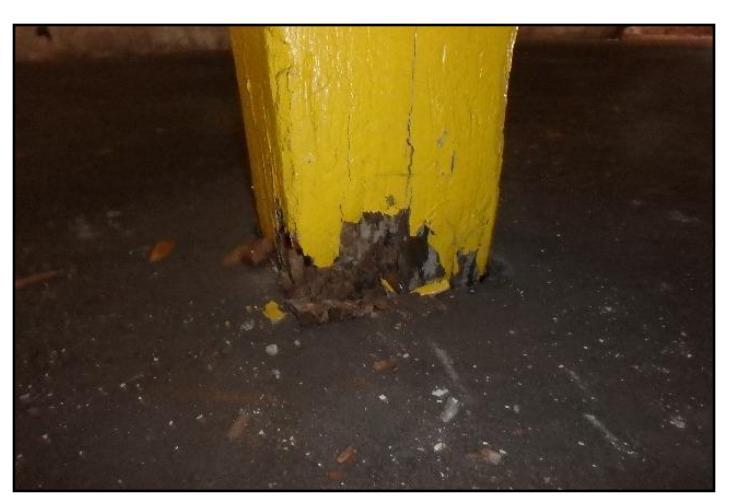
Location: Various Left Center

Rot

Task: Repair or replace. Further evaluation.

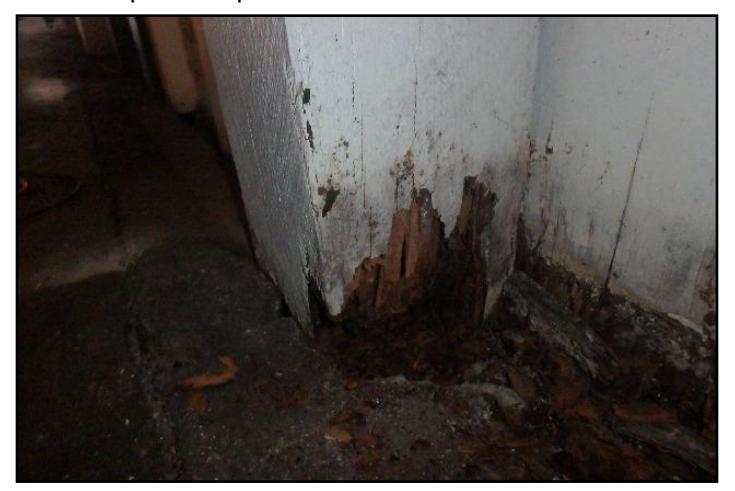
At least two to three wood columns are severely damaged by insects. **Location**: Various Throughout Left Side Middle

Insect damage

Task: Repair or replace. Further evaluation.

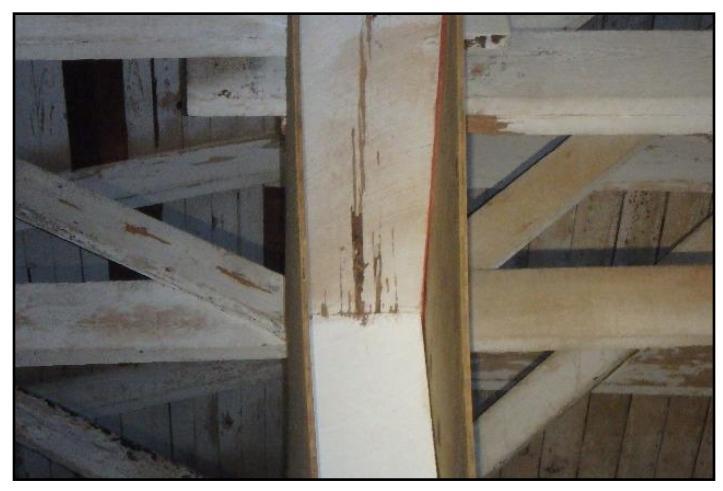
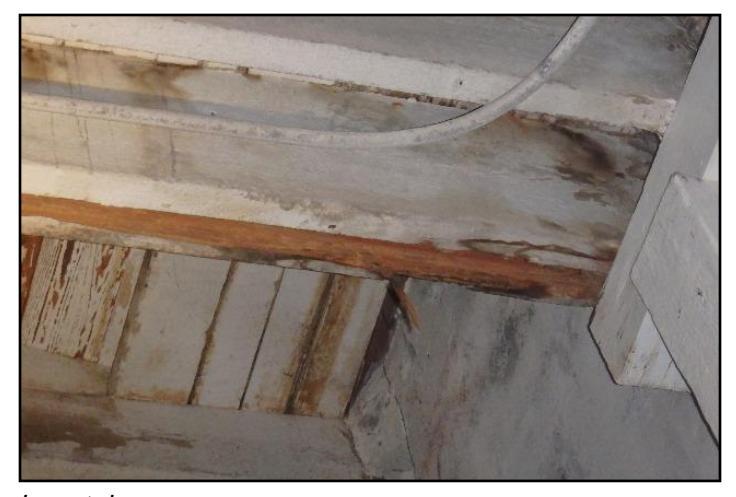
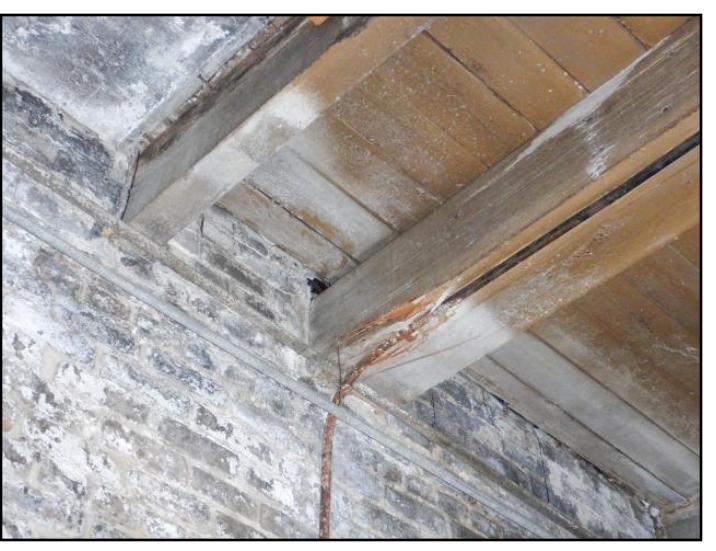
Condition: • Rot and/or insect damage Location: Various Throughout Task: Repair.

Insect damage

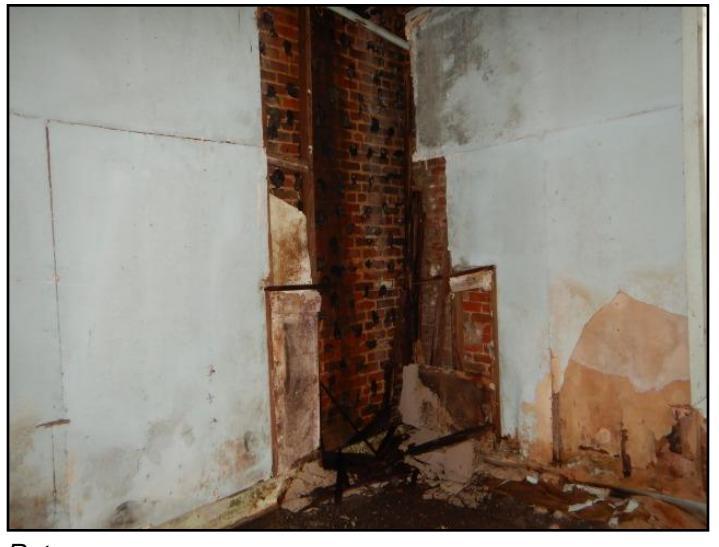
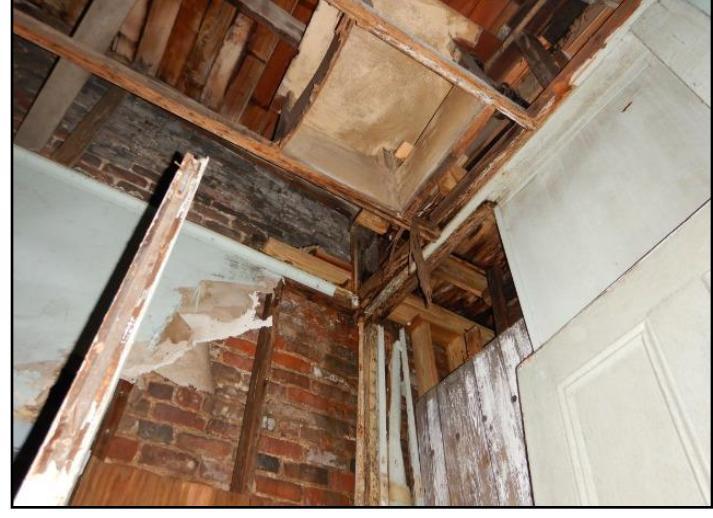
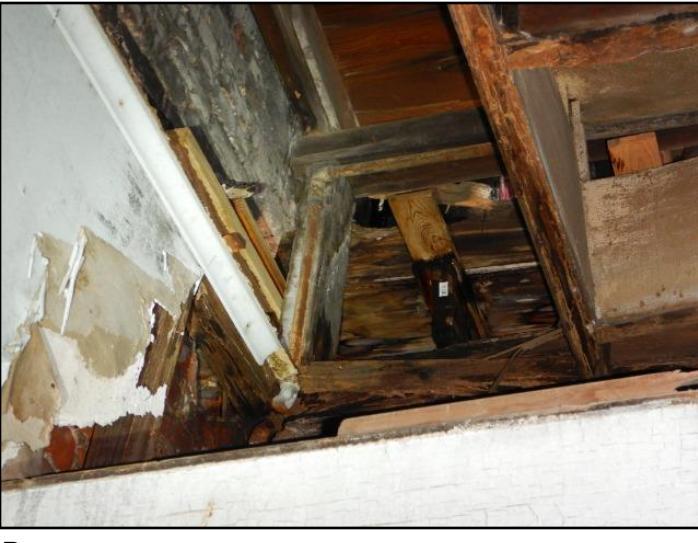
Condition: • <u>Rot</u> Major structural damage from roof leaks Location: Front Right First Floor Task: Repair.

Rot

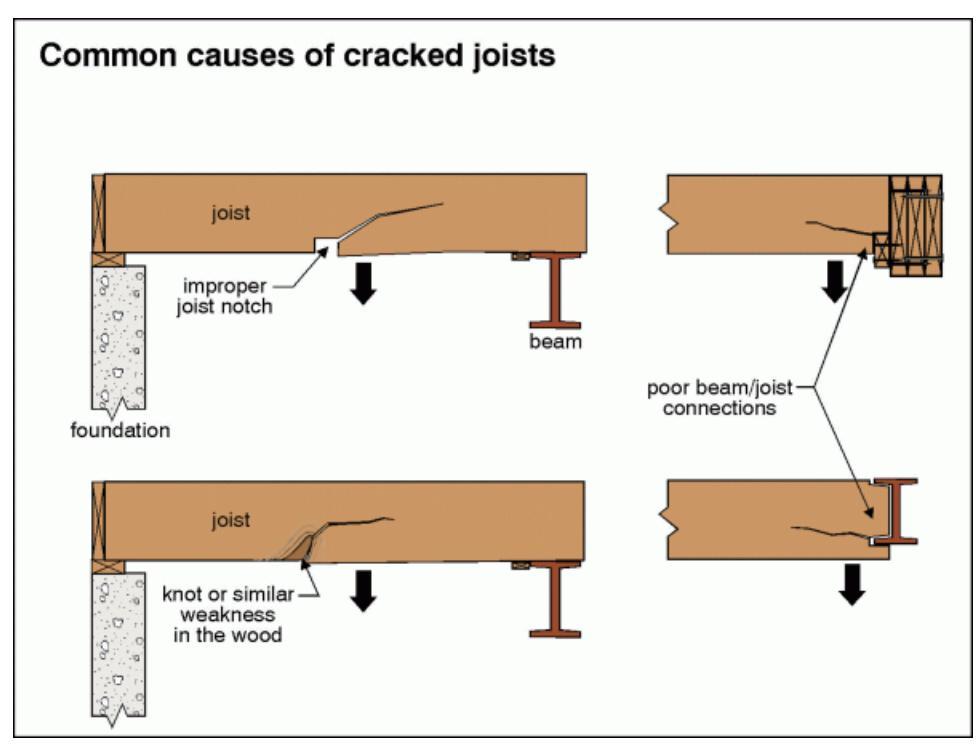
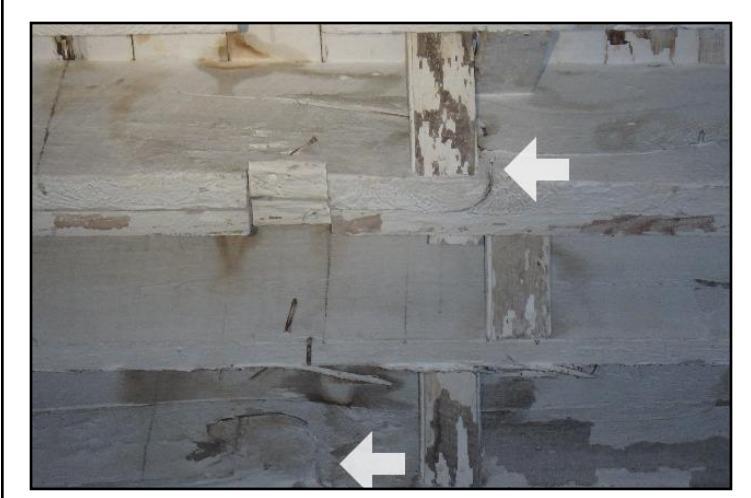
Condition: • Split or damaged

Location: Rear and left side Middle Task: Repair.

Split or damaged

Split at rotted area

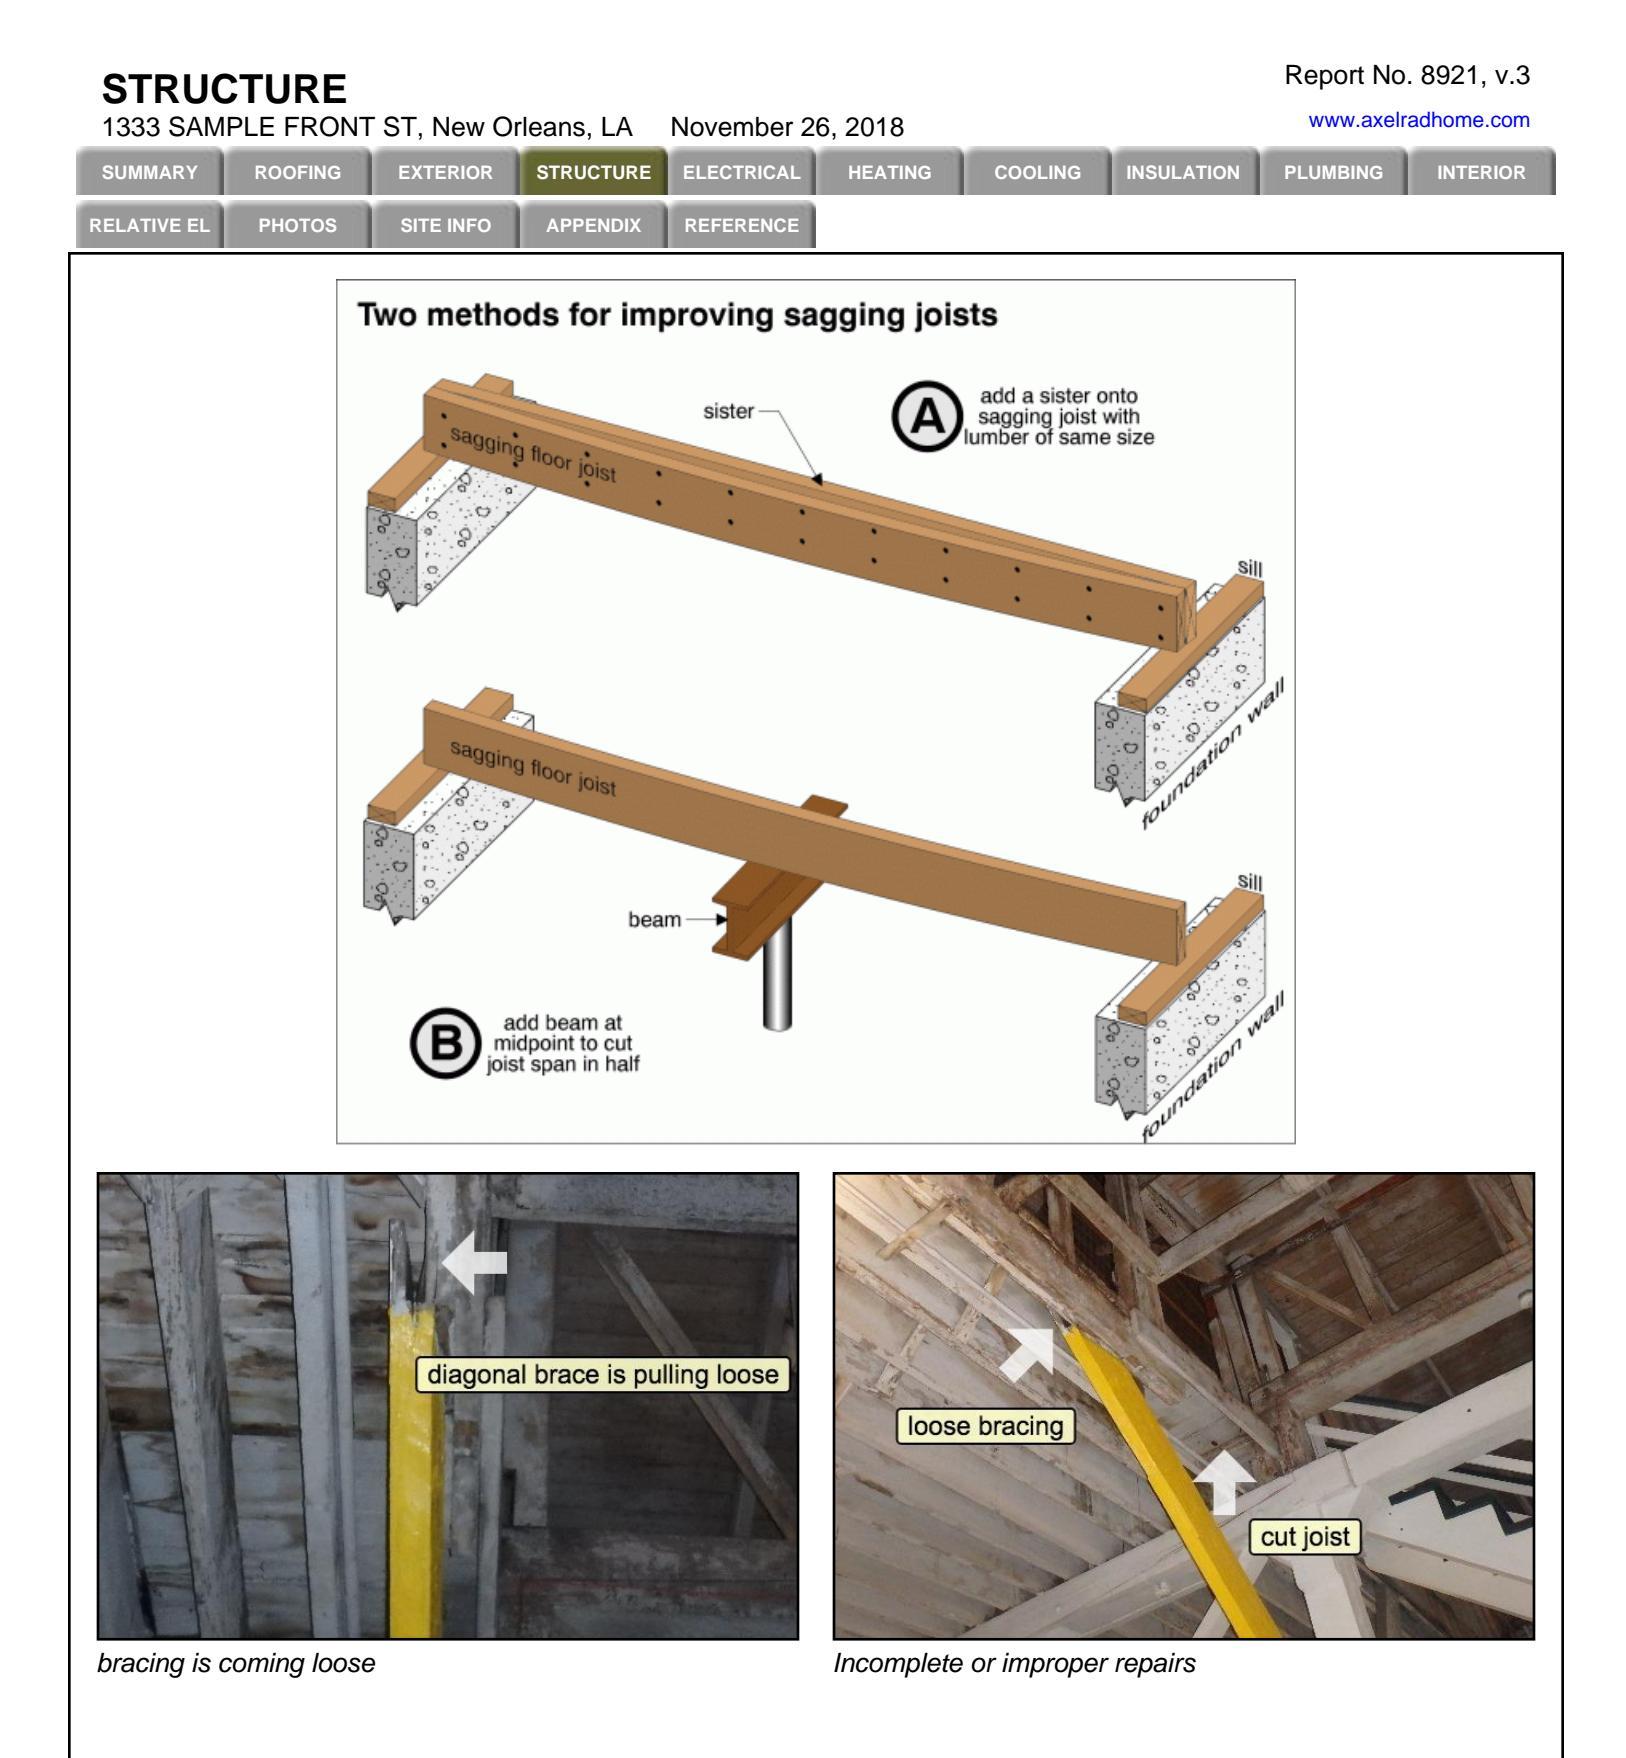
Condition: • Incomplete or improper repairs Location: Left Side Middle Task: Correct.

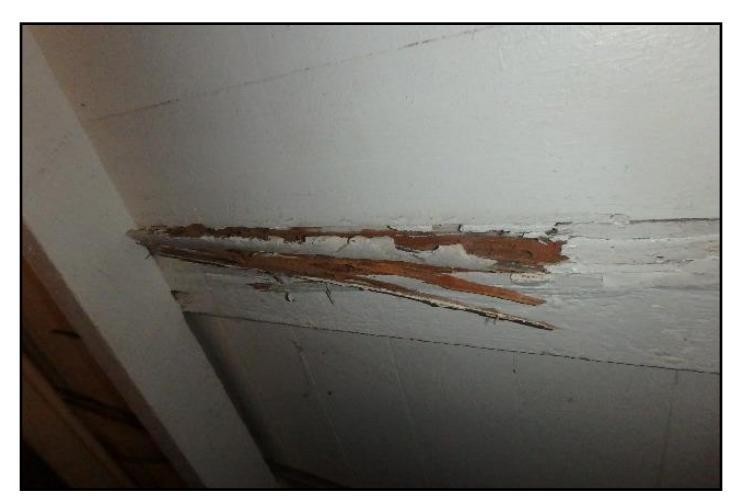
Insect damage
