Inspection Report

1333 SAMPLE FRONT ST New Orleans, LA 70130

Inspection Date: Monday, November 26, 2018

RE: Report No. 8921, v.3 1333 SAMPLE FRONT ST New Orleans, LA 70130

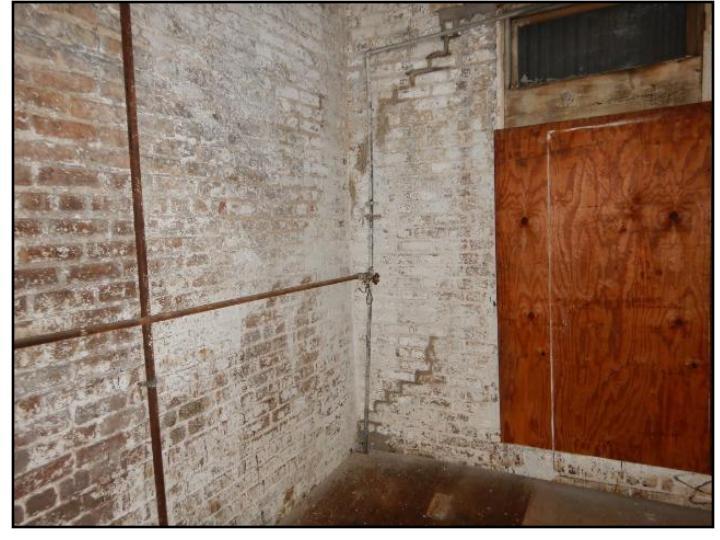
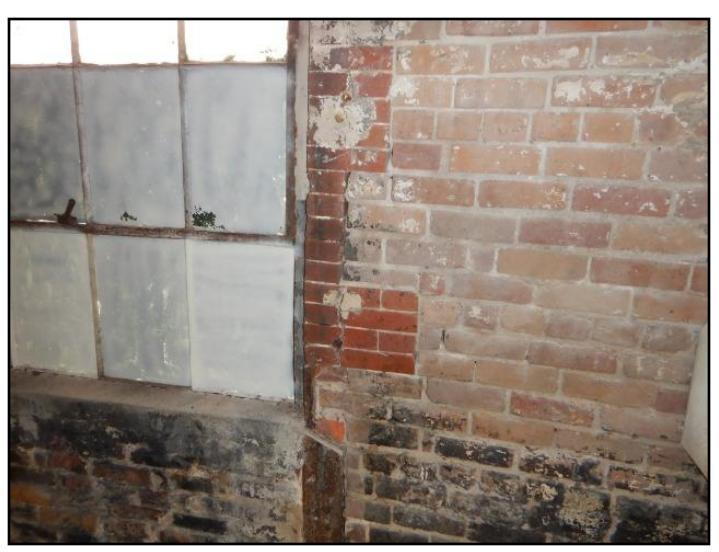
WALLS \ Solid masonry walls Condition: • Prior repairs Location: Various Task: Prior repairs should be periodically monitored.

Prior repairs

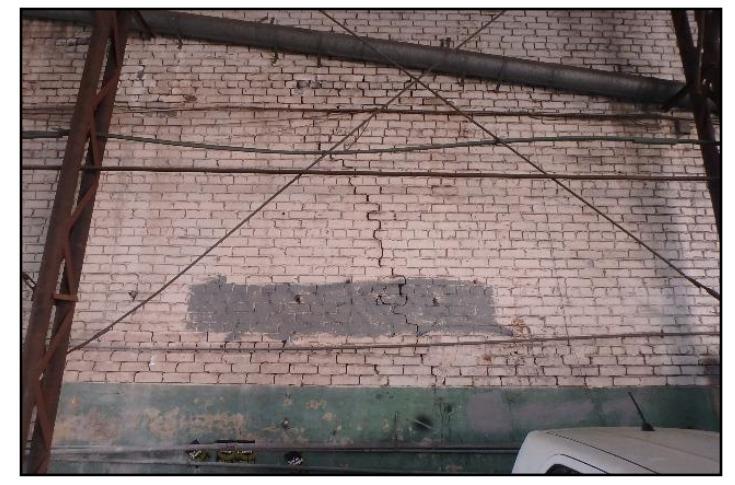
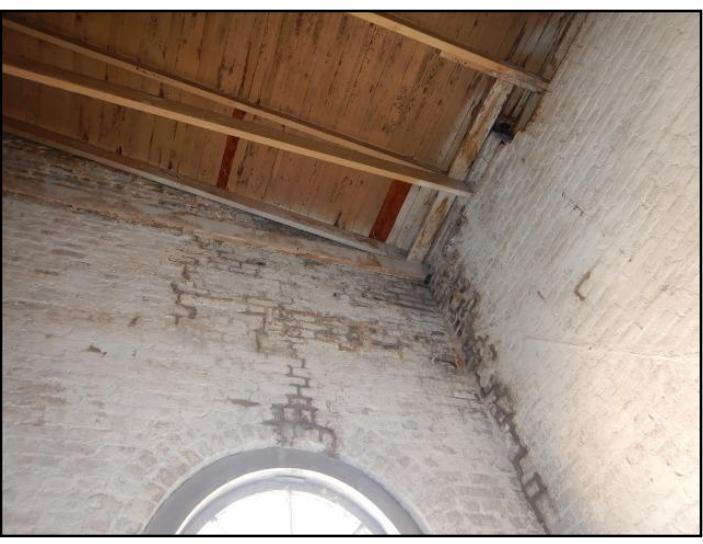
Condition: • Cracked Location: Various Throughout Task: Repair. Further evaluation.

Cracked

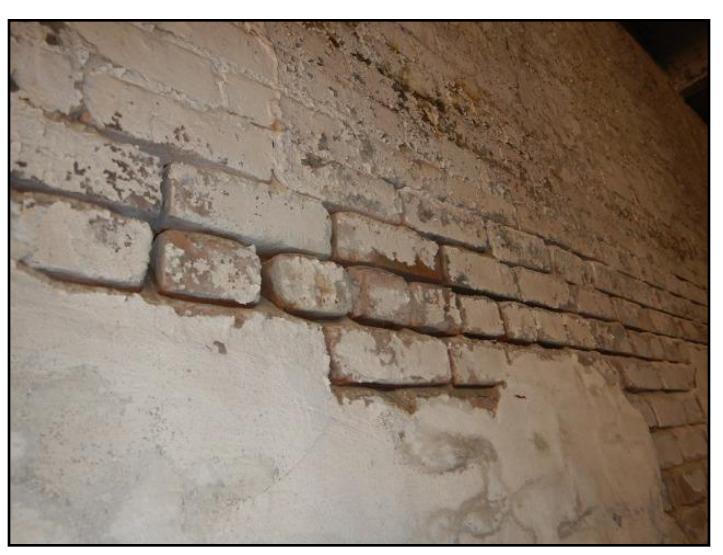
Mortar deteriorating

Task: Repair.

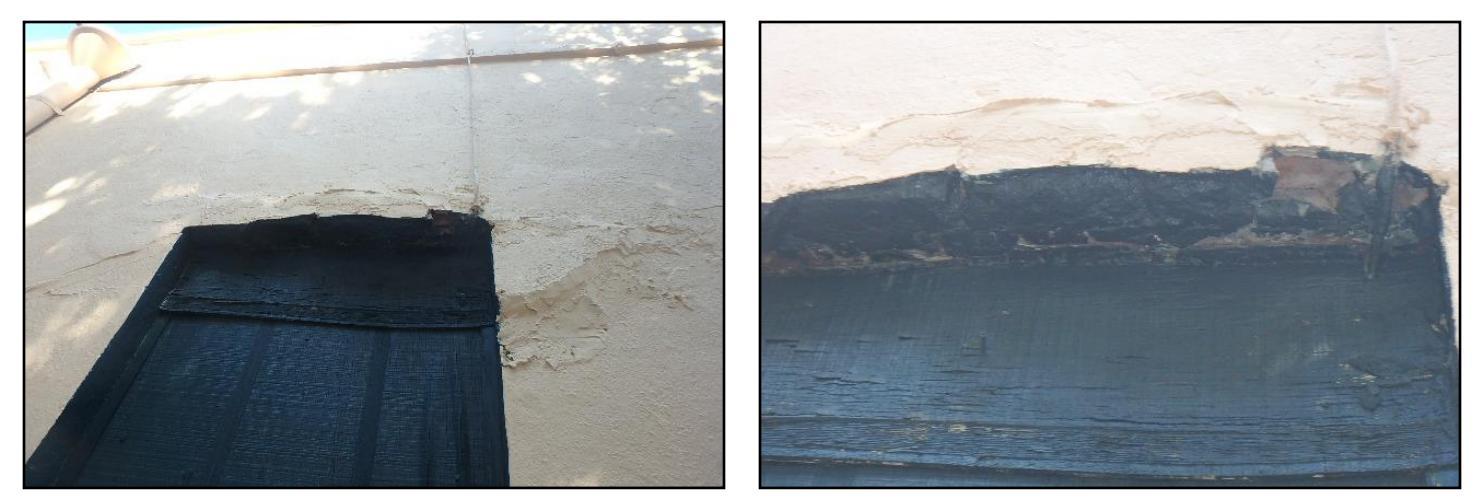
missing lintel

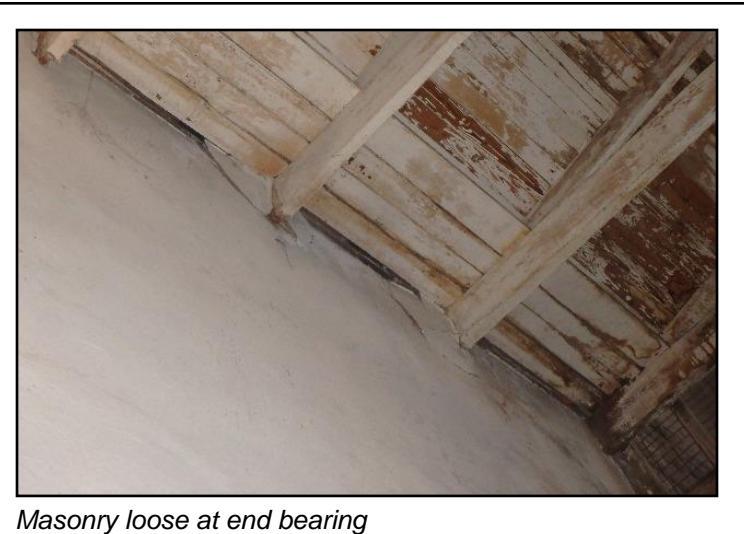
| SUMMARY | ROOFING | EXTERIOR | STRUCTURE | ELECTRICAL | HEATING | COOLING | INSULATION | PLUMBING | INTERIOR | | |
|---|---|---|---|---|---|---|---|---|---|--|--|
| Condition | : • End bear | ing inadequa | ate | | | | | | | | |
| Roof leaks | have rotted | the trusses v | where they b | ear in the ma | isonry wall. N | Many of the t | russ ends ar | e no longer s | supported | | |

No End bearing

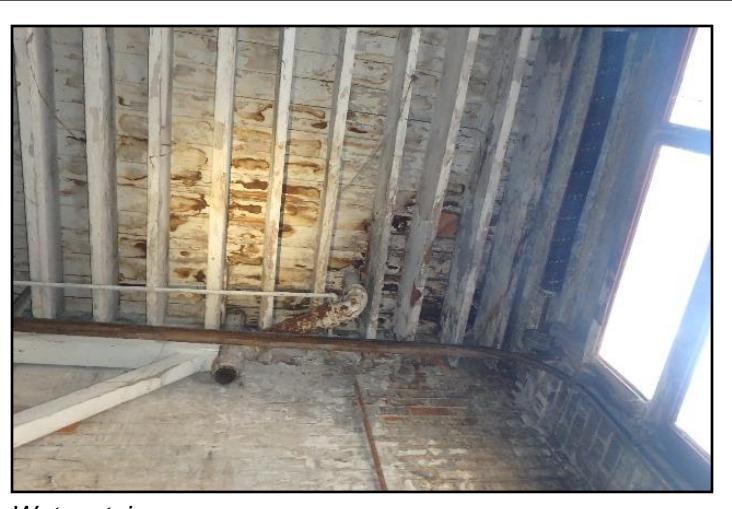
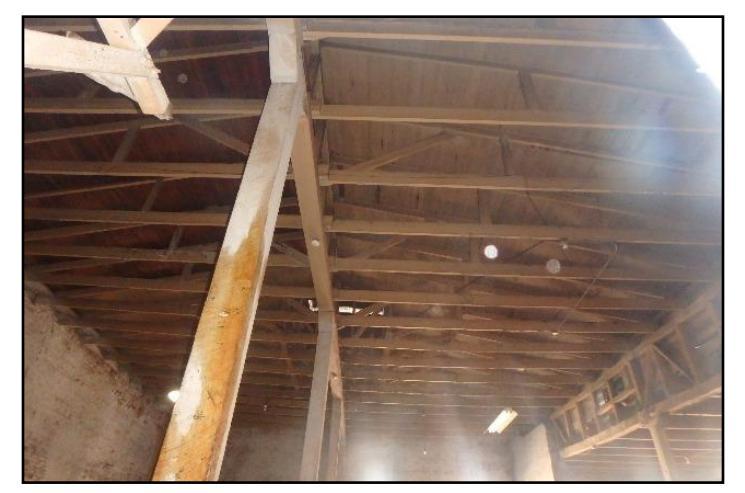
Water stains

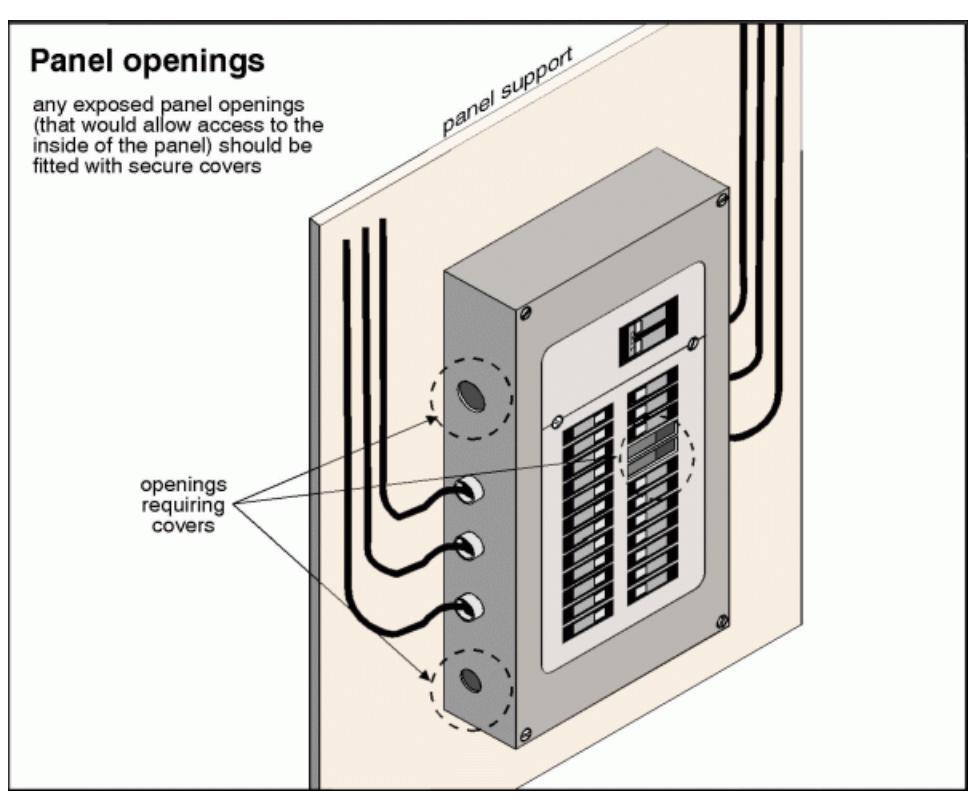
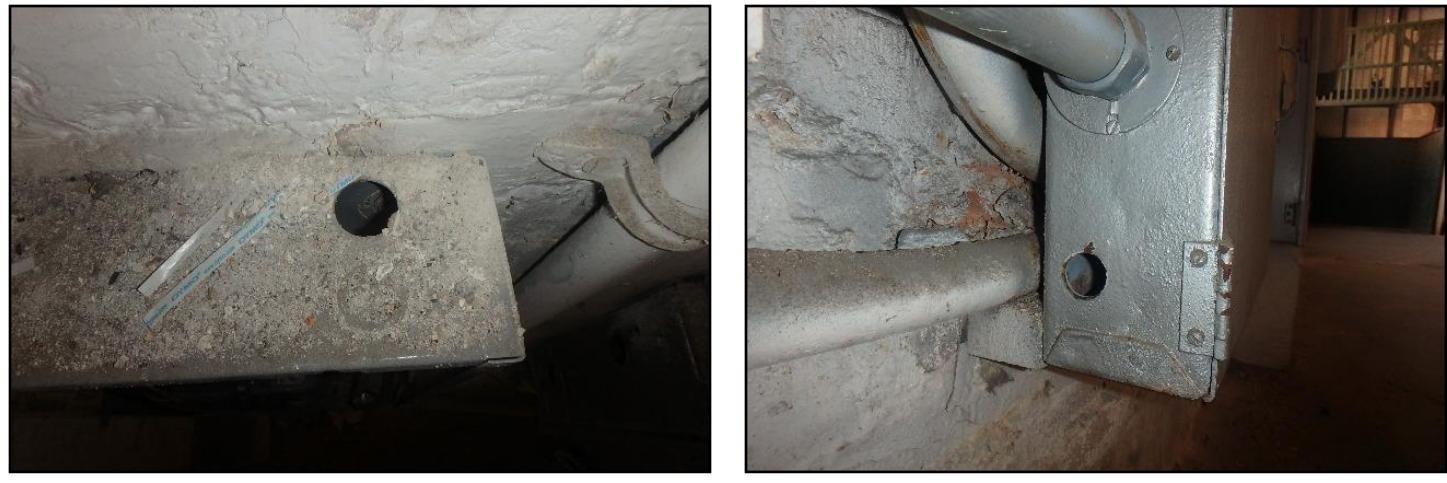
Condition: • Unprotected openings Location: Rear interior wall Task: Correct.

Unprotected openings

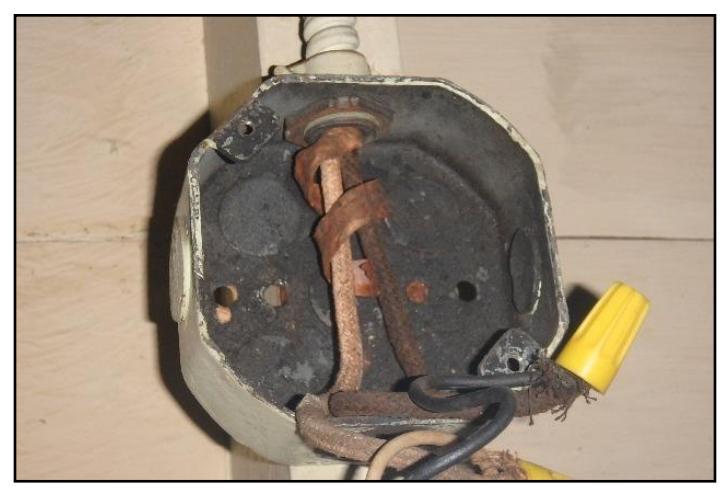
Old Wiring

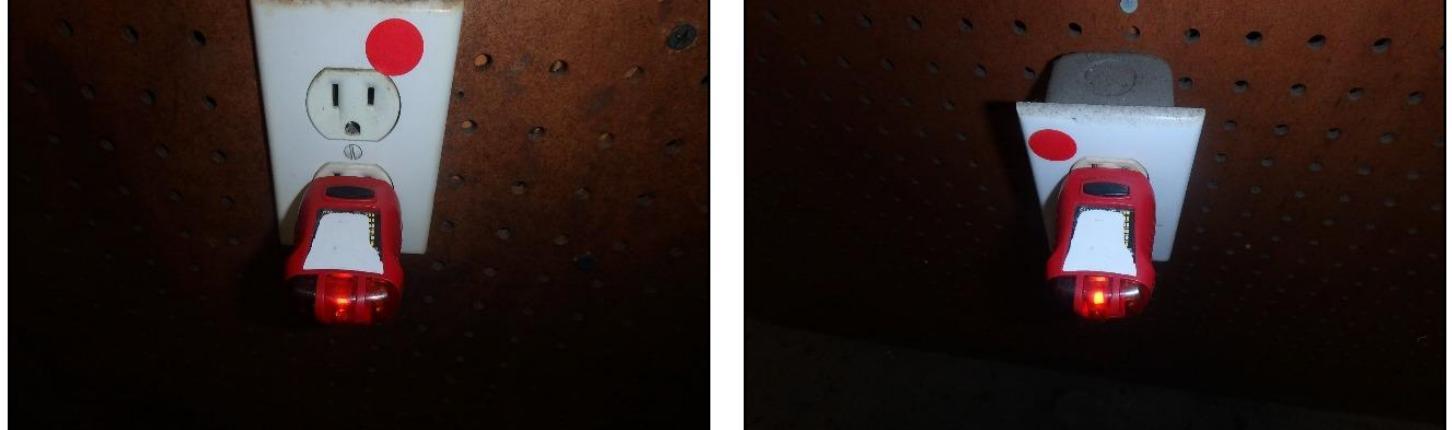
Condition: • Ground needed for 3-slot outlet

Ungrounded 3 slot outlet(s) found. The grounding of electrical outlets became standard after about 1960. The ground wire normally conducts no electricity, but serves as a path for stray current, in case something goes wrong with the appliance or receptacle. The ground wire provides a safe path for the electricity and prevents electrical shock. Three slot receptacles are sometimes installed in ungrounded situations in order to plug in appliances with three prongs, but this can be dangerous and misleading. Adapters should not be used in two slot outlets. Three slot receptacles should always be grounded. There are several options to correct this issue.

Ground needed for 3-slot outlet

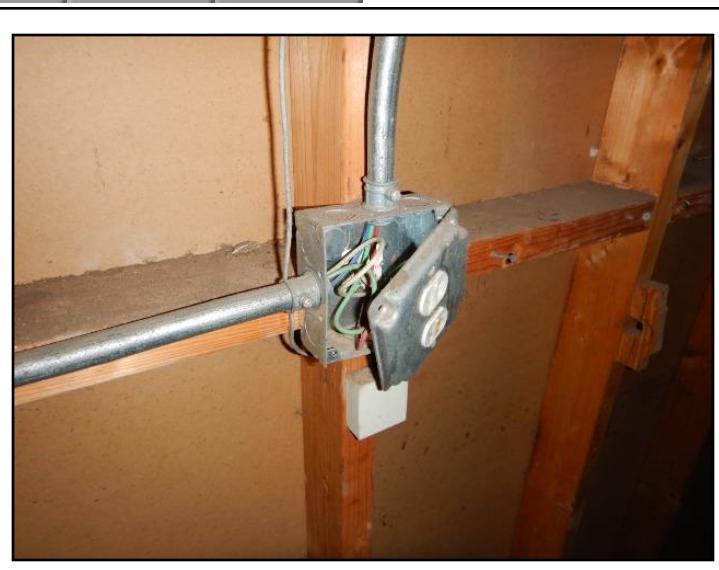
Condition: • Loose Location: Front Right First Floor Task: Correct.

Loose

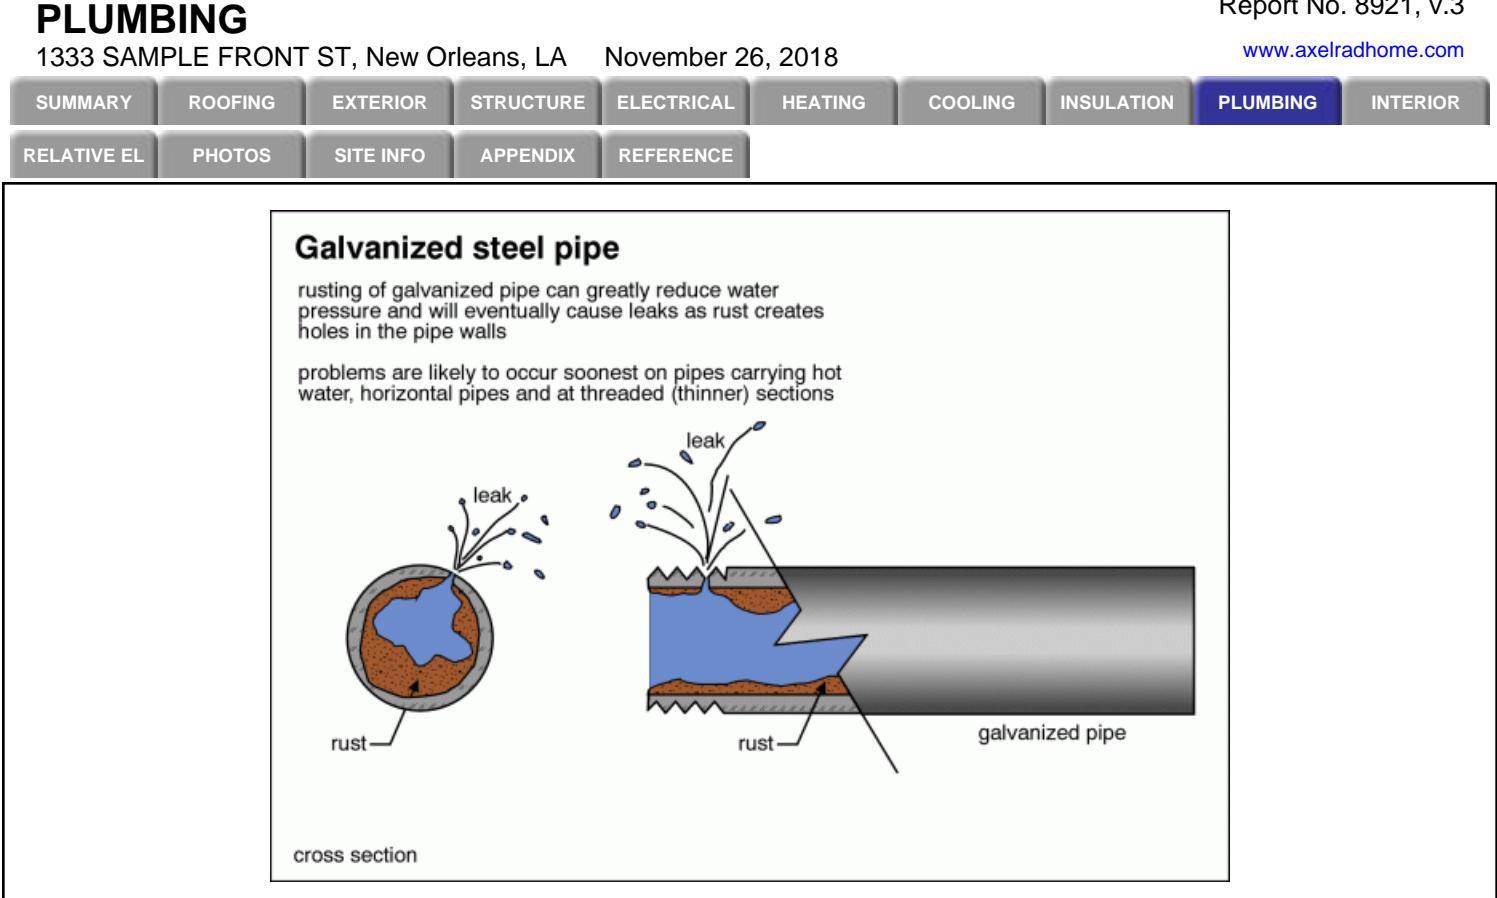
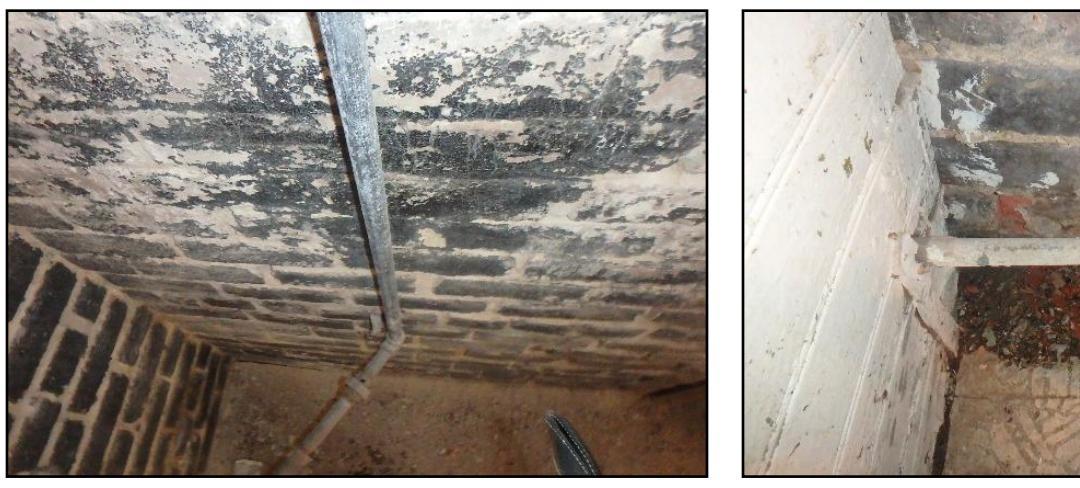
Galvanized supply lines noted. This piping is over 50 years old since it has not been in use for major work since the early 1960's. This is near the end of its expected useful life. The age is difficult to gauge based on exterior condition as galvanized pipes tend to corrode from the inside-out. Significant corrosion inside the piping can reduce water pressure as well as lead to pinhole leaks, especially around the threaded connections. Corrosion at the joints also indicates the end of useful life. When leaks become prevalent or decreased water pressure is noted, it may be time to replace the galvanized supply lines with copper or PEX. Upgrades should be referred to a licensed plumbing contractor for a

Galvanized steel

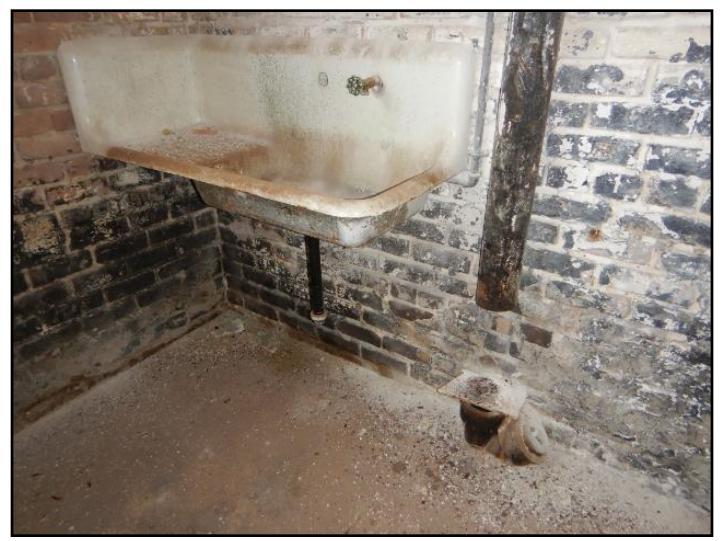
Condition: • Incomplete installation **Location**: Rear Right First Floor **Task**: Complete.

Incomplete installation

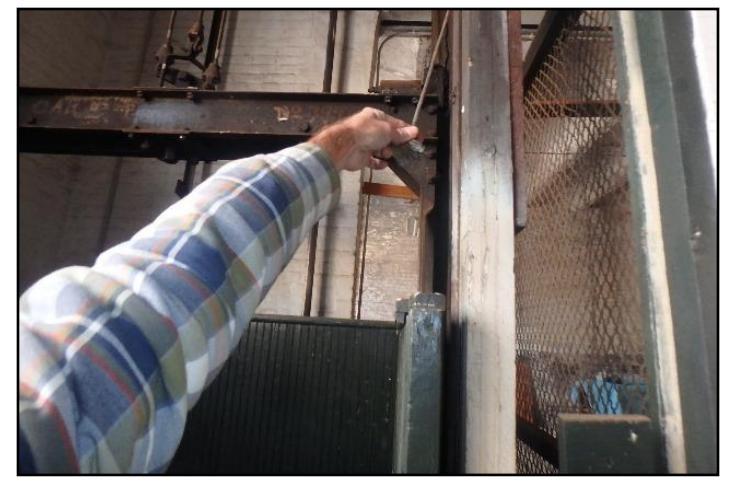
Condition: • Damaged elevator safety door. The counterweight for the elevator safety door is missing. **Location**: Rear First Floor

missing counterweight

Task: Repair.

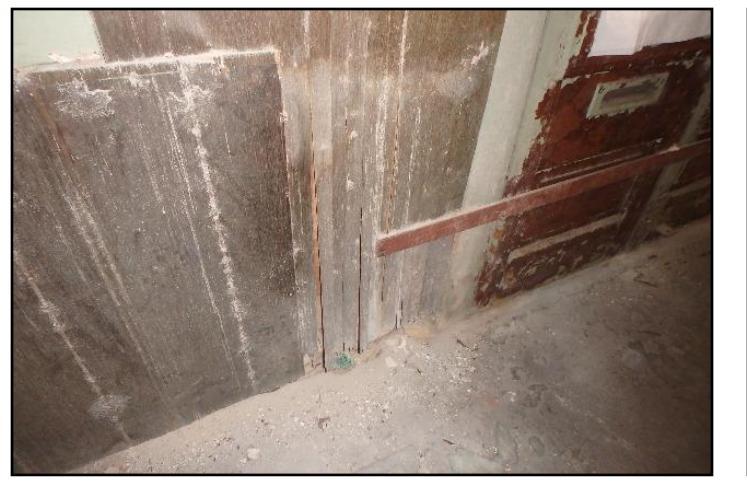
Condition: • Broken, cracked or split Location: Front Office Task: Replace.

Broken, cracked or split

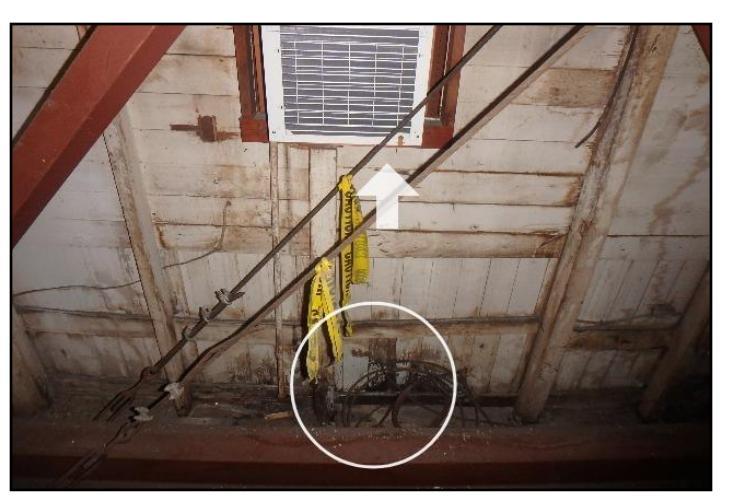
condensation dripping on walls

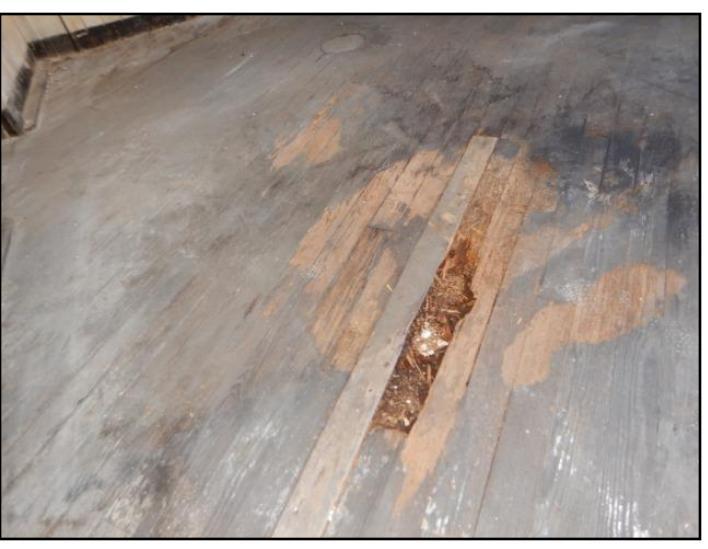
Rot or Insect damage

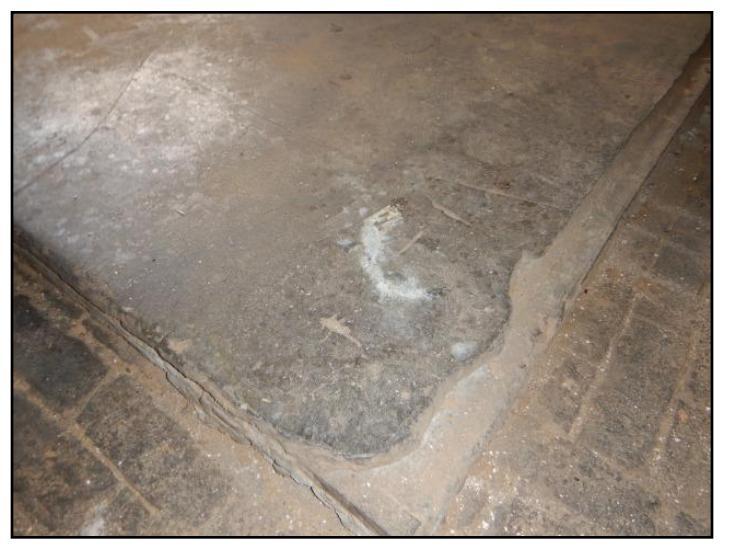
Condition: • Tiles loose Location: Rear Right First Floor Task: Repair or replace.

Tiles loose/damaged

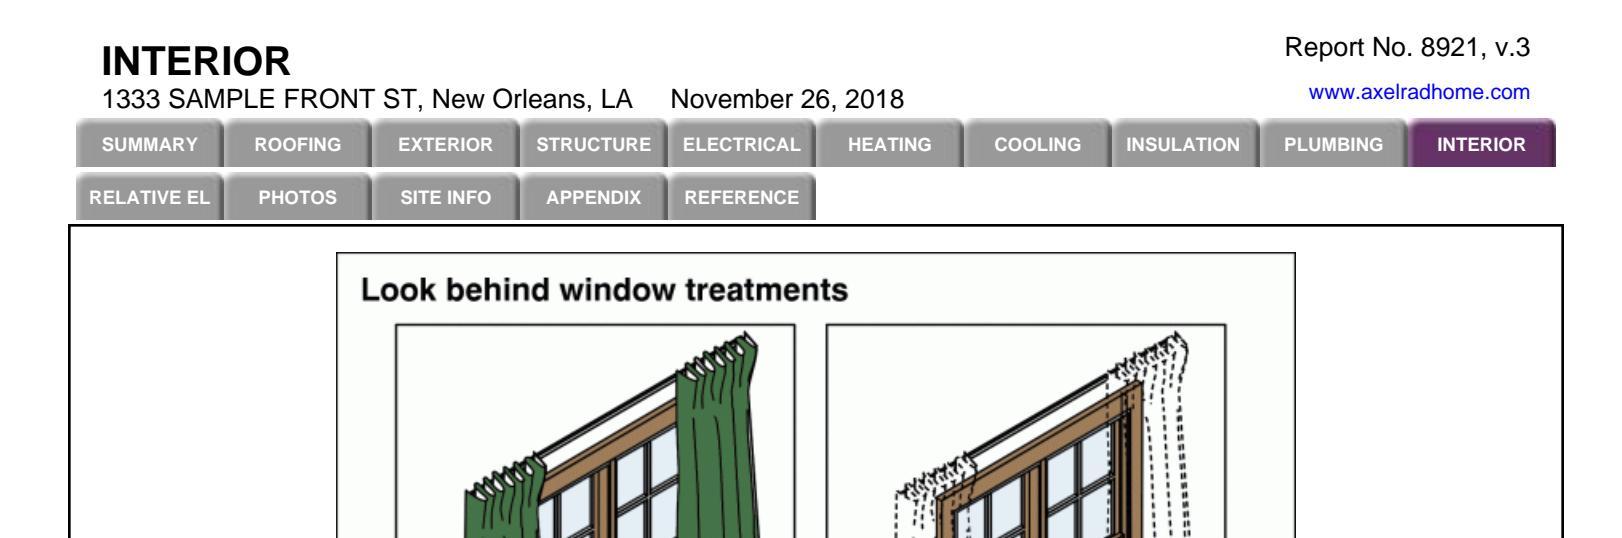
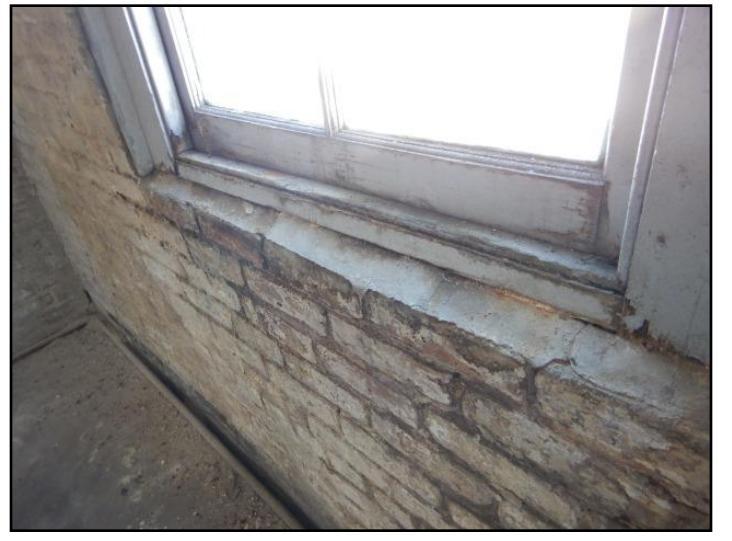
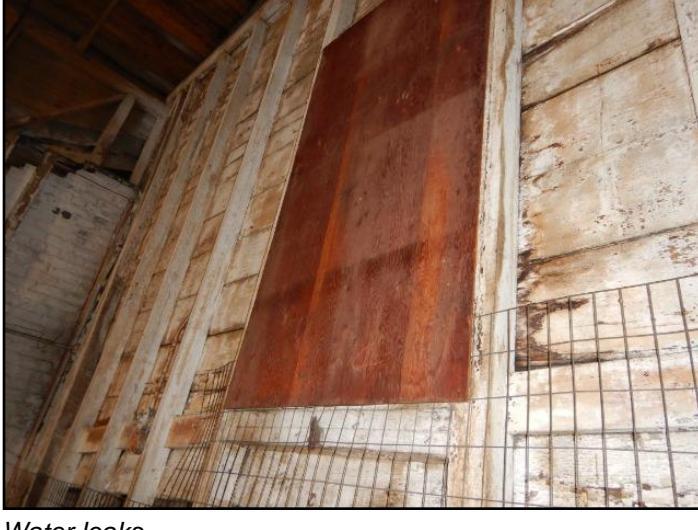
water stain peeling paint

> moisture damage often shows up below the lower corners of windows

Task: Repair and replace as needed.
