# Inspection Report

940 Barracks St, Suite Unit B  
New Orleans, LA 70116

Inspection Date:  
Tuesday, August 8, 2017

RE: Report No. 6972, v.3  
940 Barracks St, Unit B  
New Orleans, LA  
70116

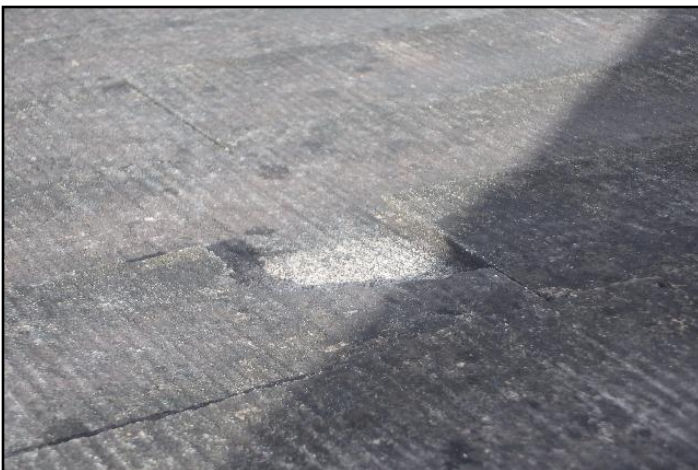
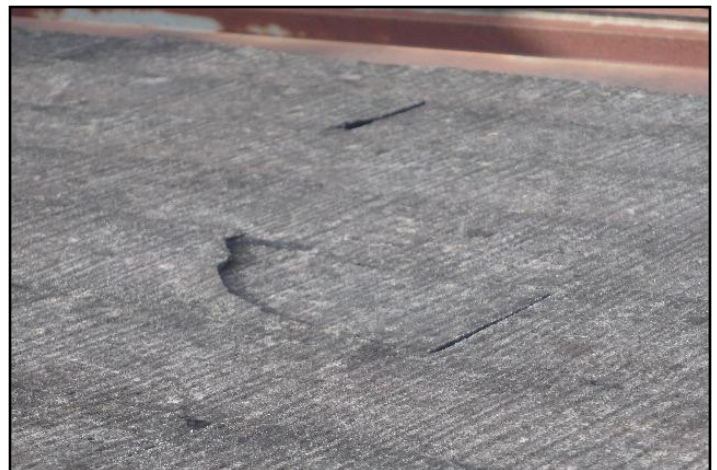
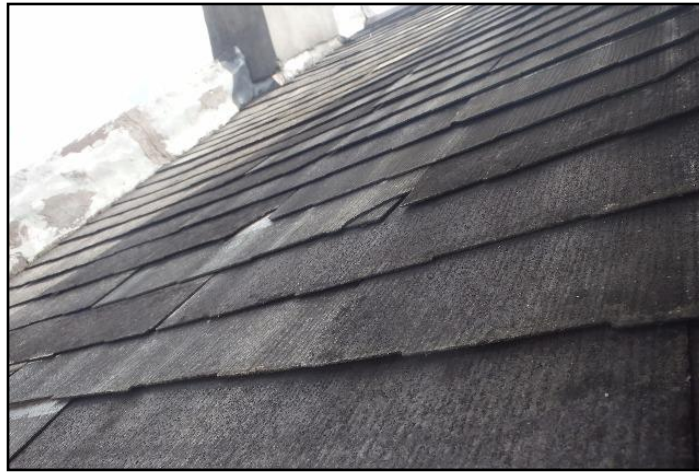
**Condition:** • [Damage](#)

Cracked, damaged shingles

**Location:** Various Shingles

Damage

*Damage*

**Task:** Repair

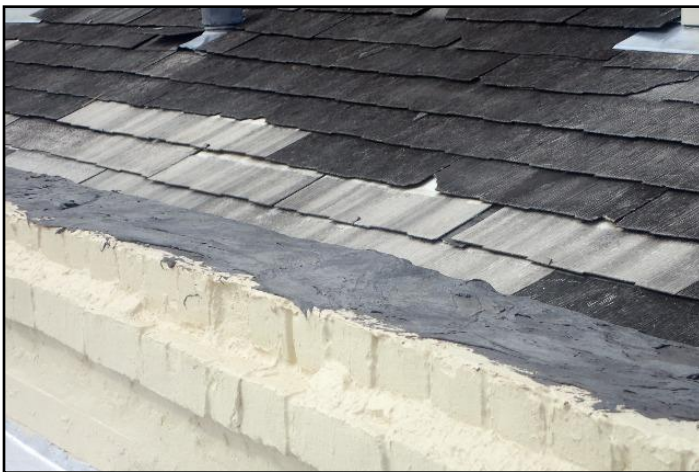
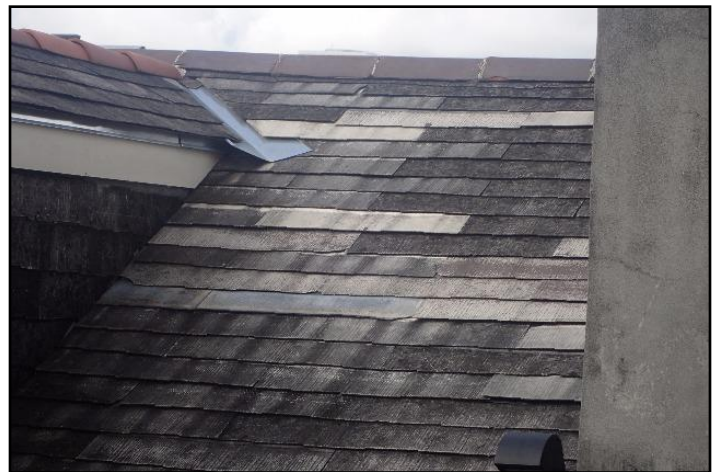
**Condition:** • Prior repairs

**Location:** Front slope

*Prior repairs*

**Task:** Monitor. Condominium Association responsibility.

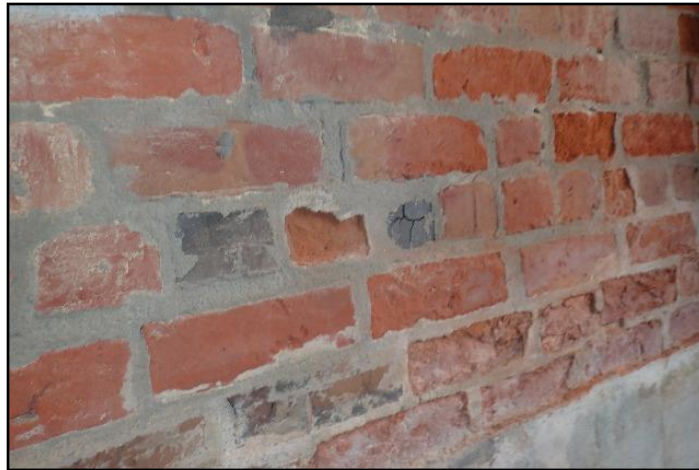
**Condition:** • [Masonry deterioration](#)

**Location:** Exterior

*Masonry deterioration*

**Task:** Repair. Monitor. Condominium Association responsibility.

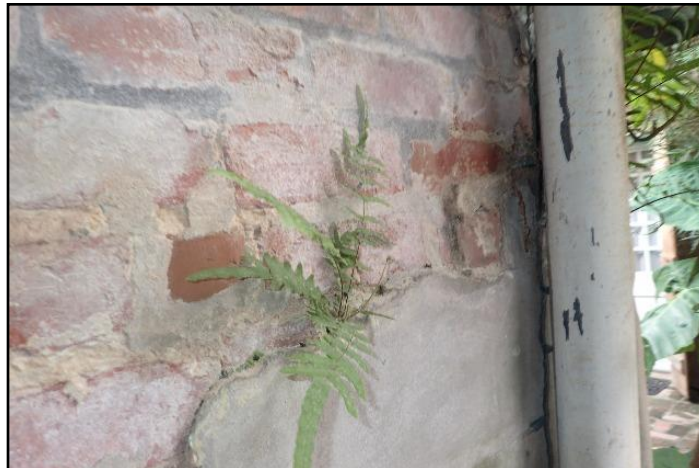
**Condition:** • One shrub was growing in the bricks.

**Location:** Exterior near entry hall

*Shrub*

**Task:** Remove and repair damage, condo association responsibility.

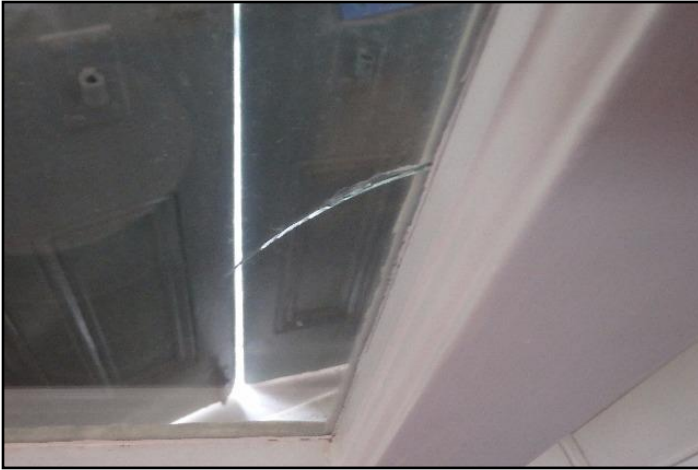
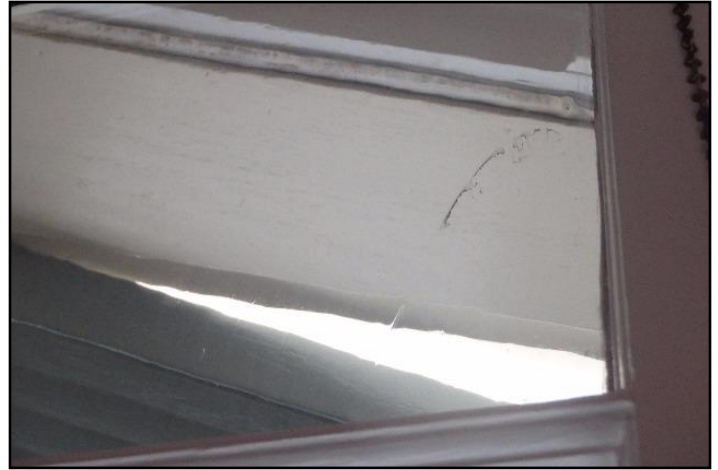
**Condition:** • [Cracked](#)

*Cracked*

**Task:** Replace

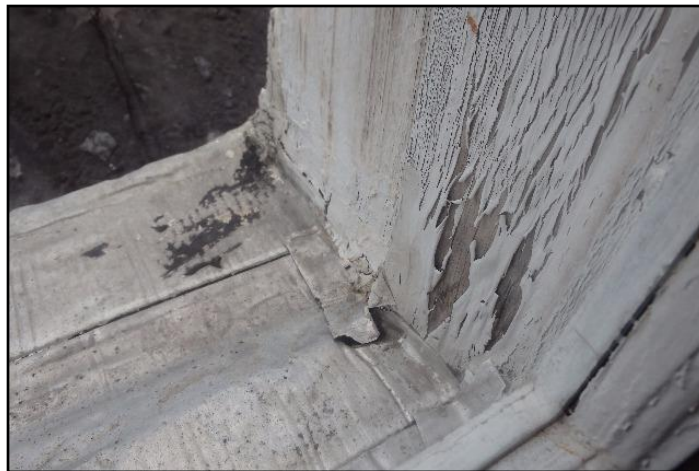
**Condition:** • Peeling paint

**Implication(s):** Material Deterioration

**Location:** Right Exterior Window Trim

*Peeling paint*

**Task:** Paint

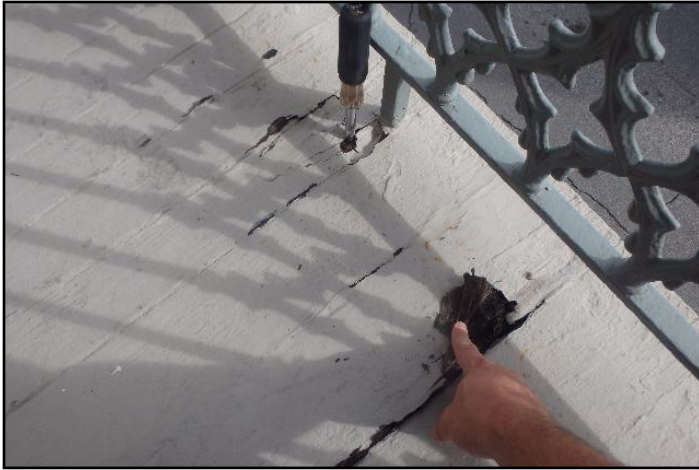
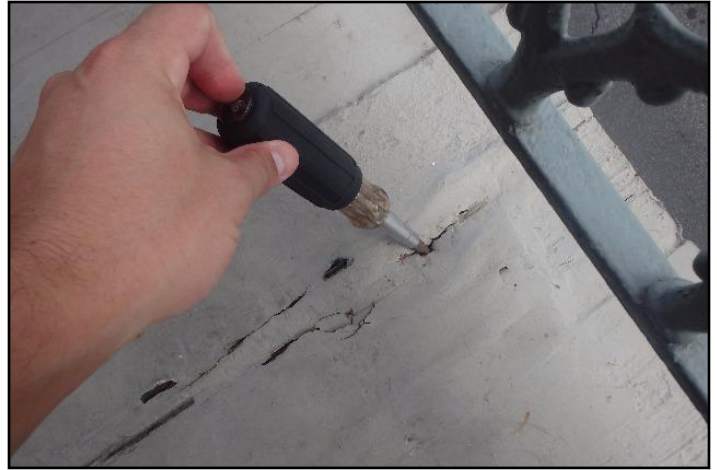
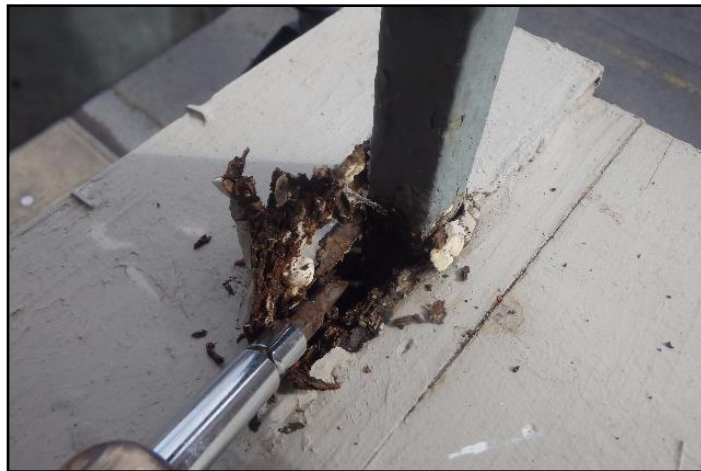
**Condition:** • [Rot](#)

Rot

**Task:** Replace rotten wood

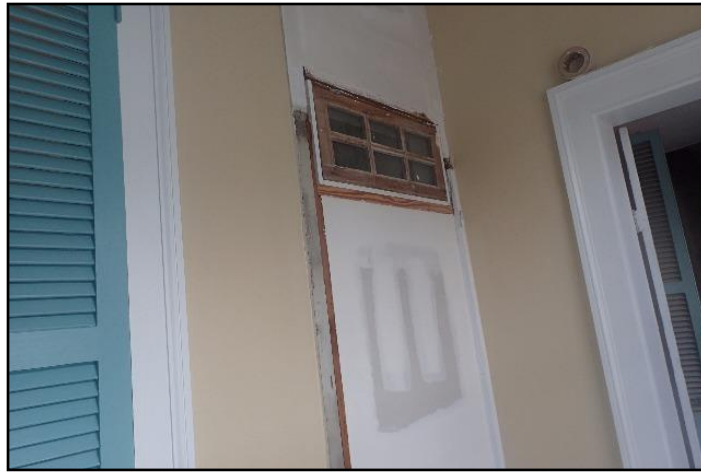
**Condition:** • AN old door was removed and the wall is in the process of being finished.

*Inprocess*

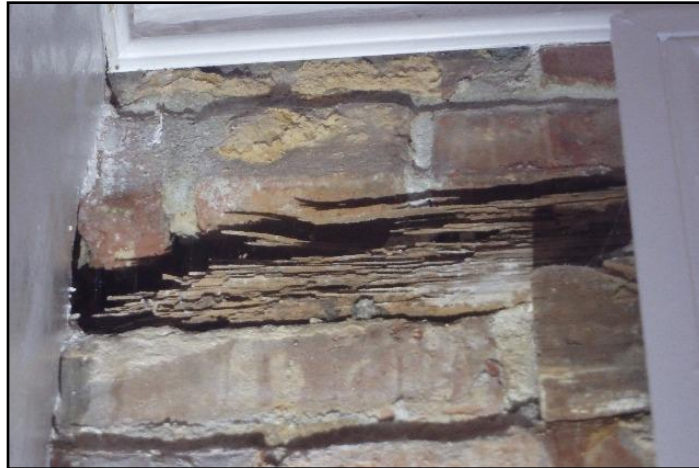
**Condition:** • Insect damage at header

**Location:** Front Right French Door Header

*Insect damage*

**Task:** Monitor

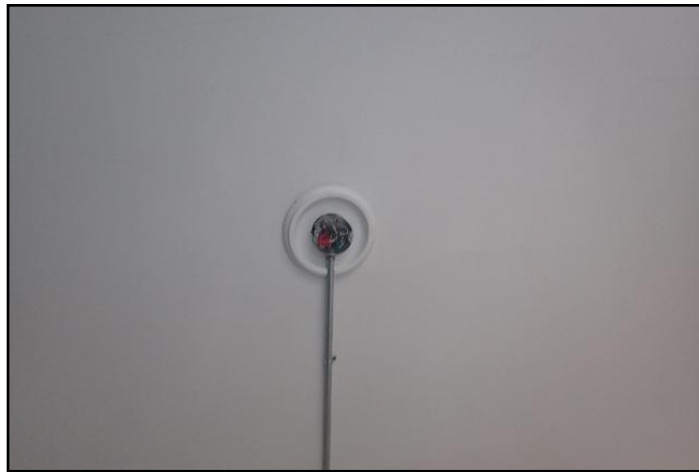
**Condition:** • Lights and wiring is in the process of being installed.

**Location:** Exterior Stairwell

Unfinished

**Task:** Condominium Association responsibility.

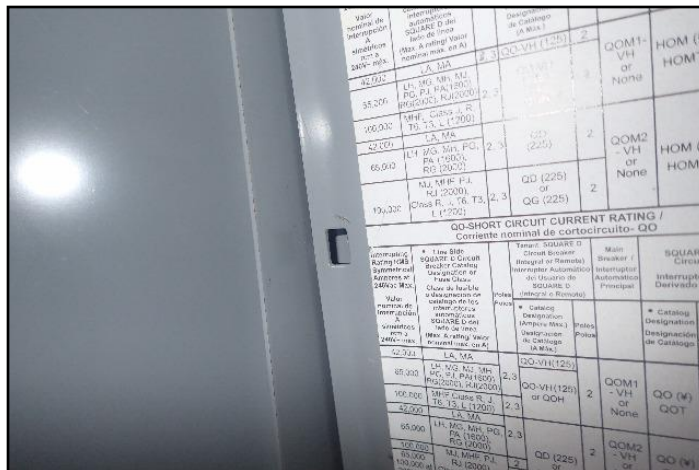
**Condition:** • Loose panel cover

**Location:** Laundry Area

Loose panel cover

**Task:** Correct.

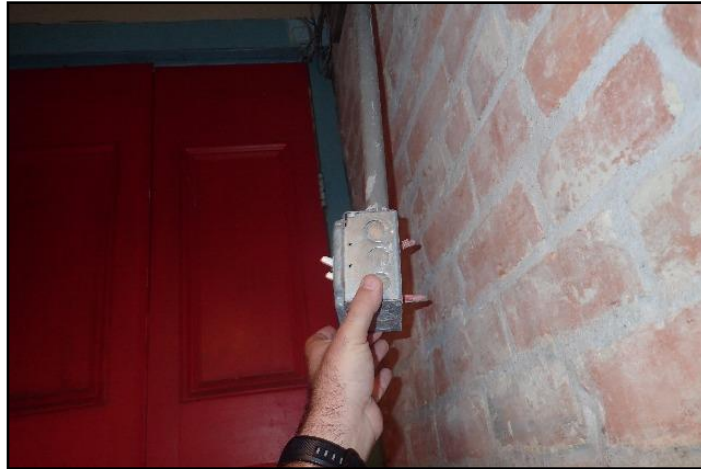
**Condition:** • [Loose](#)

**Location:** Entry hall

*Loose*

**Task:** Repair. Condominium Association responsibility.

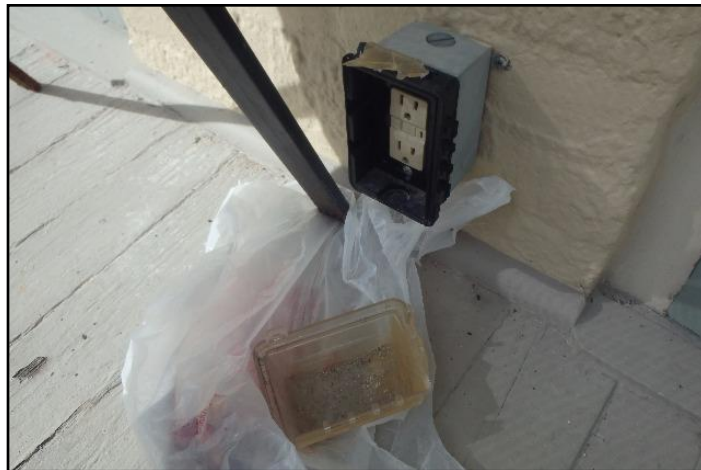
**Condition:** • [Damaged](#)

**Location:** Balcony Weatherproof GFI Cover

*Damaged*

**Task:** Replace

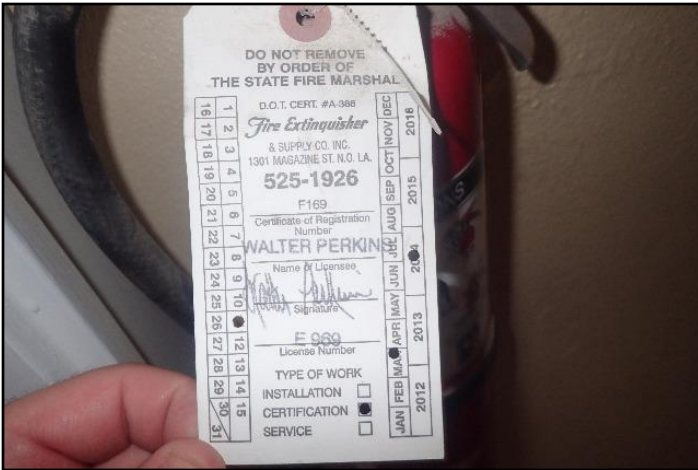
**Condition:** • Common area fire extinguisher - inspection tag out of date

Common area fire extinguisher - inspection...

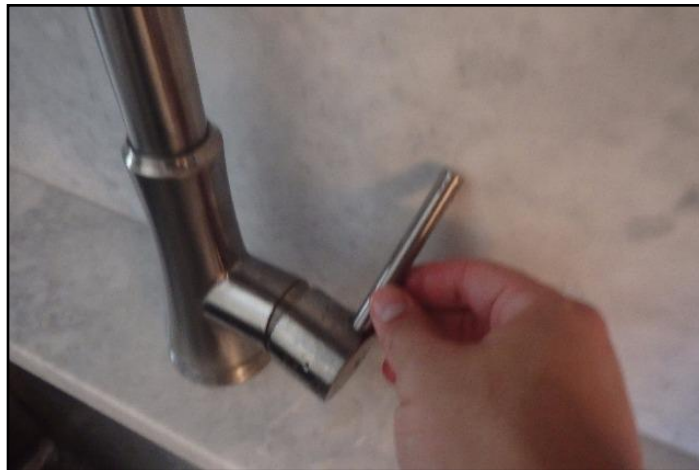
**Condition:** • Reduced operability- back splash limits operation of faucet handle

**Location:** Kitchen Sink

*Poor arrangement*

**Task:** Improve as needed

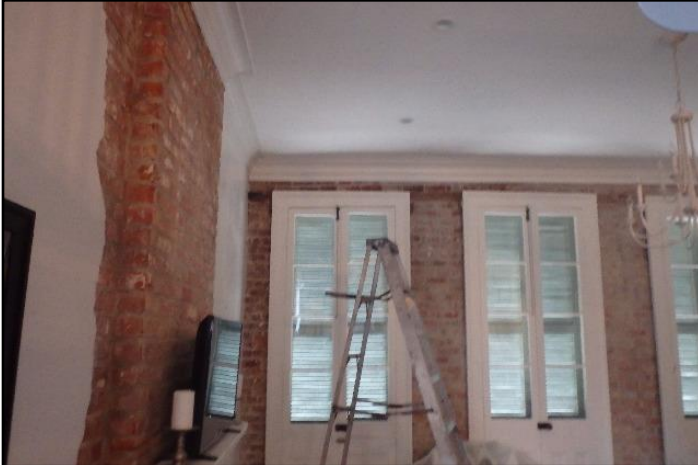
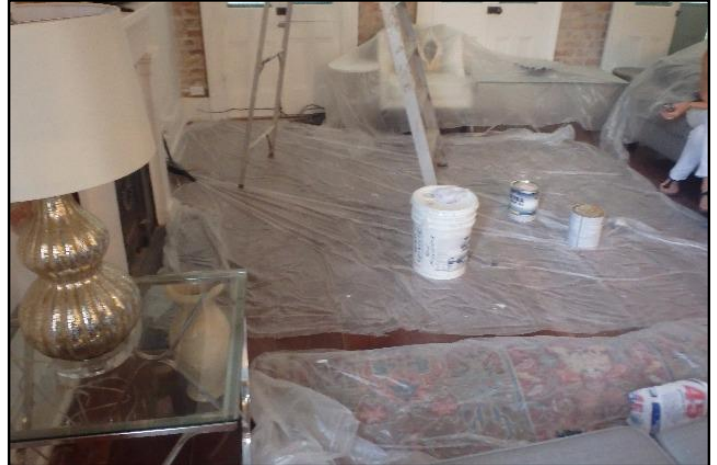
**Condition:** • [Patched](#)

A ceiling repair in the front right corner of the living room was being made during the inspection. This was apparently related to a roof leak that has been fixed.

**Location:** Living Room

*Patched*

**Task:** Monitor

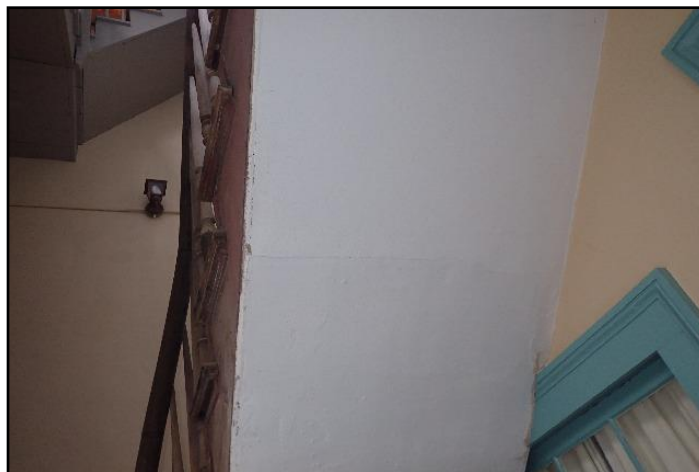
**Condition:** • Cracked

**Location:** Various Exterior

*Cracked*

**Task:** Repair. Condominium Association responsibility.

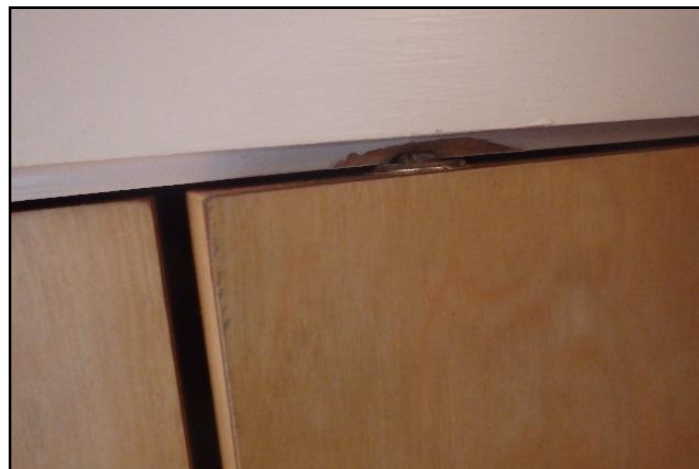
**Condition:** • Does not latch properly

**Location:** Front Bedroom Closet Door

*Does not latch properly*

**Task:** Repair
