INSPECTION REPORT

For the Property at: 4520 BURTHE ST NEW ORLEANS, LA 70118

Prepared for: JOHN BEECHEM Inspection Date: Friday, June 1, 2018 Prepared by: Beau Tanner and Matthew Del Buono

RE: Report No. 8108, v.3 4520 Burthe St New Orleans, LA 70118

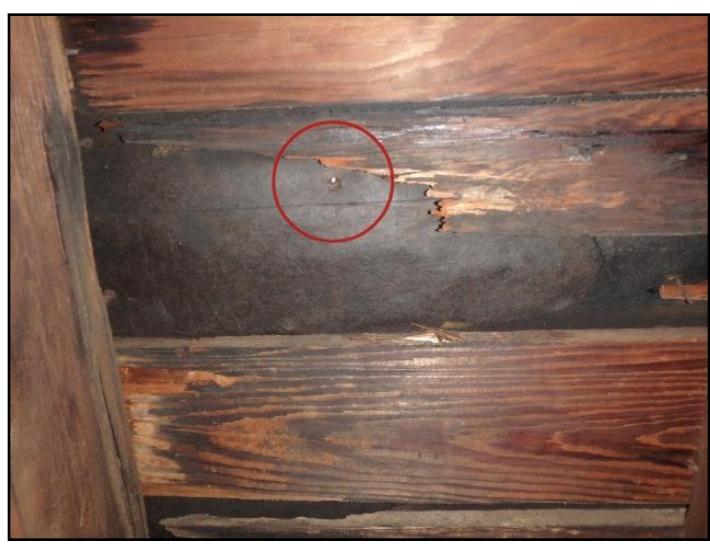
Condition: • Leak Daylight was visible through a small hole by a section of rotten sheathing in the attic. Location: Right Roof Slope Task: Repair

Leak

Task: Repair

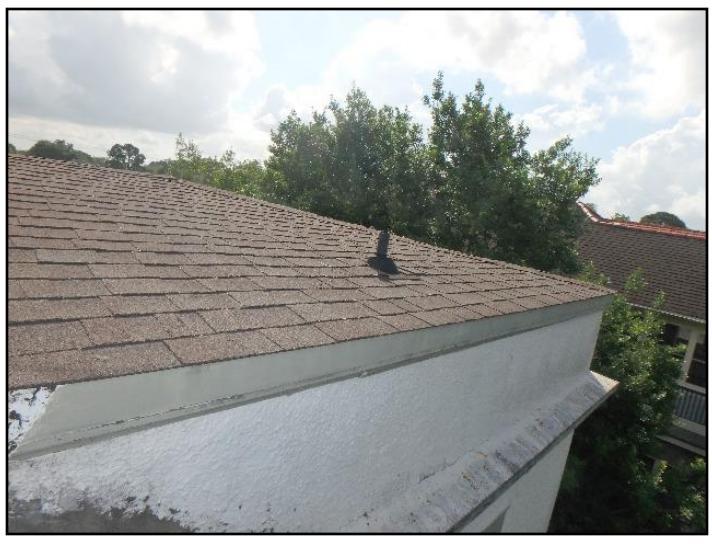
The right kitchen section of the roof had a low slope and was installed with asphalt shingles. Shingles should not be installed on a roof surface with a 2 and 12 slope or less. No evidence of any issues or leakage was observed during the inspection.

Slope too low

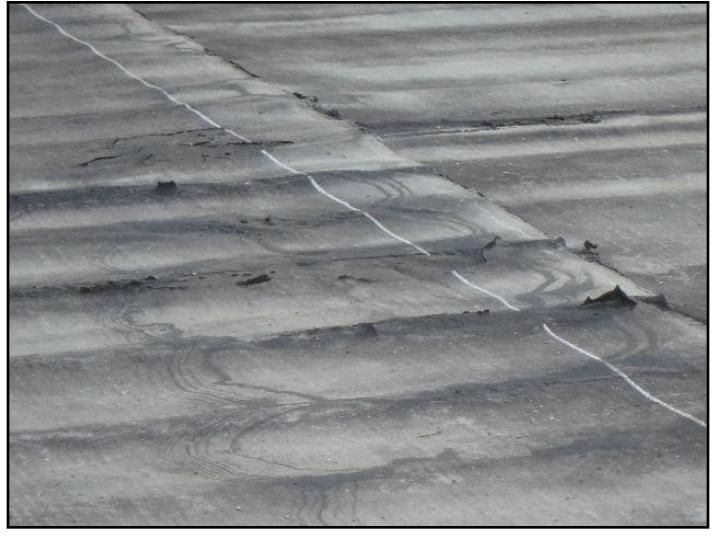
Condition: • Old, worn out Location: Rear Left Flat Roof Task: Replacement recommended

Old, worn out

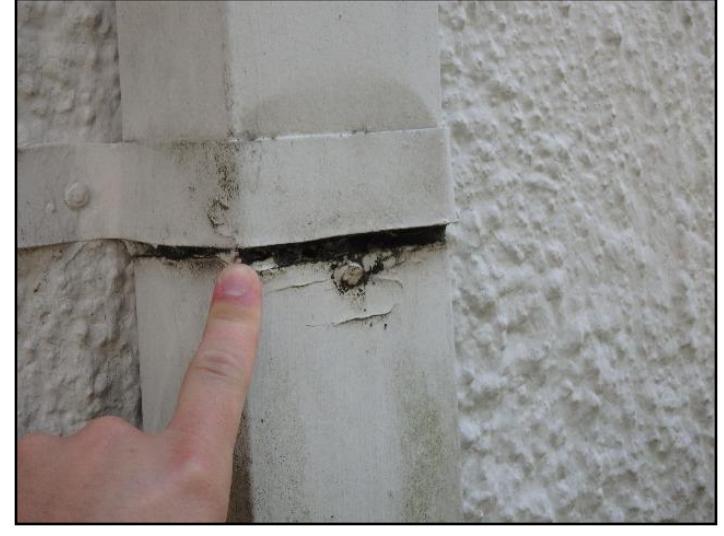
Condition: • Connections loose Location: Left Side Exterior Task: Repair or replace.

Connections loose

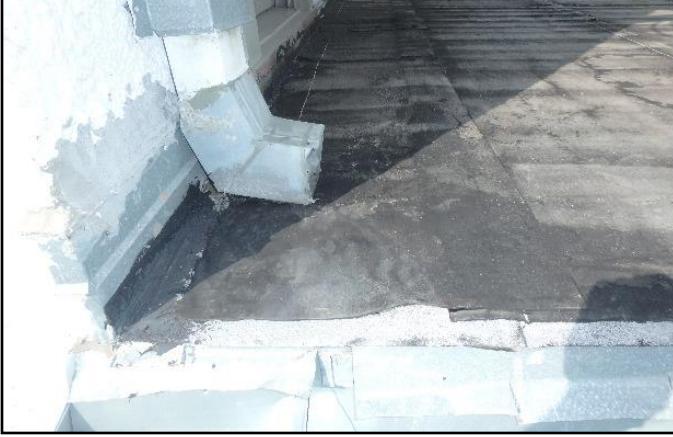
Condition: • Discharge onto roofs Location: Rear Left Flat Roof

Discharge onto roofs

Task: Correct

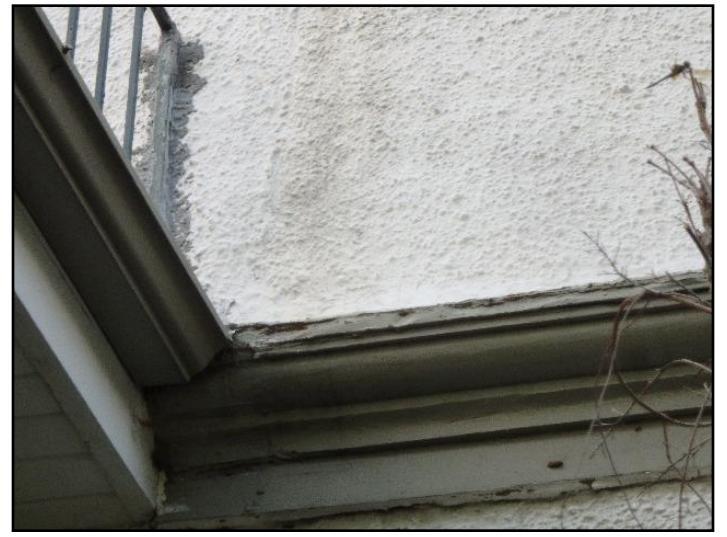
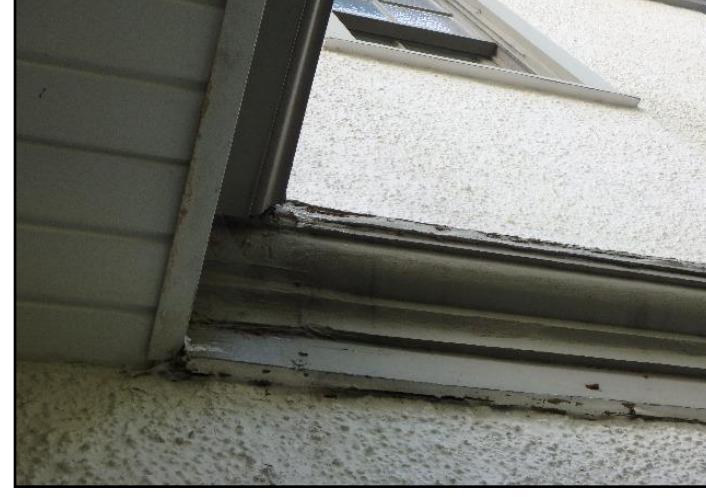
Condition:
 Insect damage Unable to determine extent of damage or if active insects were present. Location: Front Right Side Exterior Task: Further evaluation recommended in conjunction with other structural repairs

Insect damage

Task: Further evaluation recommended in conjunction with other structural repairs

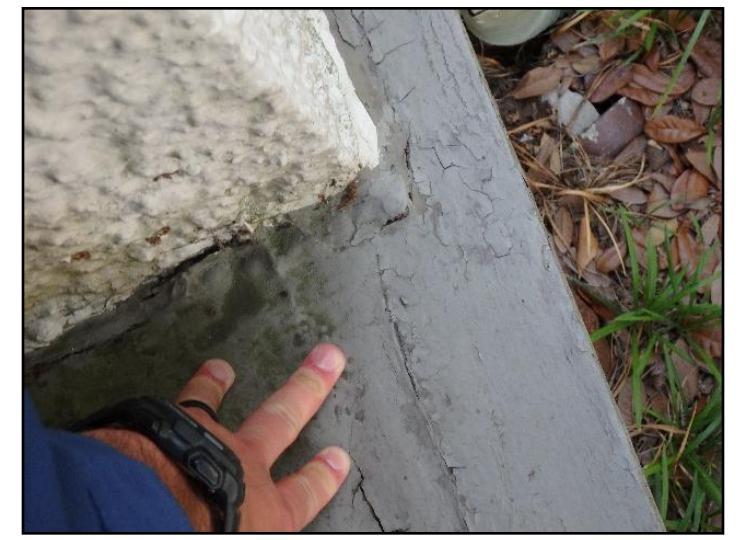
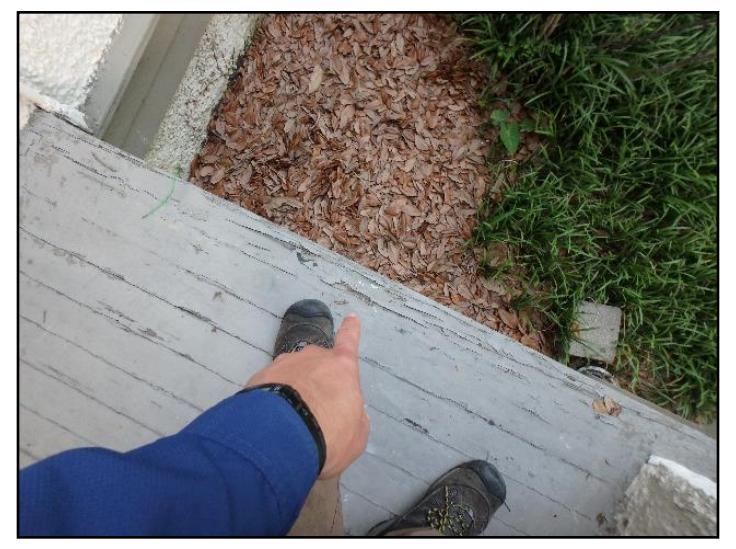
Rot

Task: Repair or replace damaged wood and paint or seal to protect from moisture intrusion.

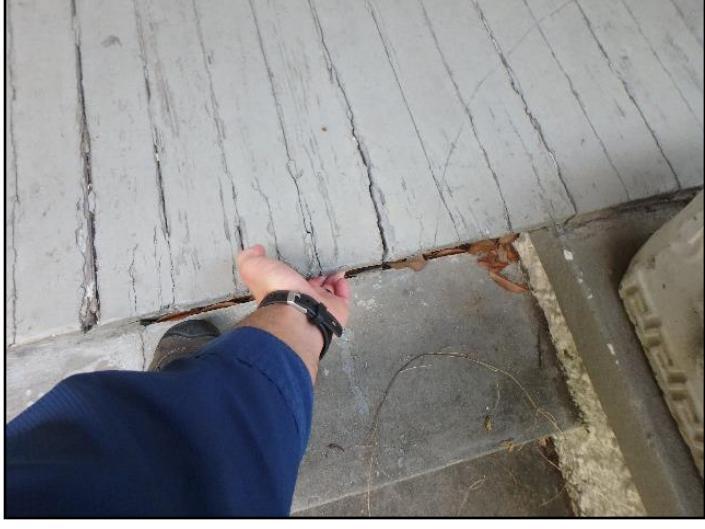
Water Damage/Loose

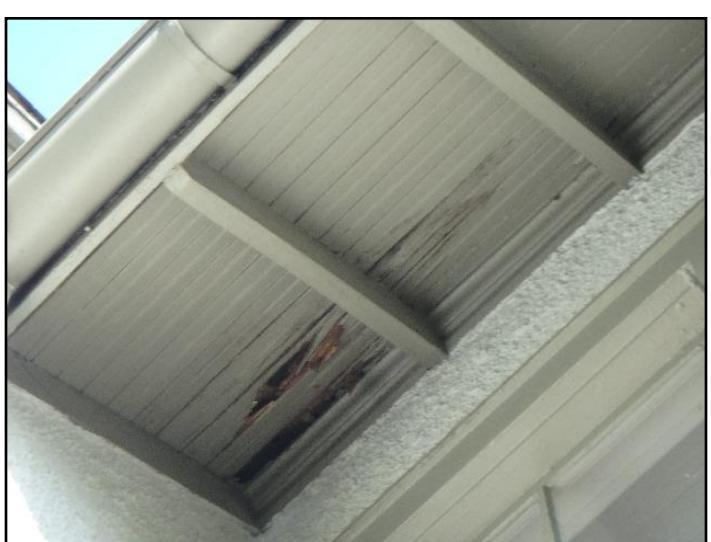
Rot

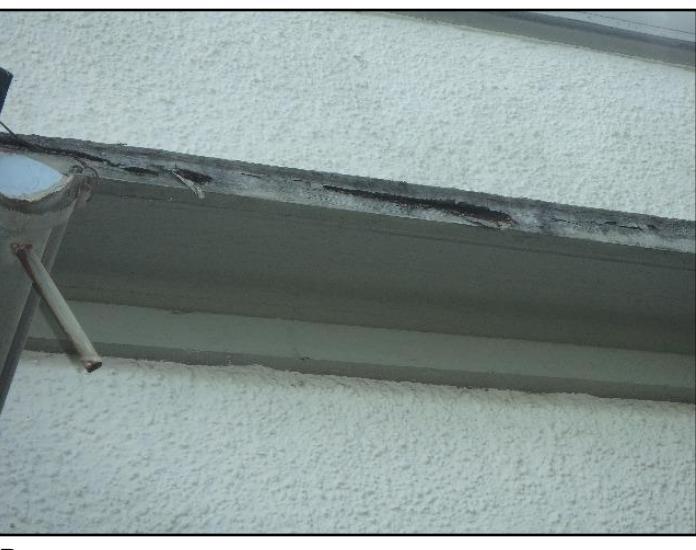
Rot

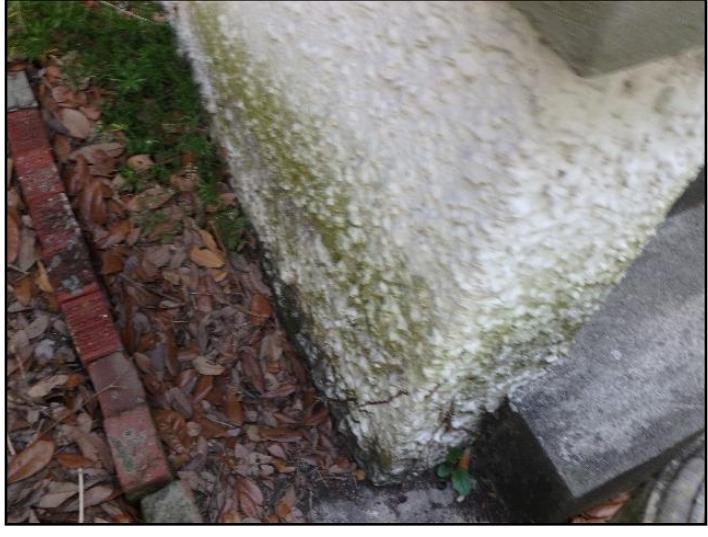
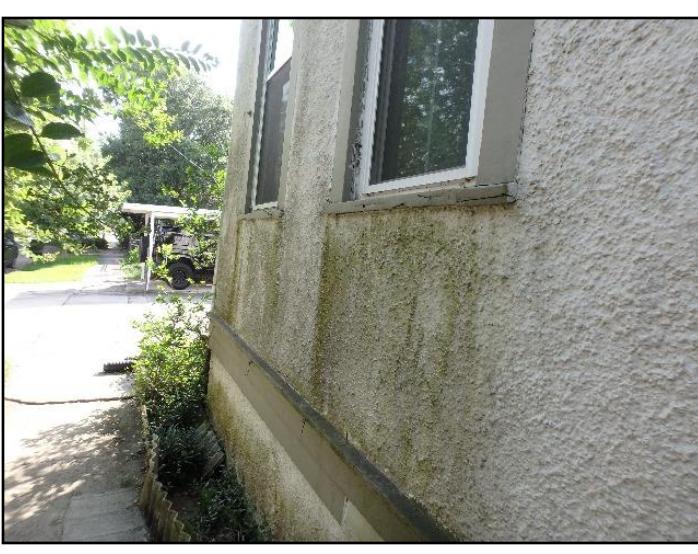
Condition: • Staining Location: Various Exterior Wall Task: Clean.

Staining

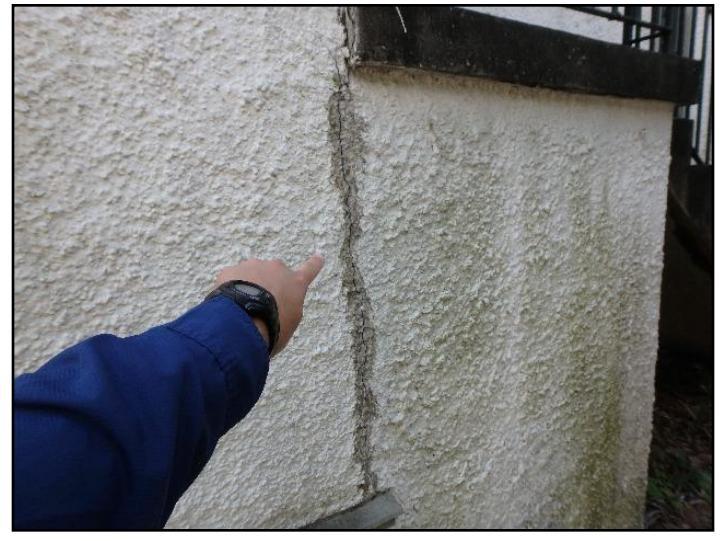
Condition: • Stucco Damage: Cracking, water damage, and other general disrepair was noted to the stucco in various areas. Further evaluation and proper repairs are recommended.

Stucco Damage: Cracking, water damage, and...

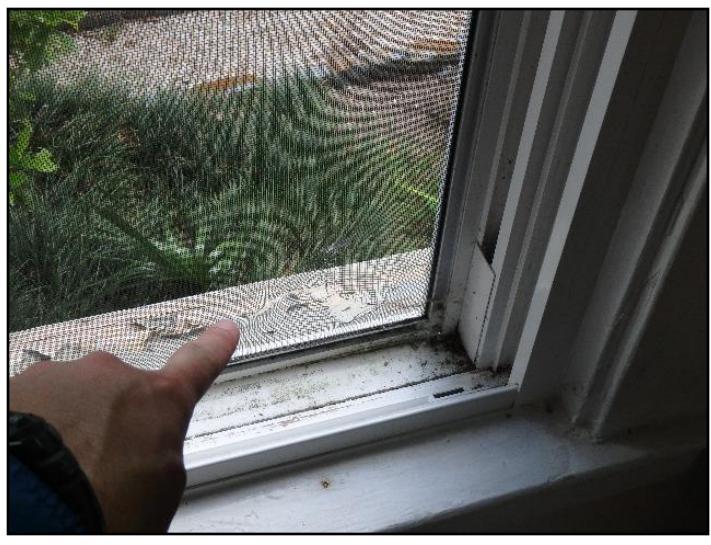
Torn or holes

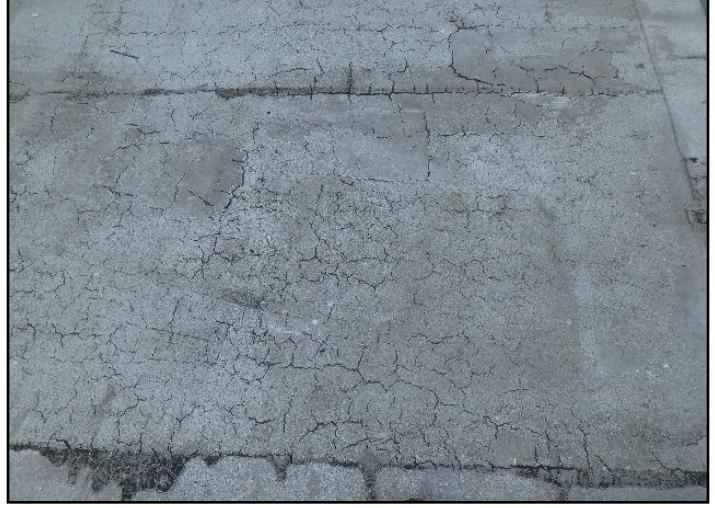
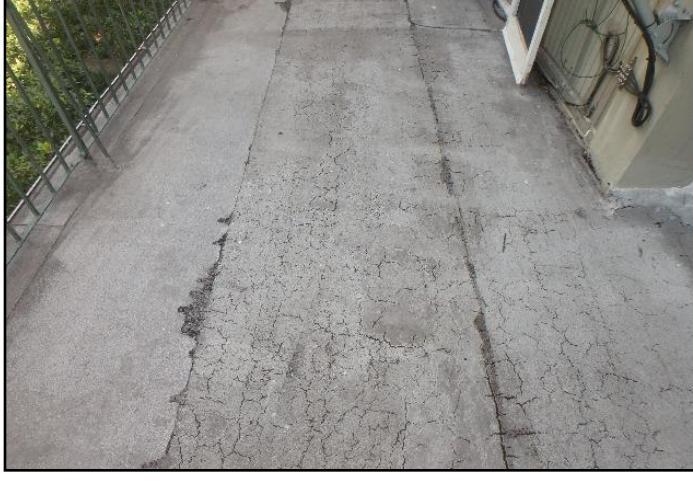
Condition: • Roofing material used as balcony flooring. End of its useful life. Location: Front Balcony Task: Replace

Aged, worn out

Flat roofing material

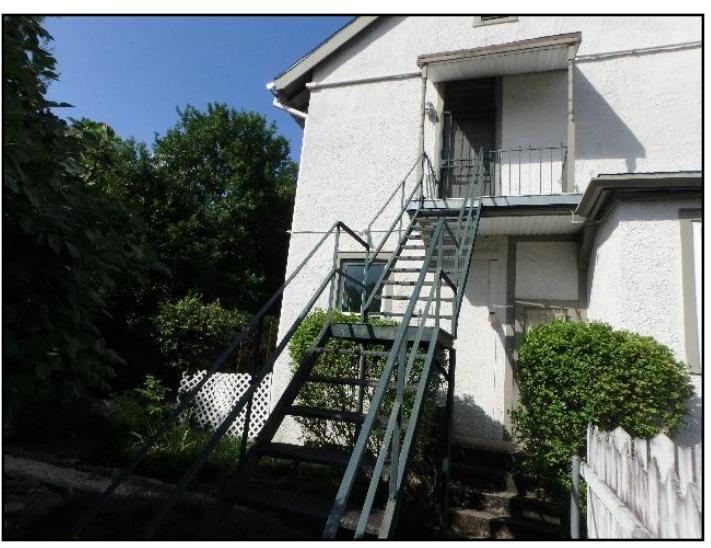
Condition: • Fall hazard Agent stated stairs were unsafe to access. Location: Rear Exterior Task: Verify. Correct/Replace as needed

Fall hazard

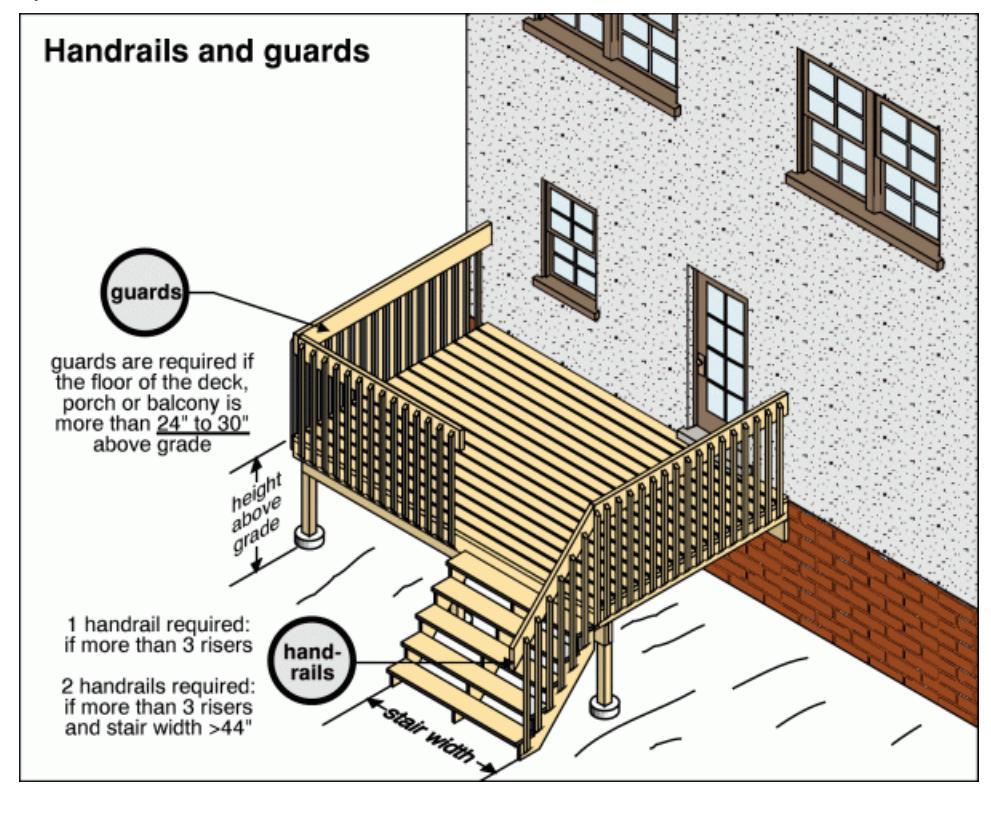
Missing handrail or guardrail. Railings should be provided wherever there is a danger of falling, or when the deck, porch or balcony is more than 30 inches off the ground. Railings should be sturdy enough to resist a person's weight and spindles spaced no more than 4". Railings should be high enough to provide adequate protection; 36 inches is common. Location: Front Porch

Task: Install for safety

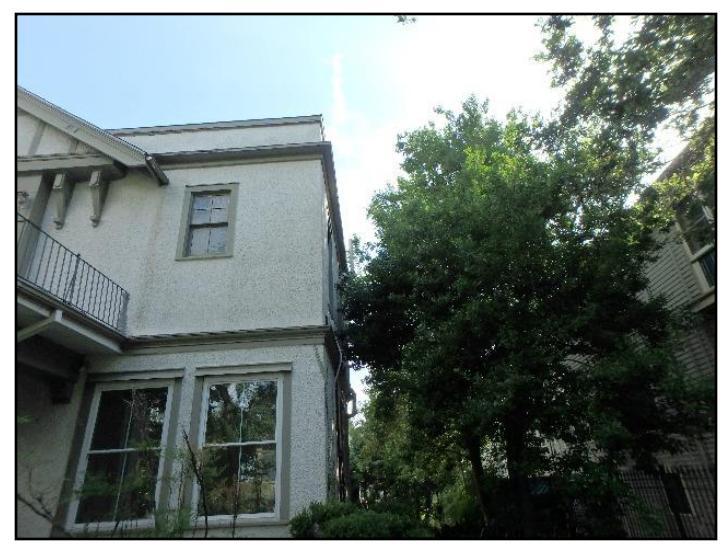
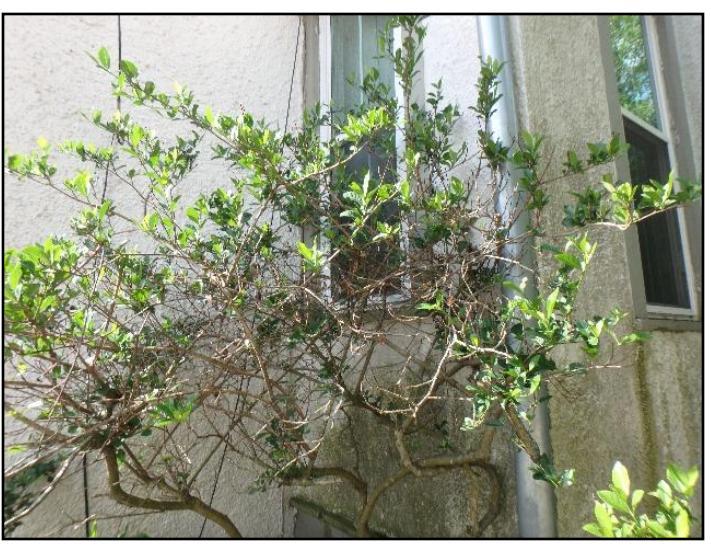
Trees and branches overhang or touch roof and prevent proper drying, increases the chance of moisture damage. Branches can also damage siding and provide an access point for pests.

Trees or shrubs too close to building

Task: Trim back trees from over roof and walls.

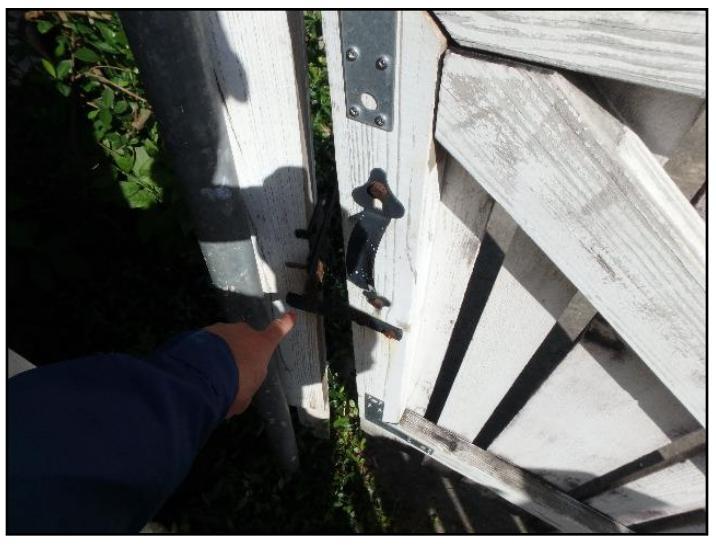
Condition: • Gate - adjustment needed **Location**: Rear Left Side Exterior **Task**: Improve. Adjust.

Gate - adjustment needed

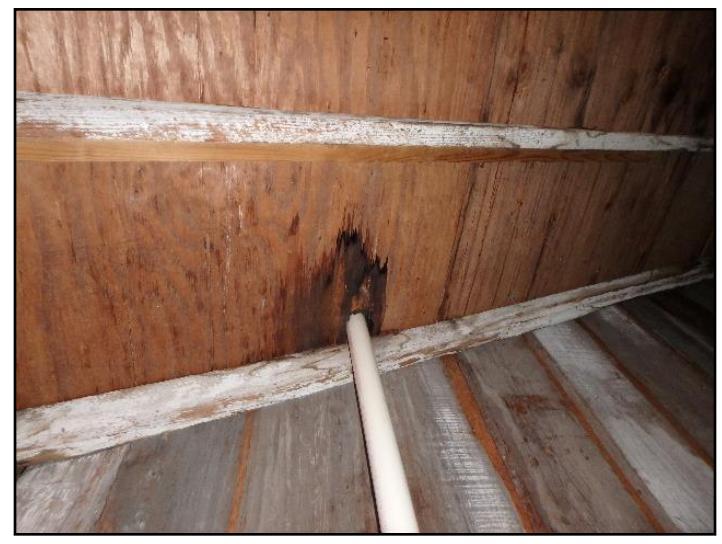
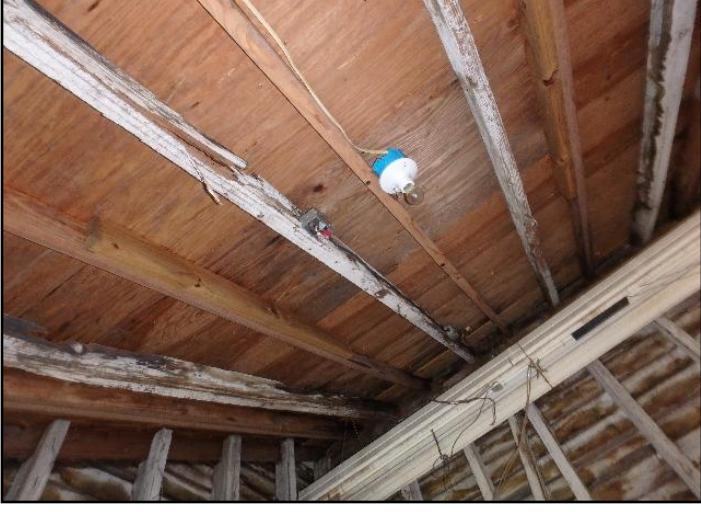
Condition: • Disrepair Garage was in a state of overall disrepair. Location: Rear Garage Task: Repair or replace.

Disrepair

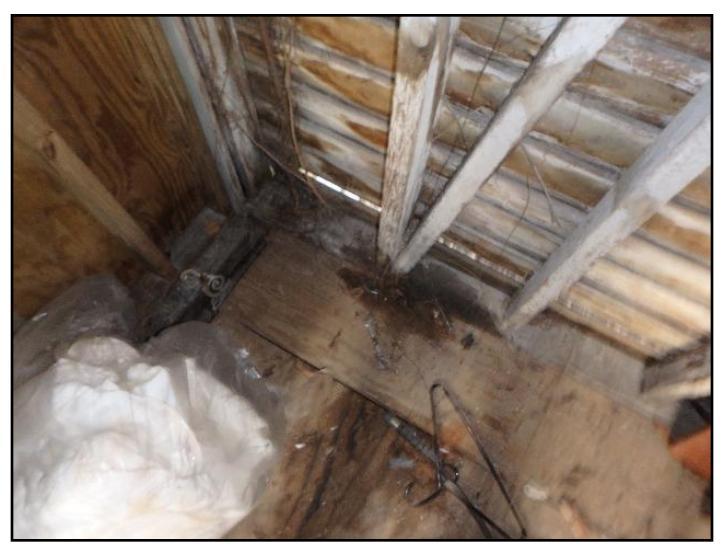
GARAGE \ General Condition: • Disrepair Garage was in a state of overall disrepair. Location: Rear Garage Task: Repair or replace.

Disrepair

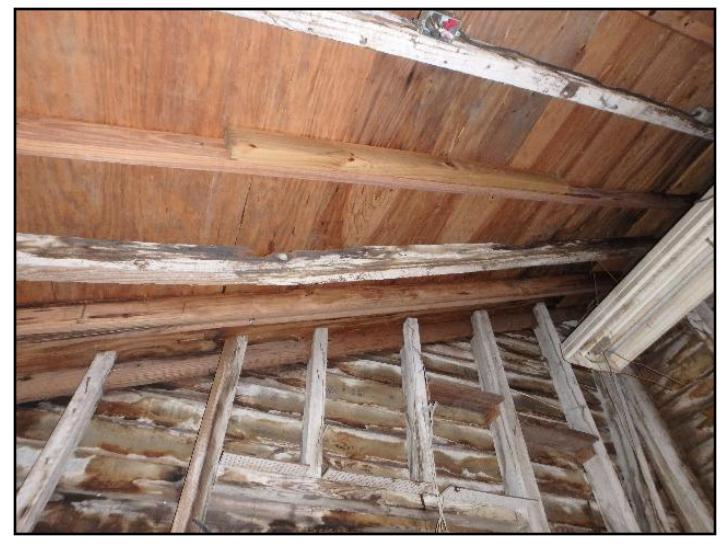
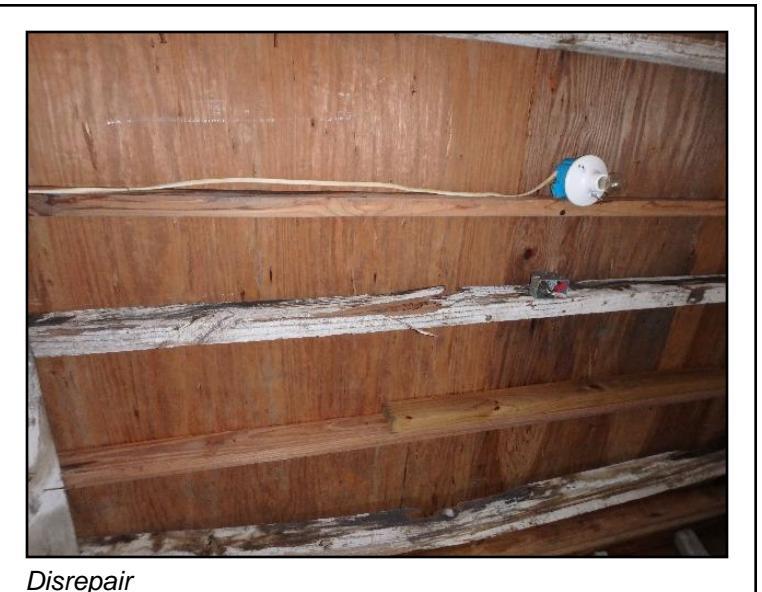
Disrepair

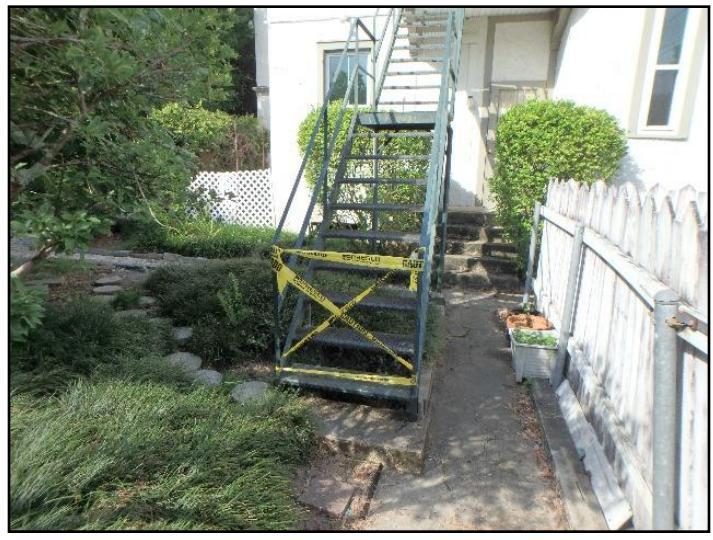
Stairs

No or limited access to: • Rear of Garage • Agent stated that exterior back stairs were unsafe to access.

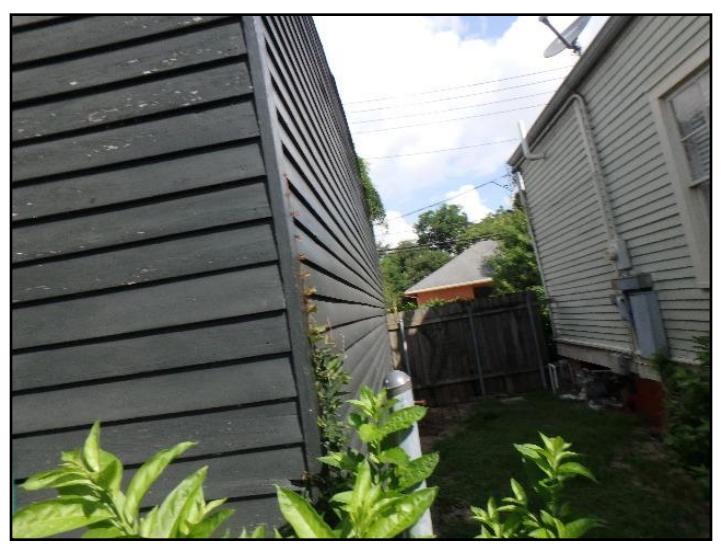
Garage

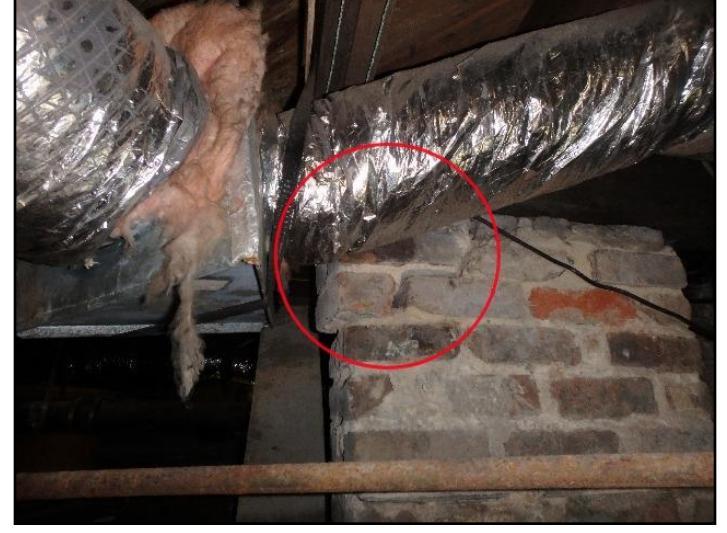
Condition: • Damage Location: Middle Crawl Space Task: Repair or replace.

Damage

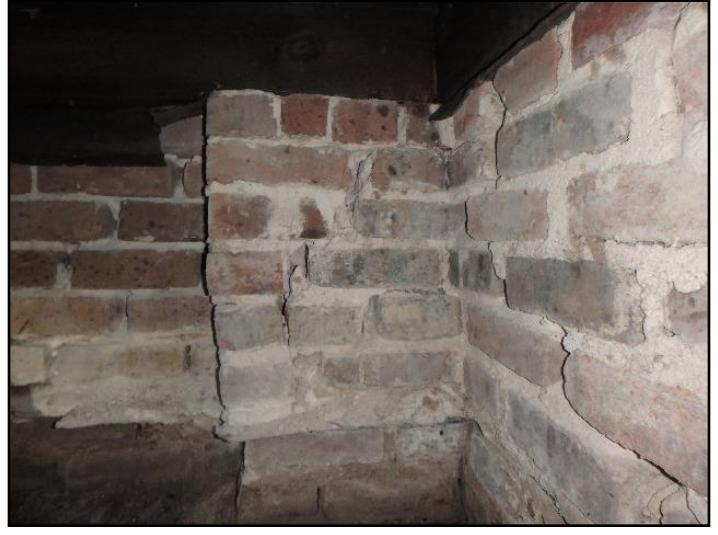
Condition: • Cracked Location: Front Left Crawlspace Task: Repair

Cracked

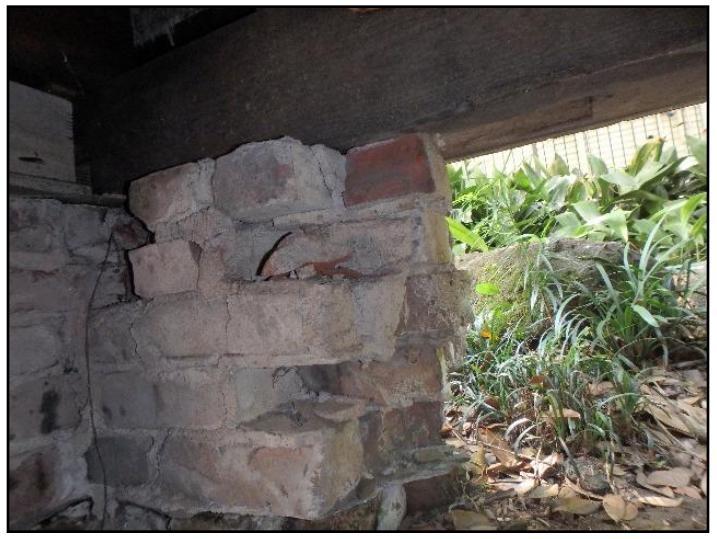
Condition: • Mortar deterioration

Piers are showing signs of mortar deterioration. This should be monitored and corrective action taken to maintain structural integrity.

Location: Various Crawlspace

Mortar deterioration

Task: Monitor. Re-point or encapsulate piers where needed to prevent further deterioration

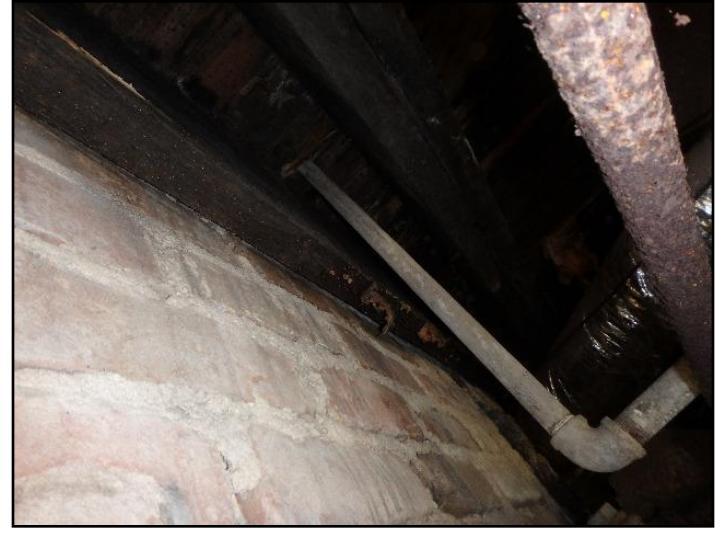
Condition: • Rot, insect or fire damage Location: Right Side Middle Crawl Space Around Fireplace Base Task: Repair or replace.

Rot, insect or fire damage

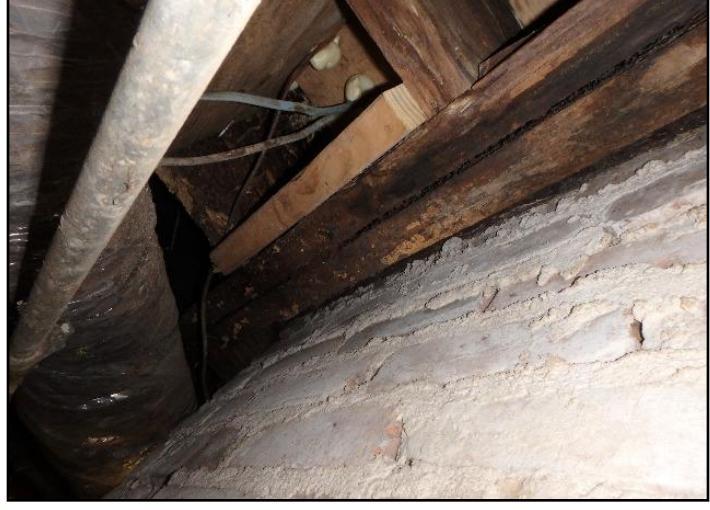
Rot, insect or fire damage

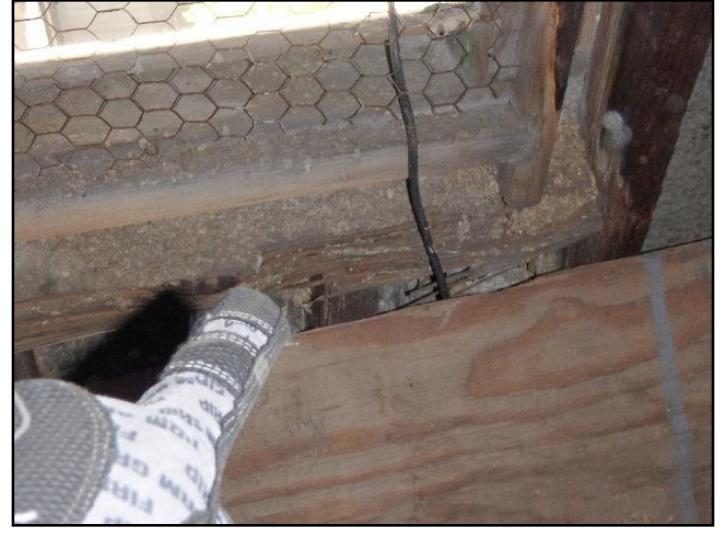
Condition: • Insect damage

Framing around gable vent damaged. Insulation and flooring limited visibility. Unable to determine extent of damage. **Location**: Rear Attic

Insect damage

Task: Verify. Repair/Replace

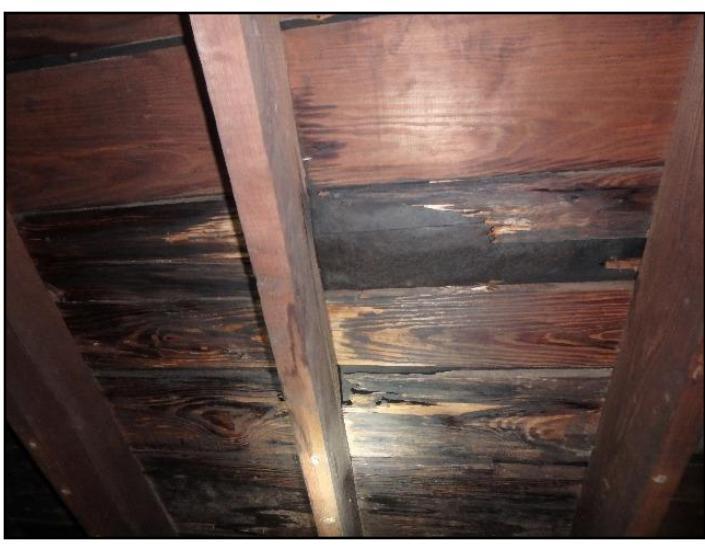
Condition: • Rot Location: Left Middle Attic Task: Replace

Rot

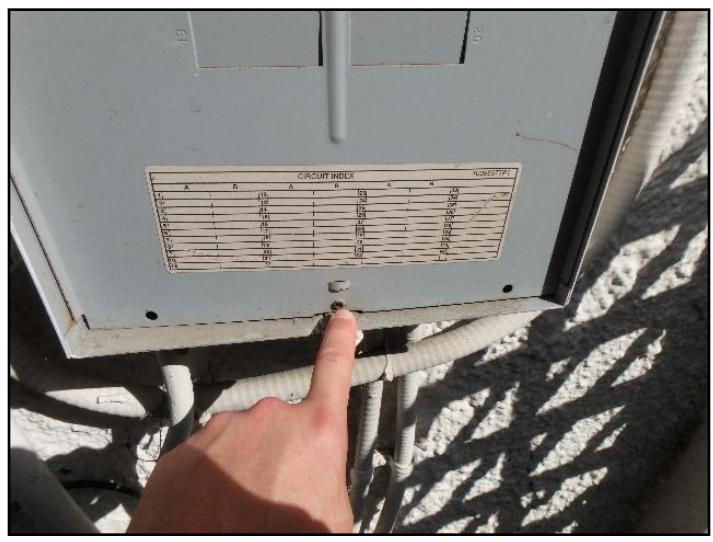
Condition: • Loose panel cover. Screws missing. **Location**: Rear Right Corner Exterior Wall **Task**: Provide or install.

Loose panel cover. Screws missing.

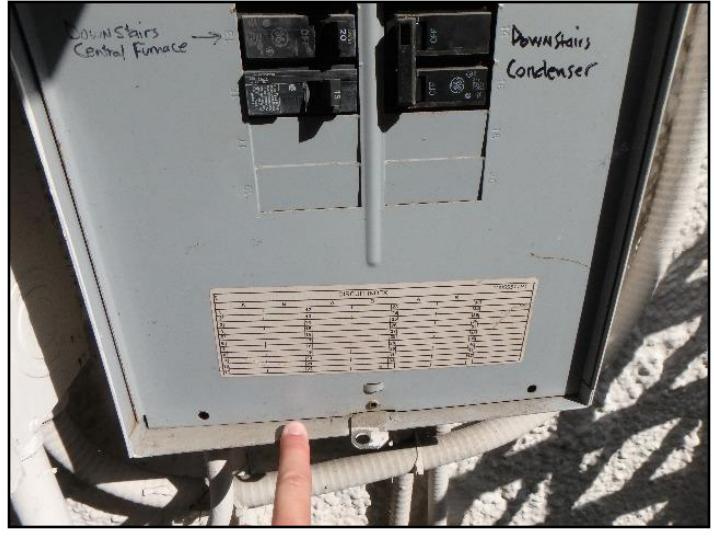
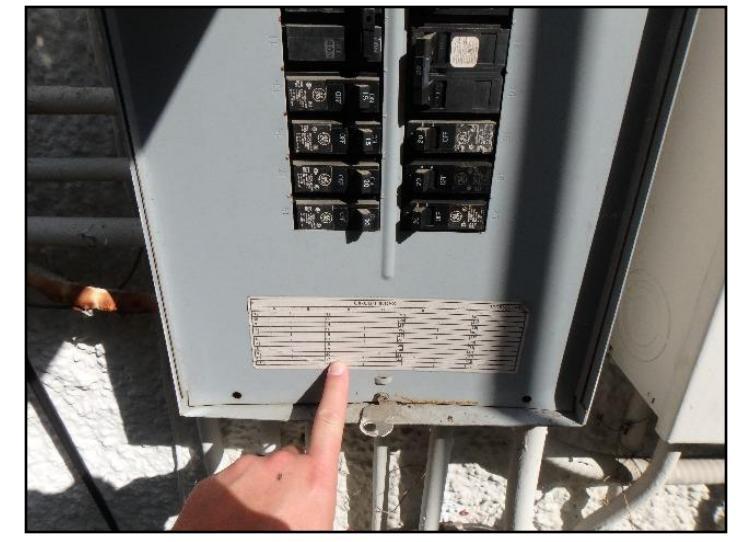
Condition: • <u>Circuits not labeled</u> Location: Rear Right Corner Exterior Wall Task: Clean.

Circuits not labeled

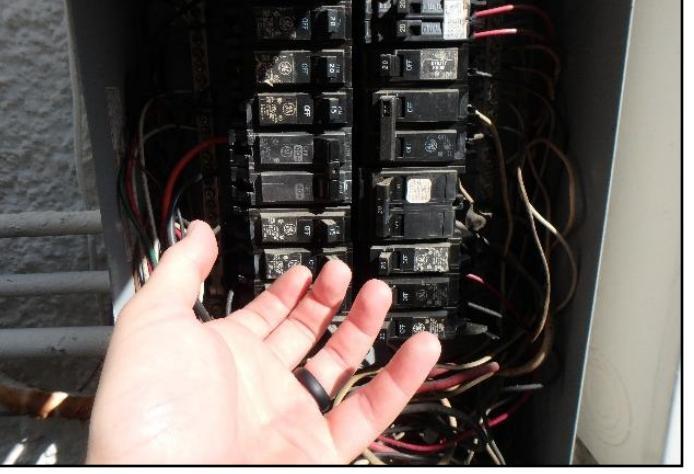
Condition: • <u>No Arc Fault Circuit Interrupter</u> Location: Rear Right Corner Exterior Wall Task: Consider upgrading to current standards

No Arc Fault Circuit Interrupter

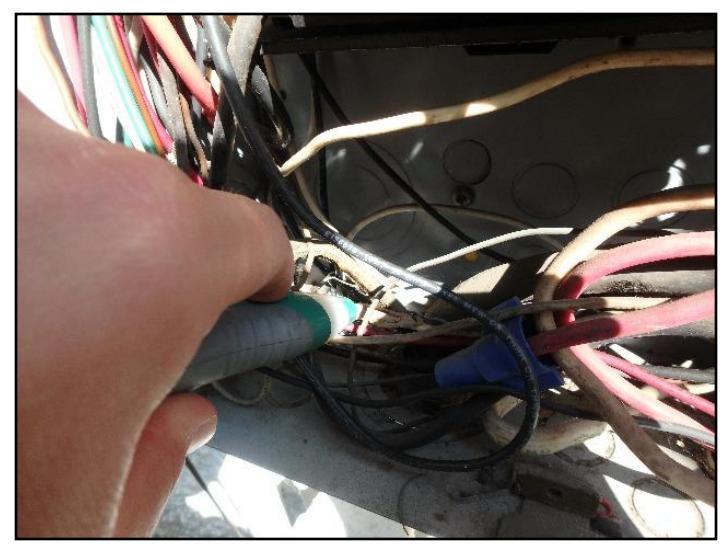
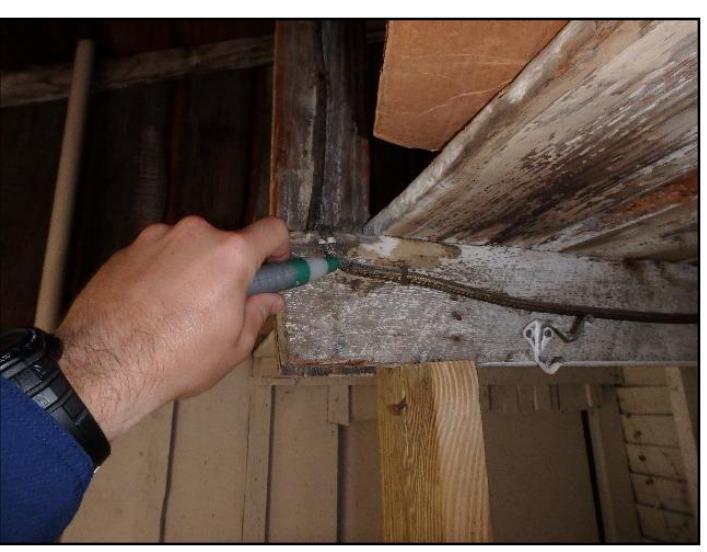
SERVICE BOX, GROUNDING AND PANEL \ Panel wires Condition: • Old Wiring Older cloth-sheathed wiring was noted in the panel or distribution system. Potential insurance issue. Location: Throughout Task: Information only

Old Wiring

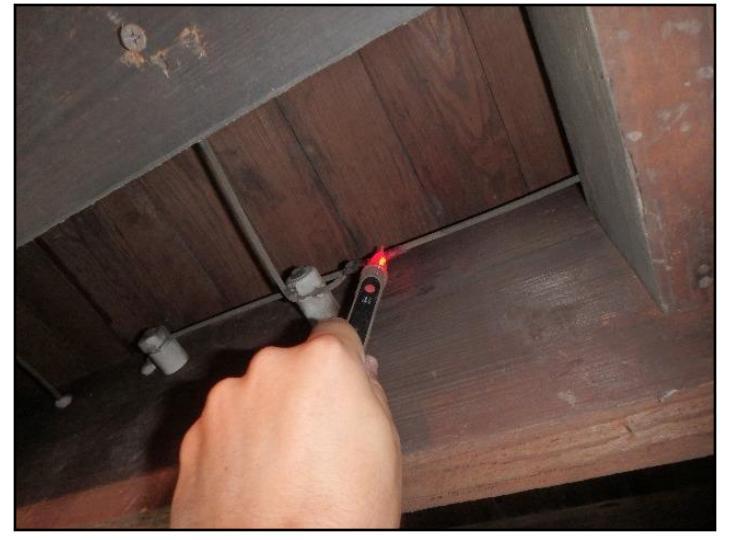
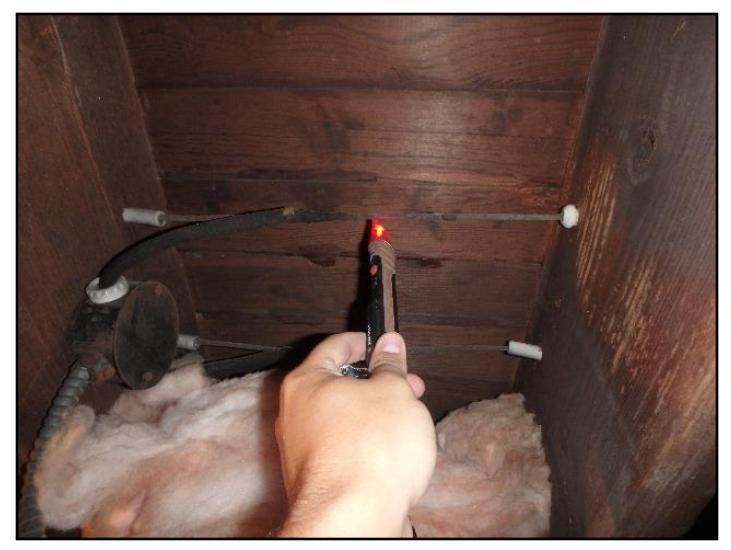
Condition: • Outdated

Location: Active found in crawlspace and attic (Some may be concealed)

Copper - knob and tube

The home has a some amount of active knob and tube type wiring. This wiring was an early standardized method, common in buildings prior to 1930's and used in some cases beyond that period. In past years, this wiring was often not completely removed during upgrades and simply tied into modern wiring. Currently, most insurance companies will not cover homes with any amount of knob and tube wiring or require significantly higher premiums. The system is considered obsolete and can be a safety hazard in many cases.

While not inherently dangerous when installed, the hazards arise from it's age, improper modifications, and the addition of building insulation around the wires. It has no ground wire and thus cannot service any three pronged appliances. The wiring insulation can become deteriorated and is also susceptible to damage by rodents. Altering the installation in an attempt to match modern needs is extremely common.

The recommendations for owners with active knob-and-tube wiring is as follows:

1. Although not advised, if any of the knob-and-tube is to be kept, have the system evaluated by a licensed electrical contractor to confirm that it is safe, installed correctly and without unsafe modifications. Confirm that this will be acceptable to your insurance carrier.

2. Until updates or repairs are completed, do not run an excessive amount of appliances in the home as this can be a fire hazard.

3. Any knob-and-tube active in kitchens, baths, laundry or outside should be replaced. Ungrounded systems in these areas is a safety concern.

4. Remove all flammable insulation or other materials from around the system to reduce fire hazard.

5. Secure an estimate of cost of removal and replacement from a licensed electrical contractor. This can vary greatly depending on the extent of the system, the type of structure and the new installation size and requirements. Most insurance companies will no longer cover properties with active knob and tube wiring.

Task: Replacement of all knob and tube wiring with current system standards.

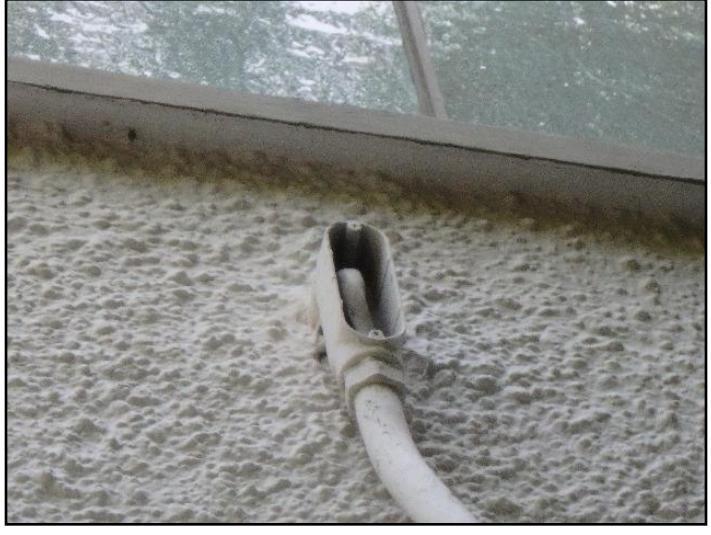
Condition: • Open conduit, exposed wiring Location: Right Side Exterior Wall Task: Correct.

Open conduit, exposed wiring

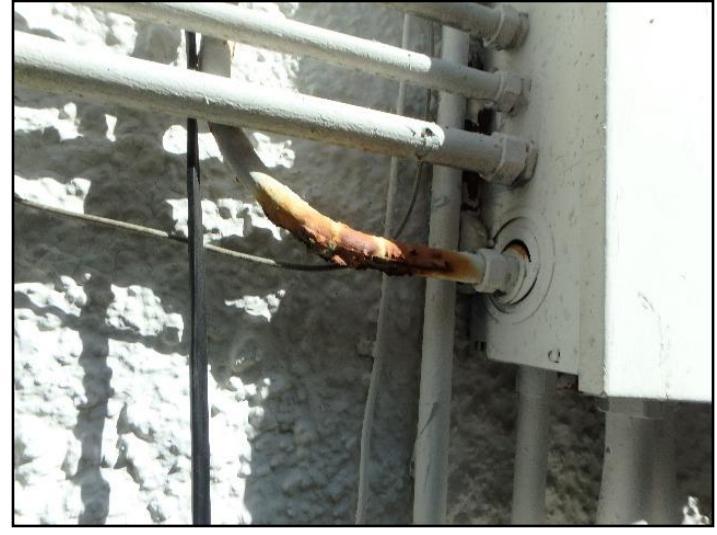
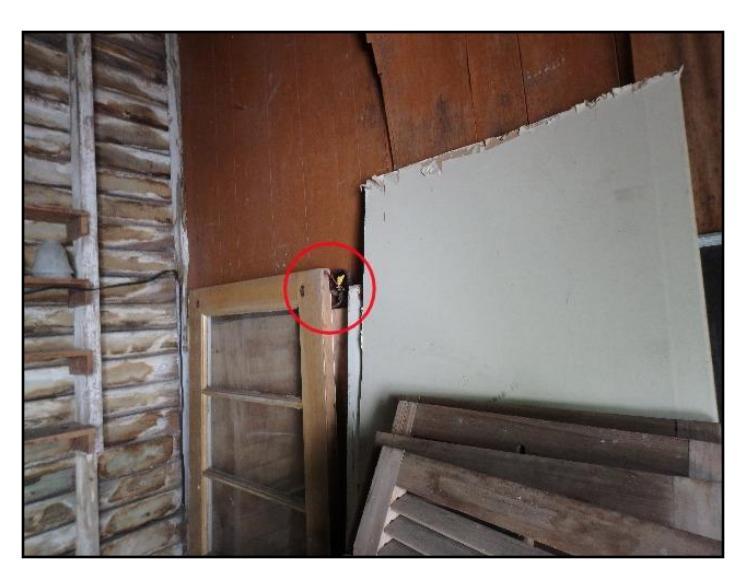
Condition: • Damaged or corroded conduit **Location**: Rear Right Corner Exterior Wall **Task**: Replace.

Damaged or corroded conduit

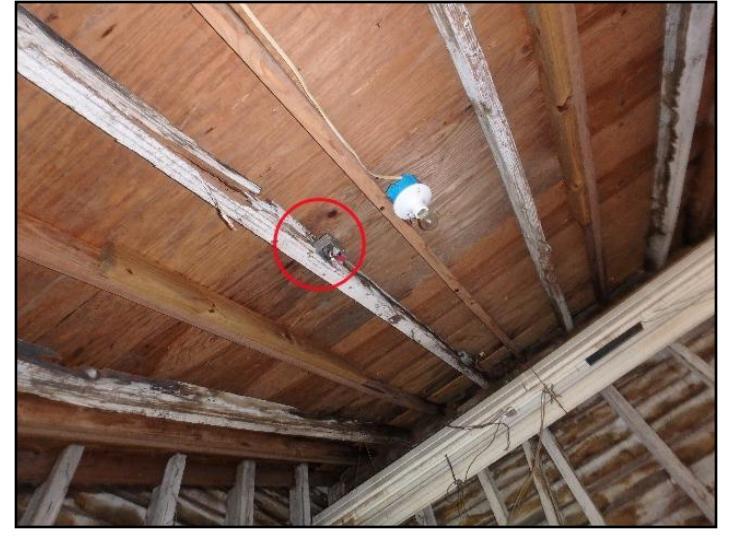
Condition: • Cover loose or missing

Cover missing on junction box(s), exposed, live wiring. Electrical connections should be in closed junction boxes. **Location**: Throughout Garage

Cover loose or missing

Task: Correct.

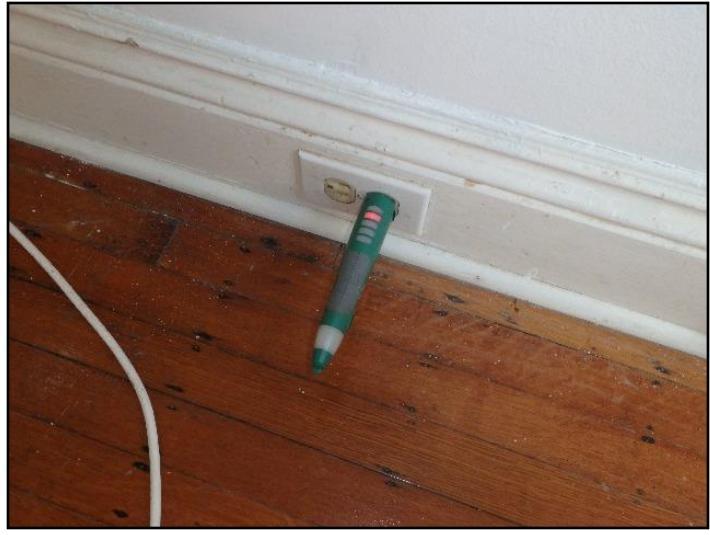
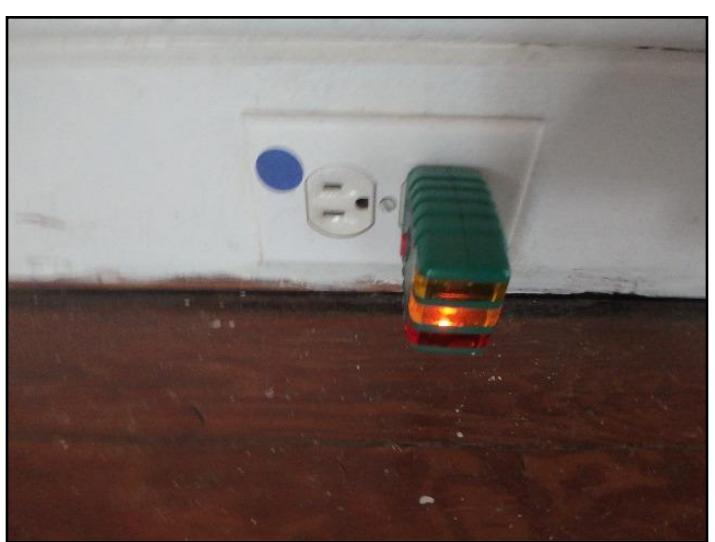
Condition: • Ground needed for 3-slot outlet

Ungrounded 3 slot outlet(s) found. The grounding of electrical outlets became standard after about 1960. The ground wire normally conducts no electricity, but serves as a path for stray current, in case something goes wrong with the appliance or receptacle. The ground wire provides a safe path for the electricity and prevents electrical shock. Three slot receptacles are sometimes installed in ungrounded situations in order to plug in appliances with three prongs, but this can be dangerous and misleading. Adapters should not be used in two slot outlets. Three slot receptacles should

Location: Various Interior

Ground needed for 3-slot outlet

Task: Correct. Discuss options with your electrician.

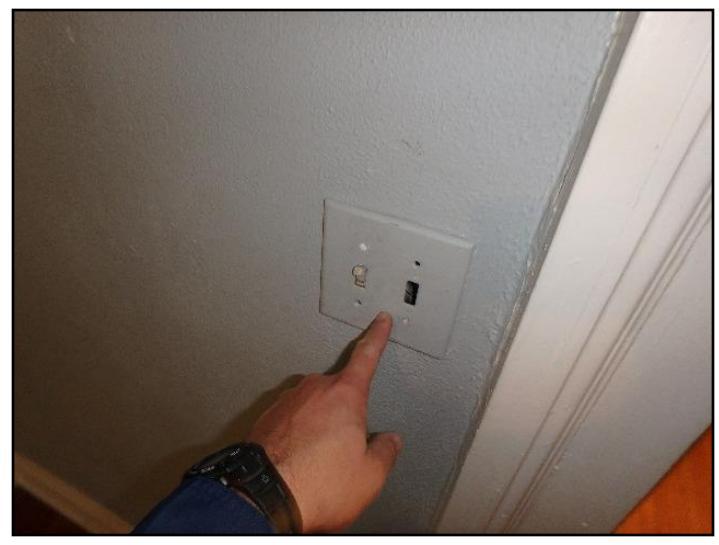
Condition: • Opening in switch Location: First Floor Front Left Bedroom Task: Correct.

Opening
