INSPECTION REPORT

For the Property at: 4520 BURTHE ST NEW ORLEANS, LA 70118

Prepared for: JOHN BEECHEM Inspection Date: Friday, June 1, 2018 Prepared by: Beau Tanner and Matthew Del Buono

RE: Report No. 8108, v.3 4520 Burthe St New Orleans, LA 70118

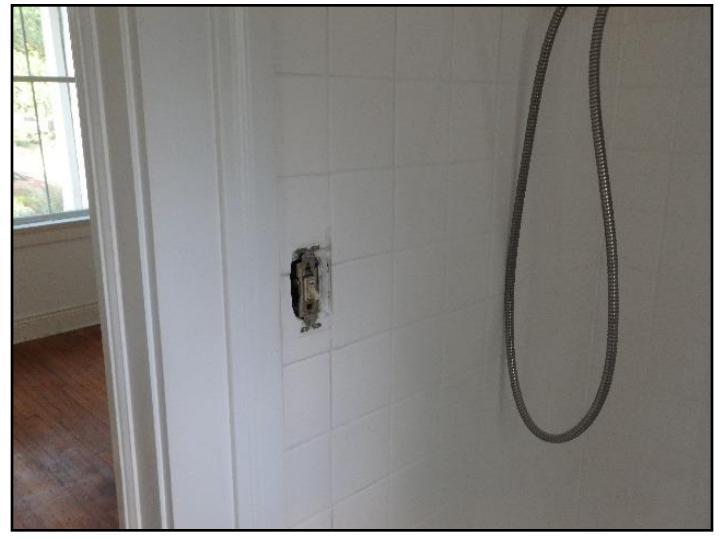
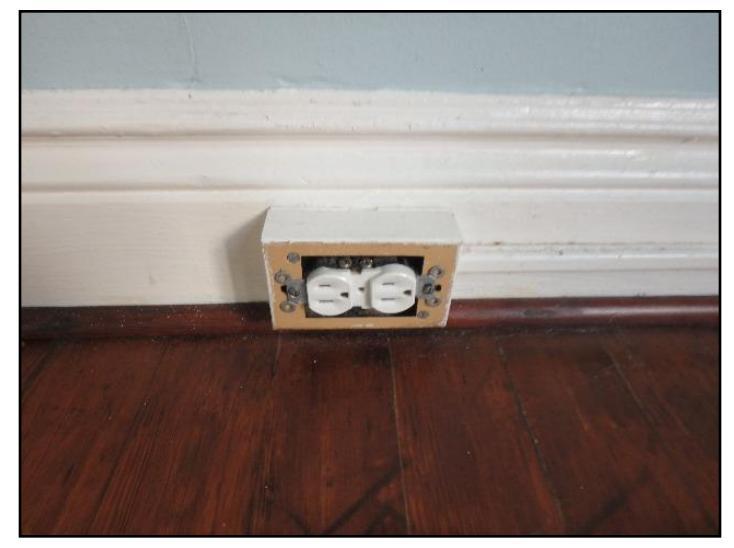
Condition: • <u>Missing</u> Location: Various Task: Provide or install.

Missing

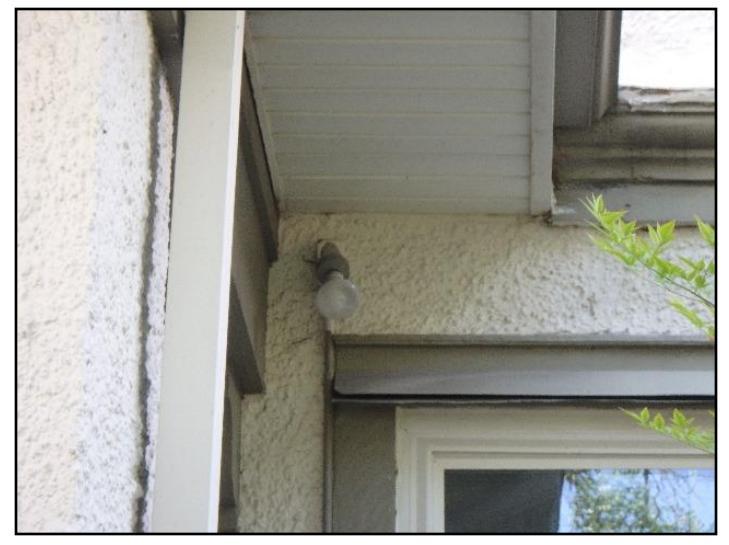
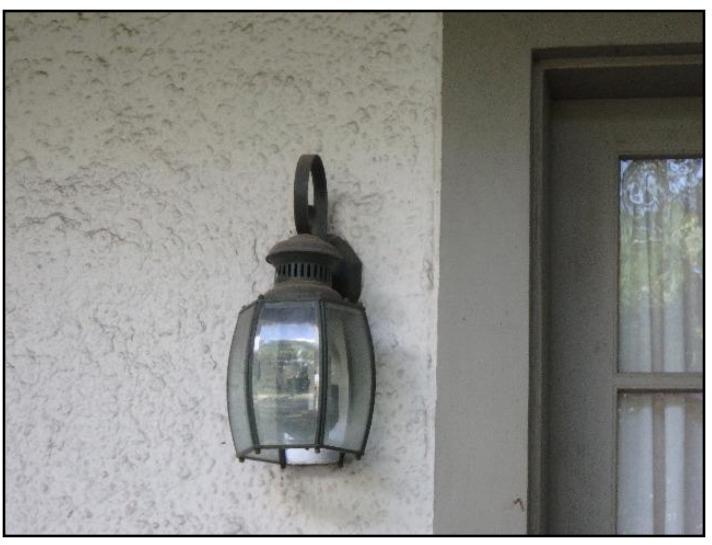
Condition: • Inoperative Location: Various Task: Replace Bulbs and test. Verify. Correct as needed.

Inoperative

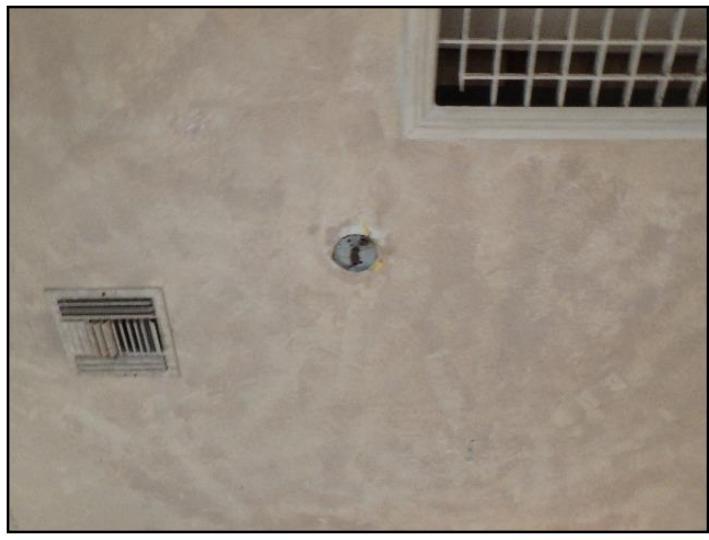
Condition: • Missing Location: Second Floor Stairway Task: Install

Missing

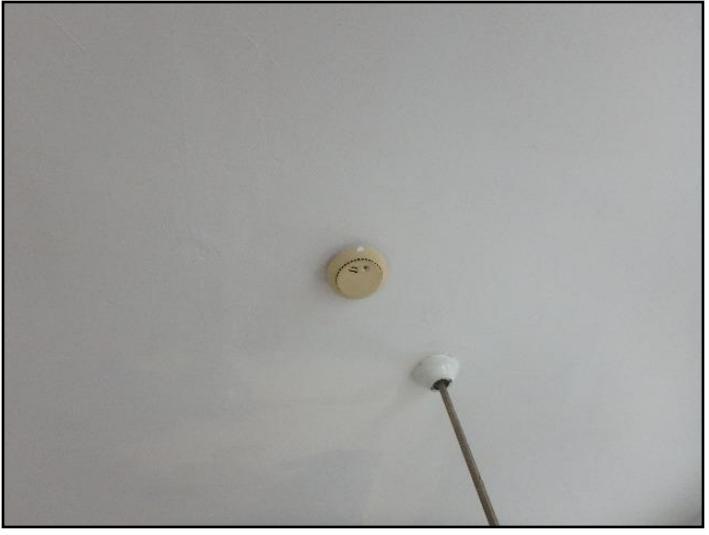
Condition: • Appear to be more than 10 years old, recommend replacement.

Most alarms installed today have a life span of about 8-10 years. After this time, the entire unit should be replaced. It is a good idea to write the date of purchase with a marker on the inside of your alarm so you will know when to replace it. Some of the newer alarms already have the purchase date written inside. In any event, always follow the manufacturer's instructions for replacement.

Implication(s): Smoke detector failure or malfunction - safety issue

Appear to be more than 10 years old,...

Task: Replace.

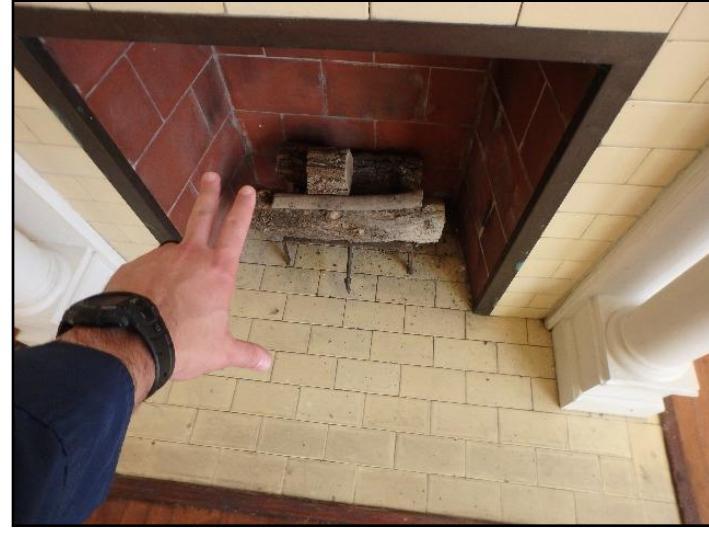
Condition: • Inappropriate materials

Location: First Floor Living Room

Inappropriate materials

Task: Verify. Replace as needed.

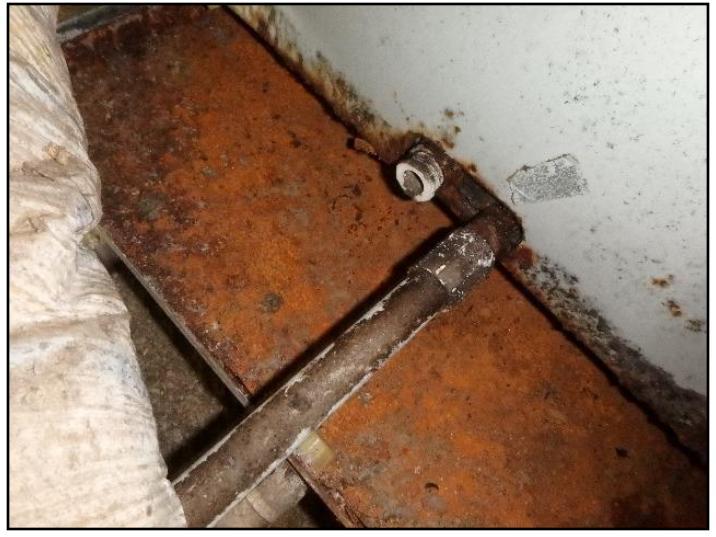
Condition: • <u>Rust or holes in pan</u> Location: Attic Task: Replace.

Rust or holes in pan

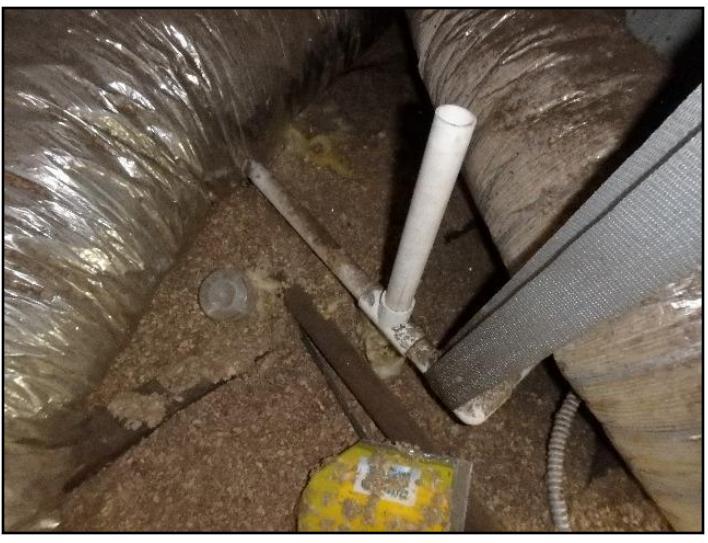
Condition: • Line not insulated

Line not insulated

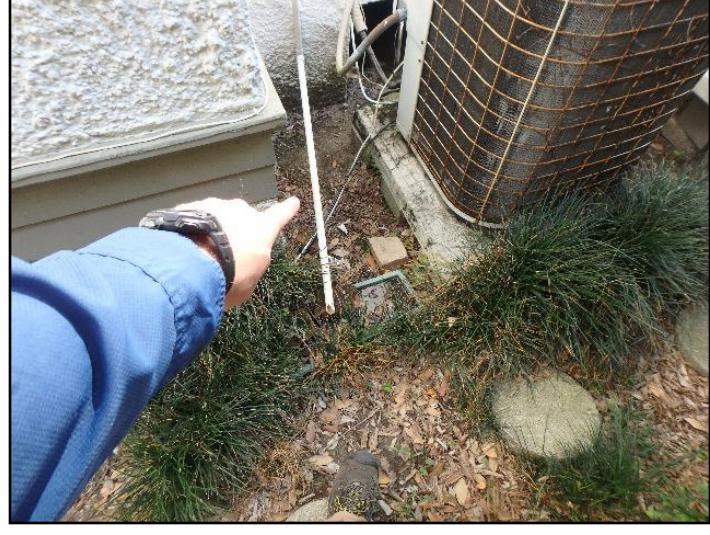
Condition: • Improper discharge point Location: Right Side Exterior Wall Task: Correct.

Improper discharge point

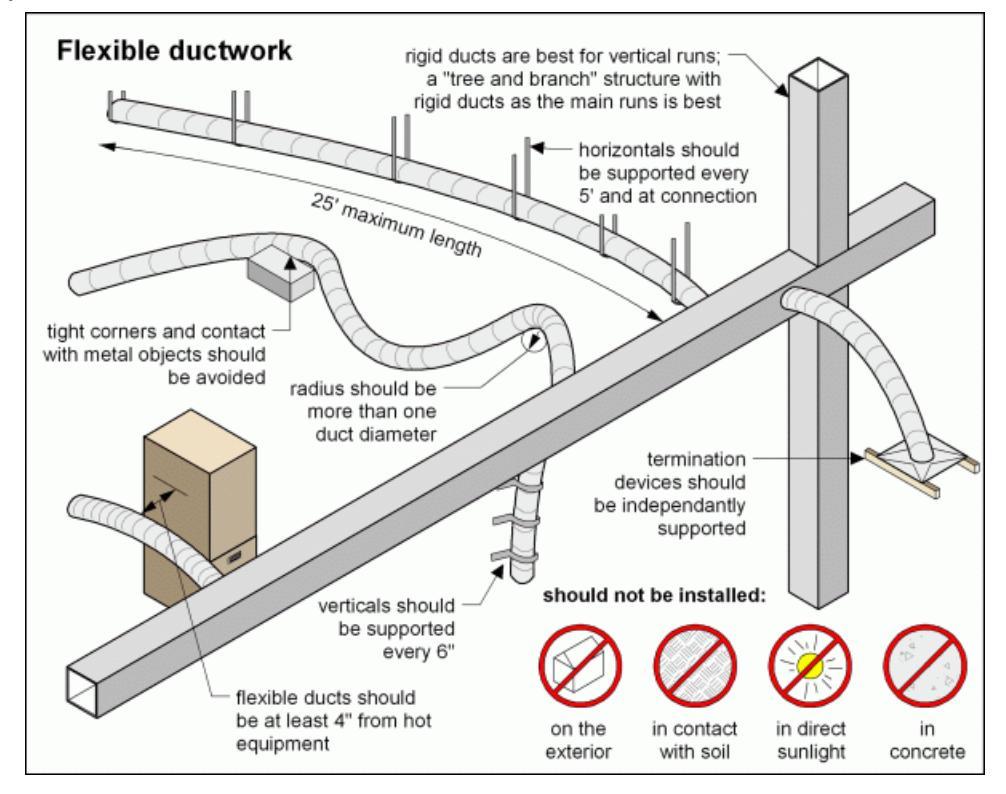
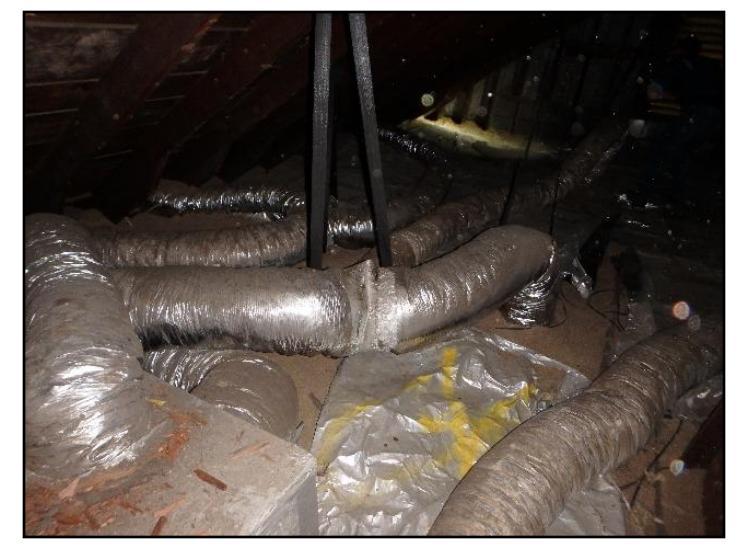
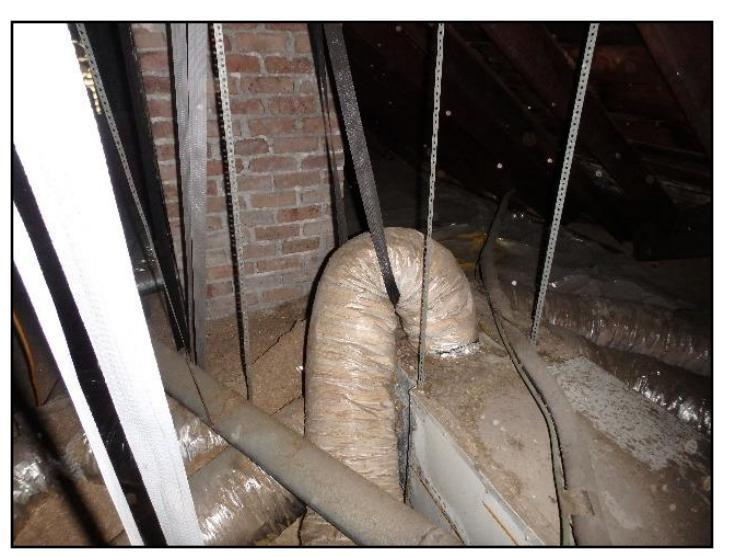
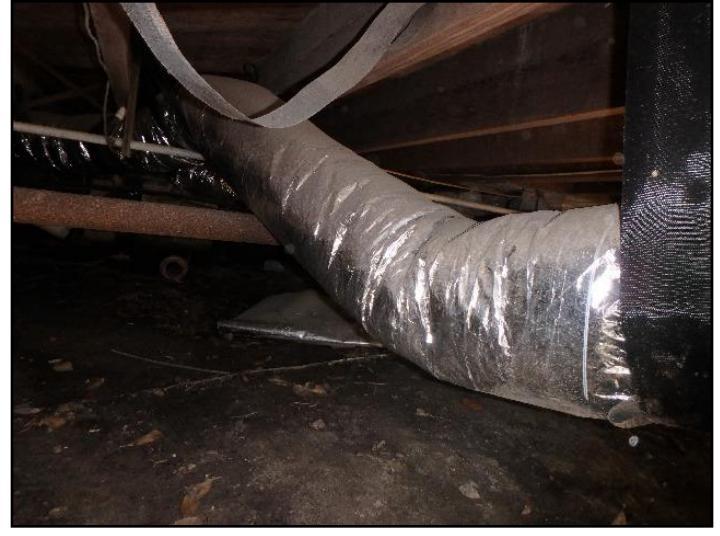
Condition: • Poor support

Location: Various Crawl Space Attic Task: Improve. Adjust.

Poor support

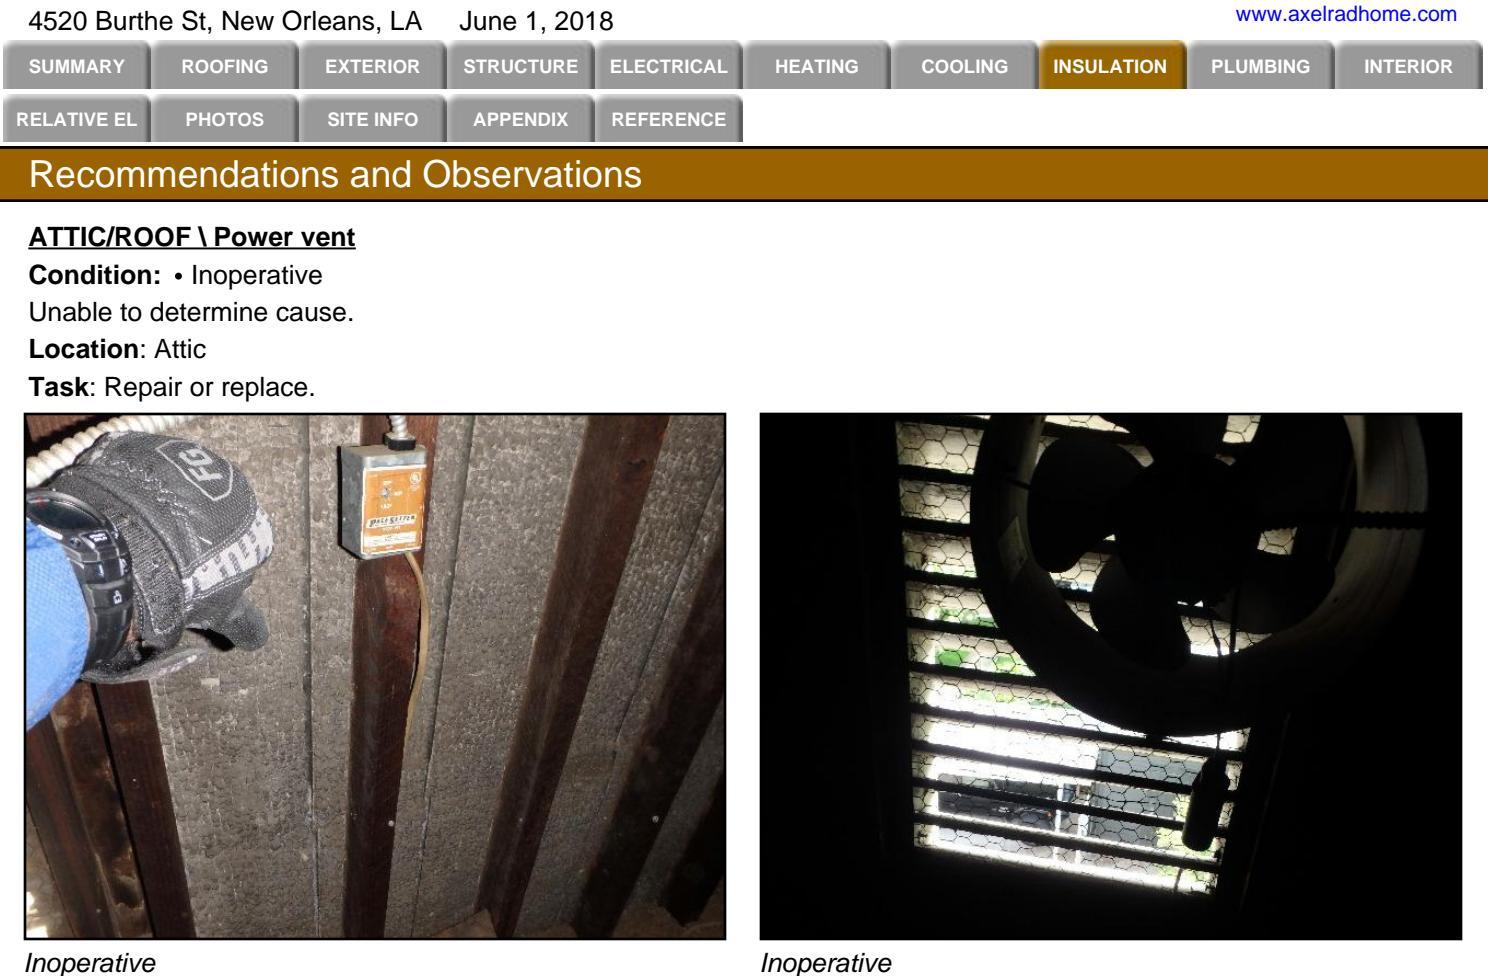
Inoperative

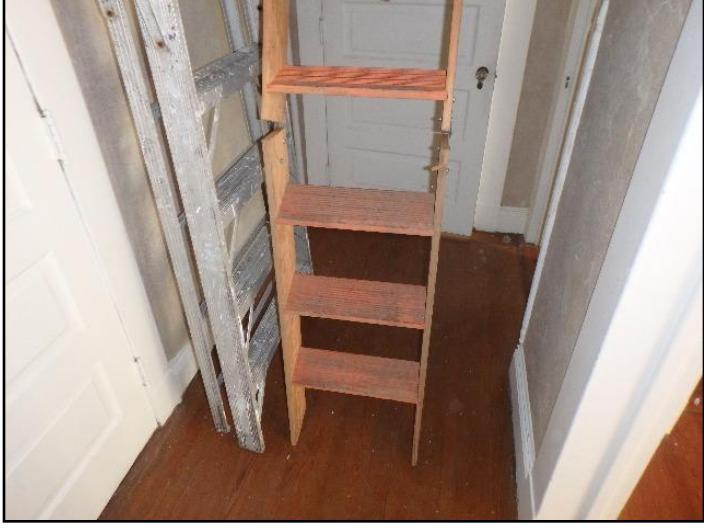
Condition: • Attic pull down ladder was cut too short and difficult close. Location: Second Floor Hall Task: Repair or replace.

Cut Short

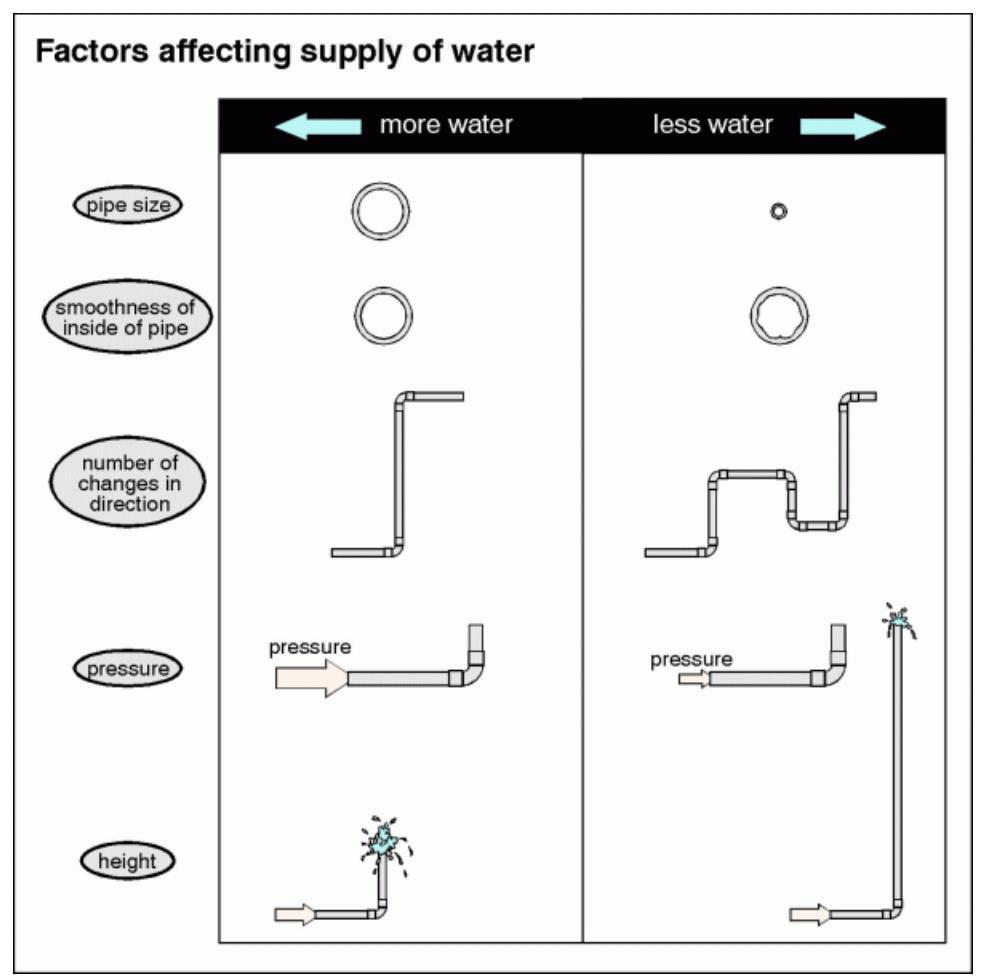
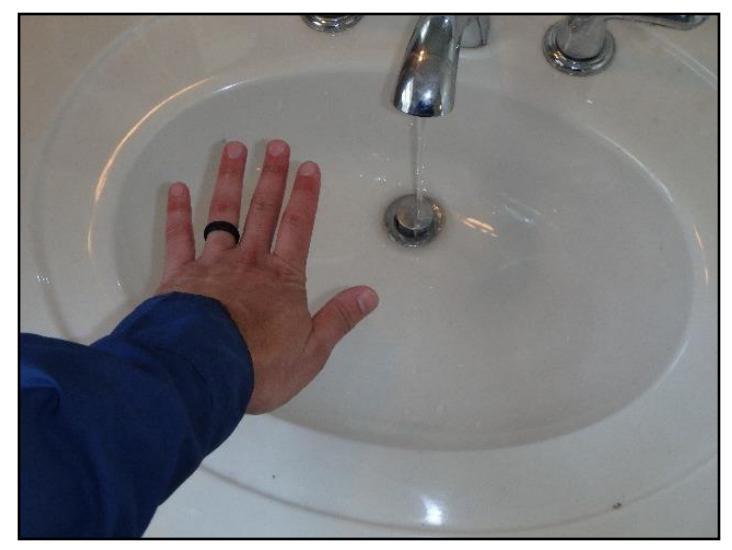
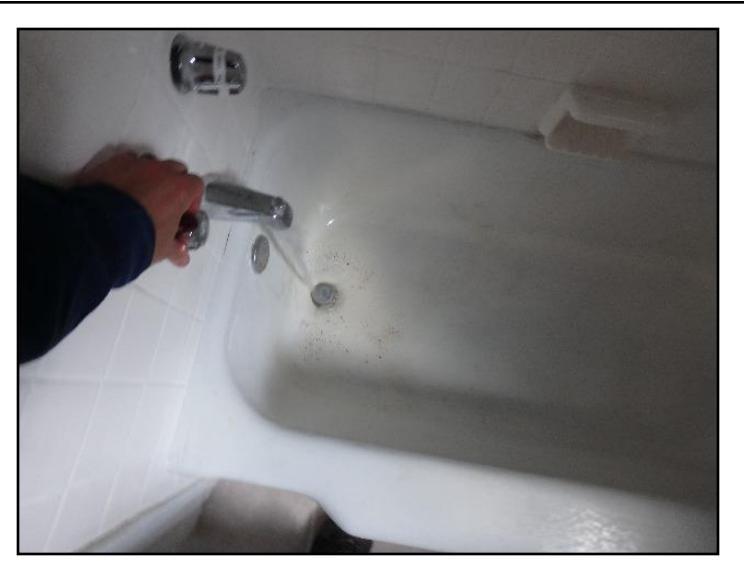
Condition: • Low pressure

Probably related to galvanized supply lines found.

Low pressure

Task: Further evaluation recommended.

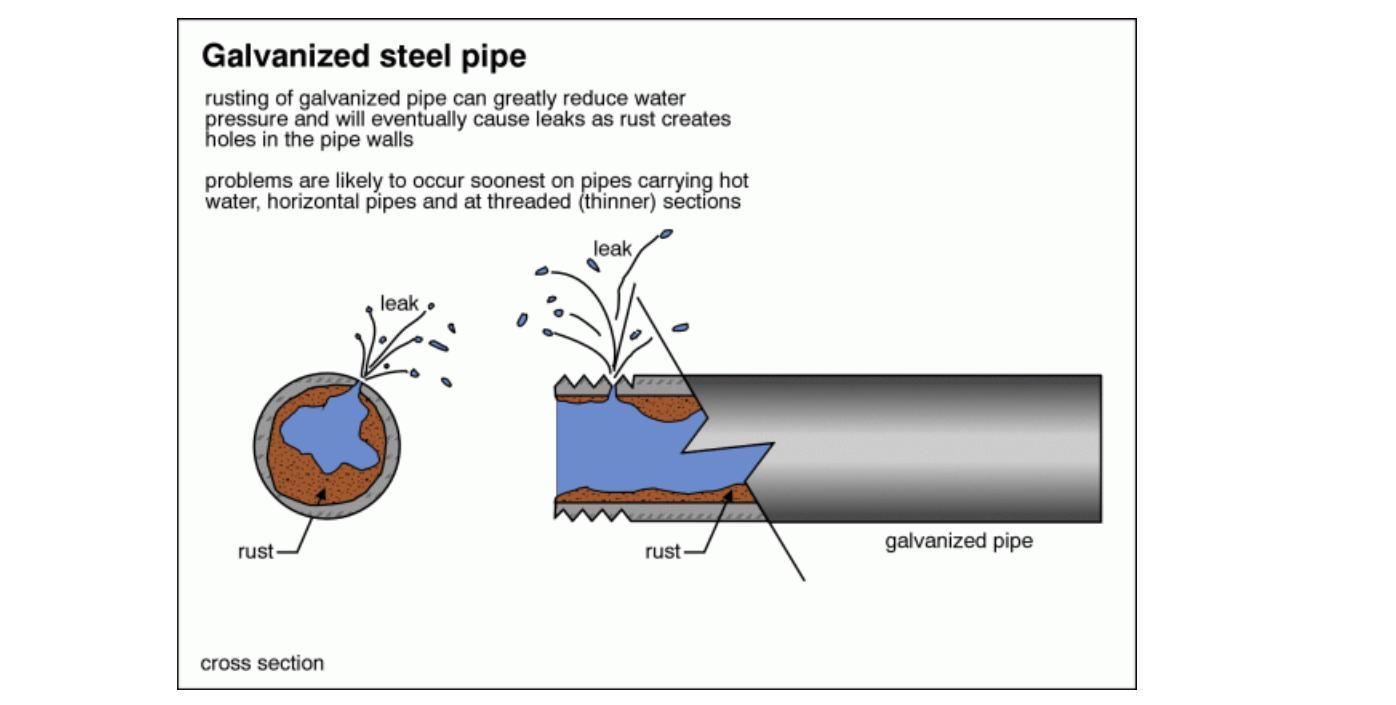
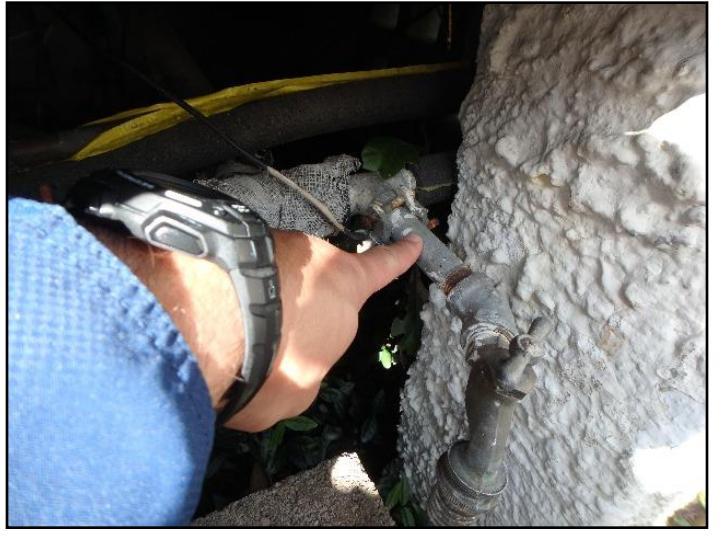
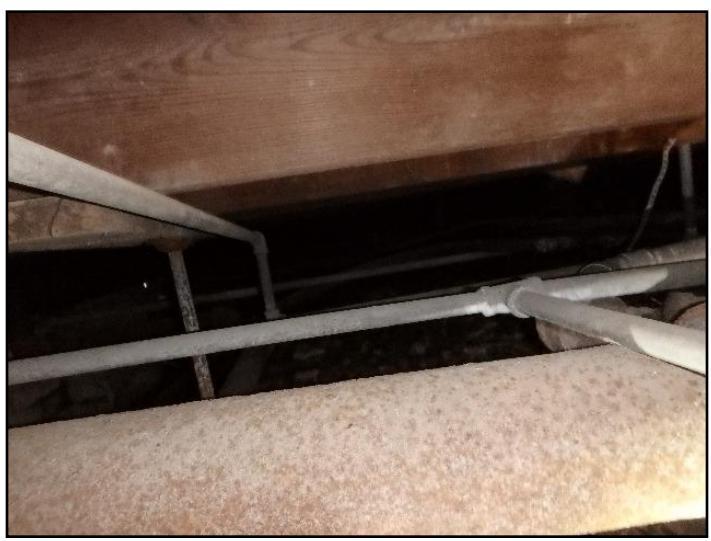
Condition: • Galvanized steel

Some amount of galvanized supply lines noted. This piping is over 50 years old since it has not been in use for major work since the early 1960's. This is near the end of its expected useful life. The age is difficult to gauge based on exterior condition as galvanized pipes tend to corrode from the inside-out. Significant corrosion inside the piping can reduce water pressure as well as lead to pinhole leaks, especially around the threaded connections. Corrosion at the joints also indicates the end of useful life. When leaks become prevalent or decreased water pressure is noted, it may be time to replace the galvanized supply lines with copper or PEX. Upgrades should be referred to a licensed plumbing contractor for a complete evaluation and written estimates of work needed.

It should be noted that decreased water pressure or even complete stoppage of individual lines can occur suddenly when inside corrosion loosens.

Galvanized steel

Task: Monitor or replace. When issues arise, replacement will be necessary.

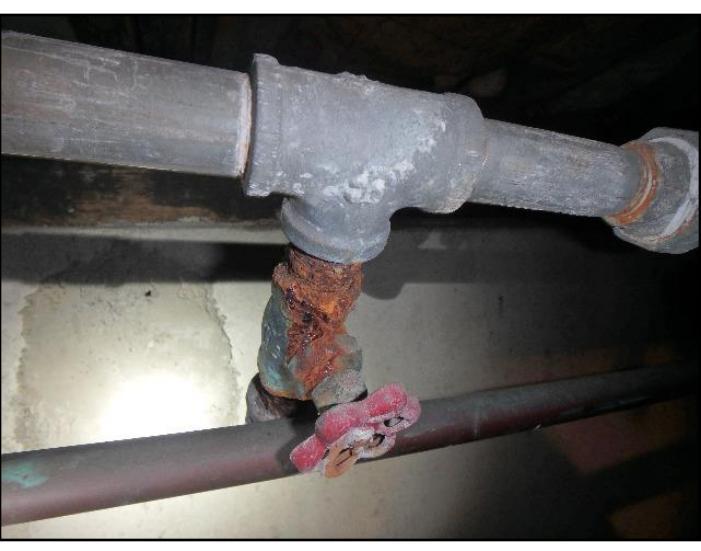
Condition: • <u>Rust</u> Location: Basement Galvanized Supply Line Task: Repair

Rust

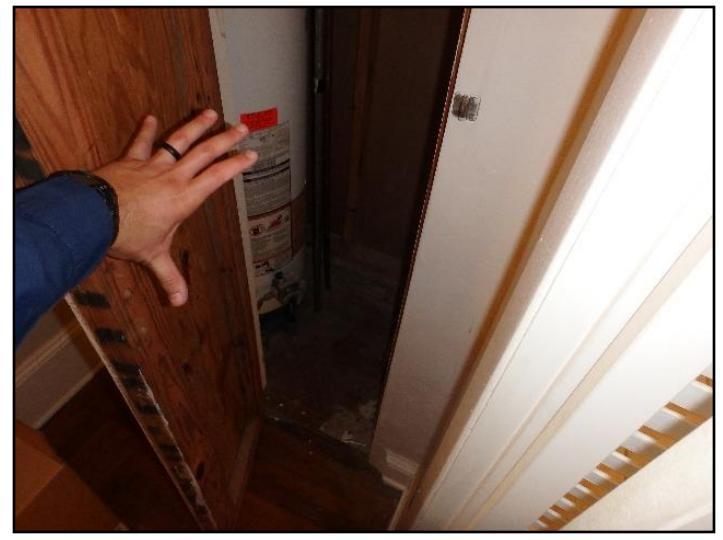
Condition: • Inadequate combustion air

Inadequate combustion air

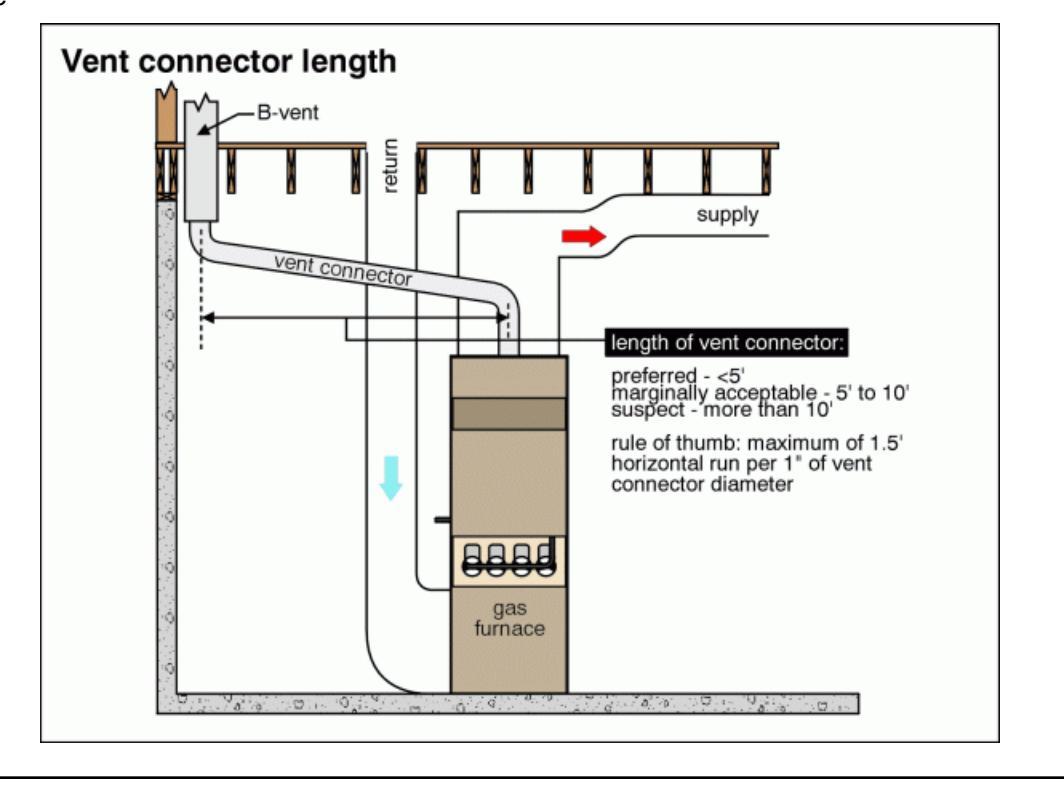
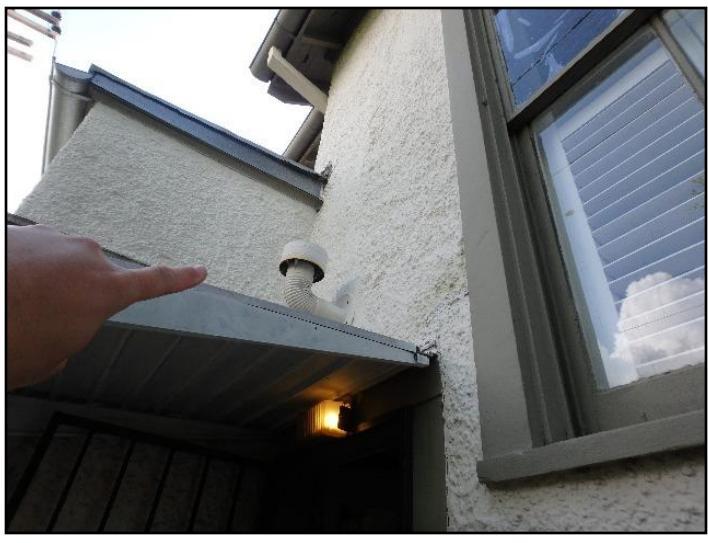
Condition: • Termination point too low

This is improper and unsafe. Gas exhaust vent generally should be 2 feet higher than anything within a 10 foot radius. This is typical for type B and L vent pipe installations.

Implication(s): Equipment not operating properly | Hazardous combustion products entering building | Increased fire hazard, life safety issue

Termination point too low

Task: Repair/replace/correct

Time: Immediate

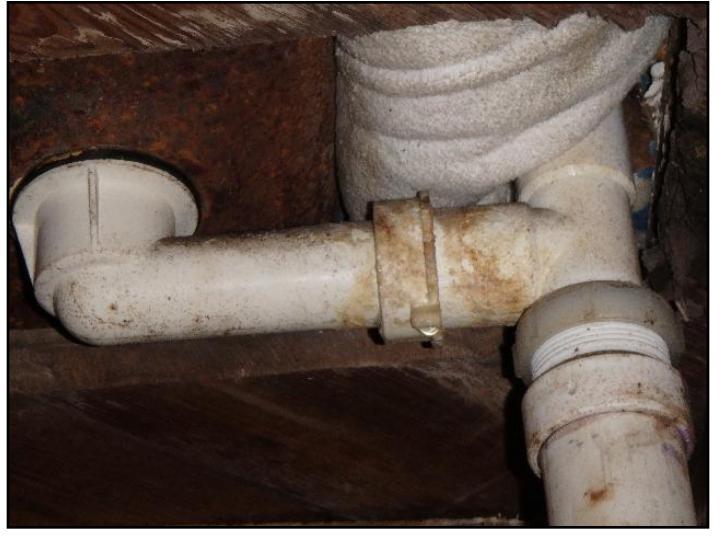
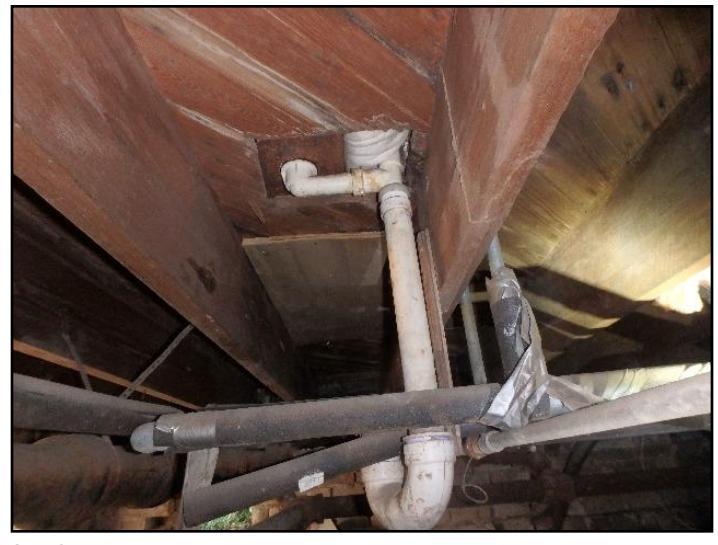
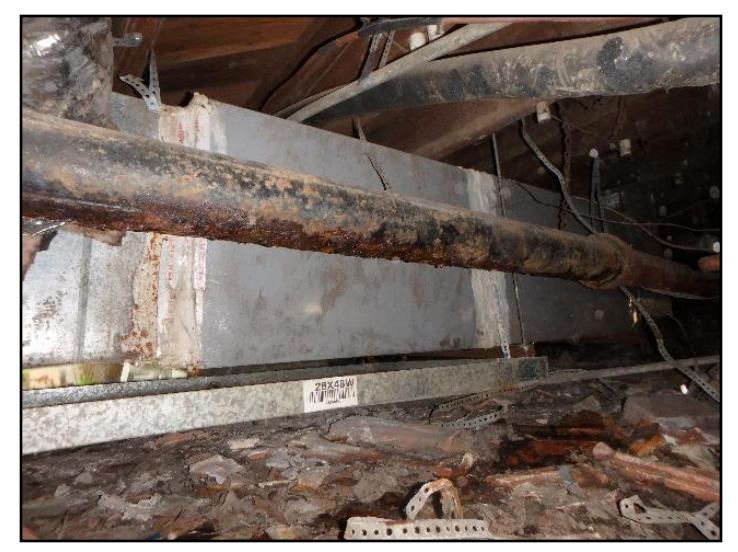
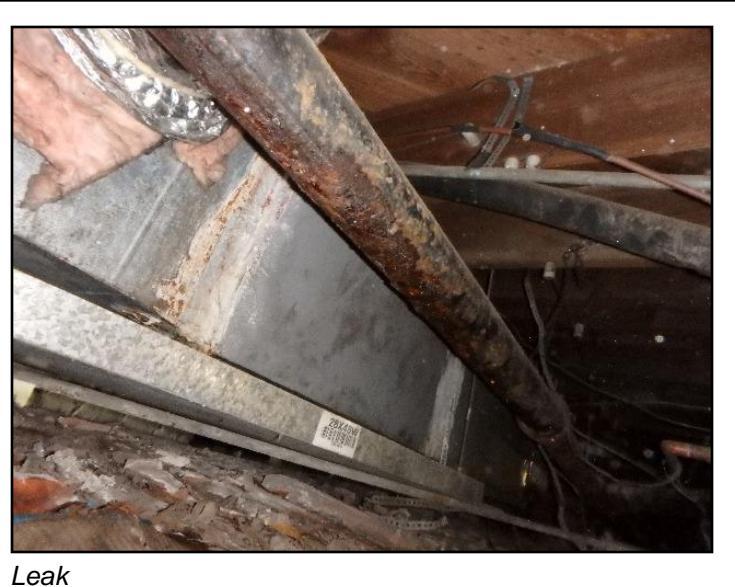
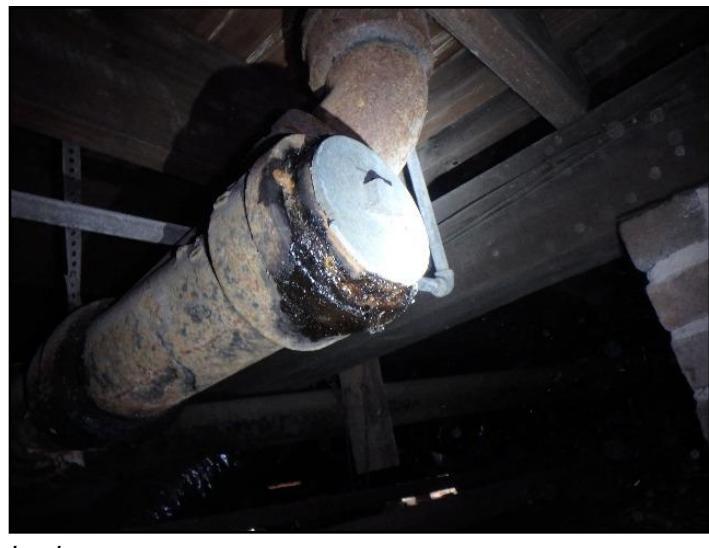
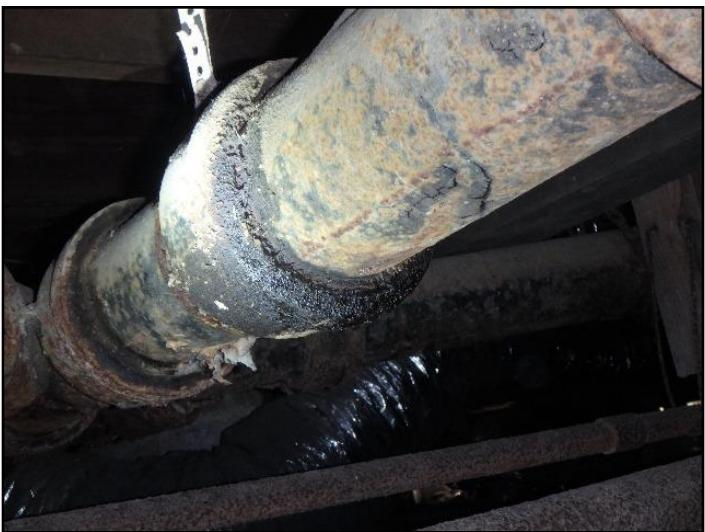
Condition: • Leak Location: Throughout Crawl Space Task: Repair or replace.

Leak

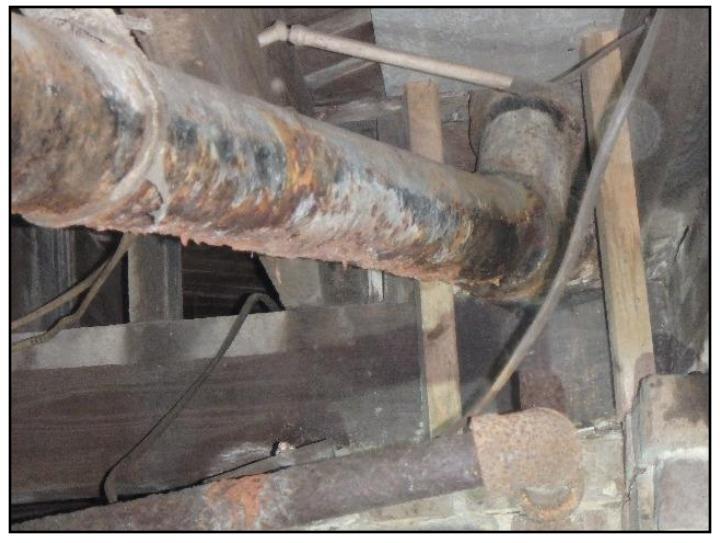
Condition: • Rust

All of the cast iron drain lines in the crawlspace were excessively rusted, and appear to be at the end of their life. Location: Throughout Crawl Space

Rust

Task: Replacement recommended. Further Evalaution

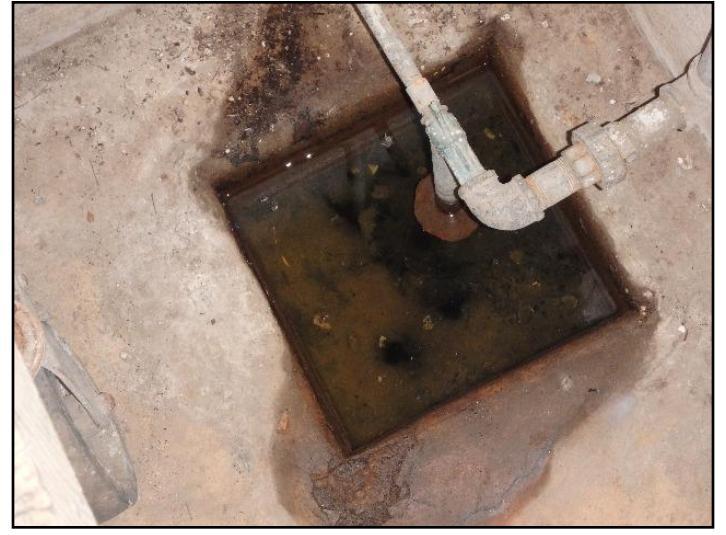
Condition: • Possible sump pump issue. Unable to determine cause of water pooling.

Location: Basement

Possible Sump Pump Issue

Task: Further evaluation recommended.

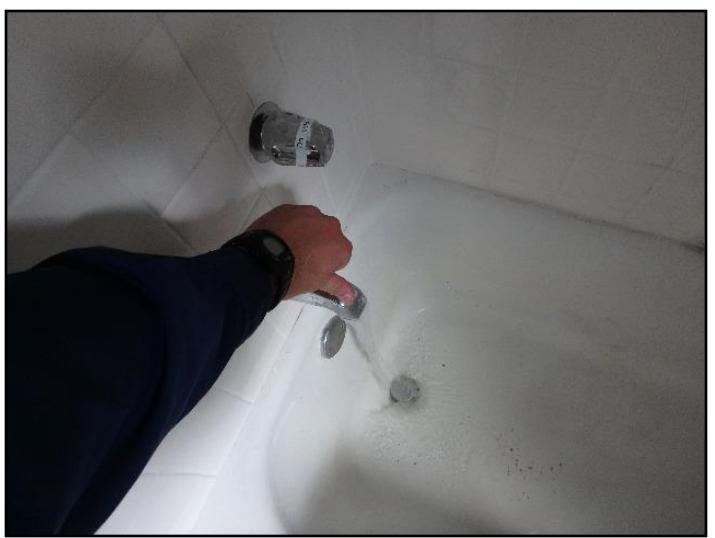
Condition: • <u>Shower diverter inoperative or defective</u> Location: First Floor Bathroom Task: Correct. Adjust.

Shower diverter inoperative or defective

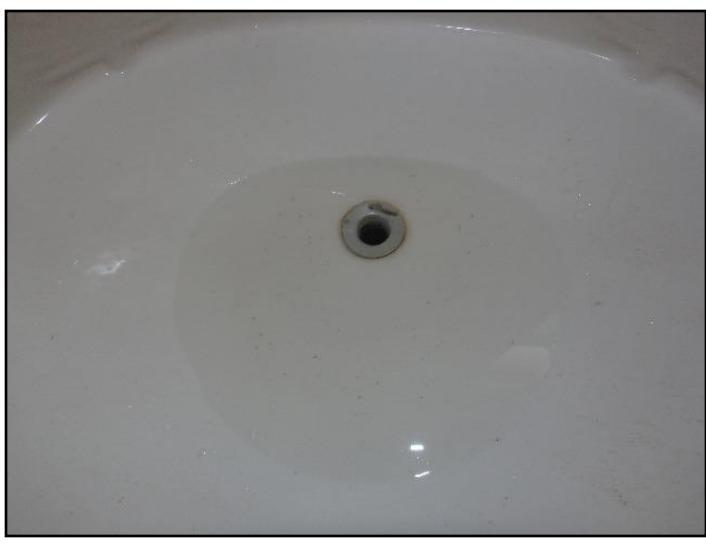
Condition: • <u>Slow drains</u> Location: Second Floor Bathroom Sink Task: Clean

Slow drains

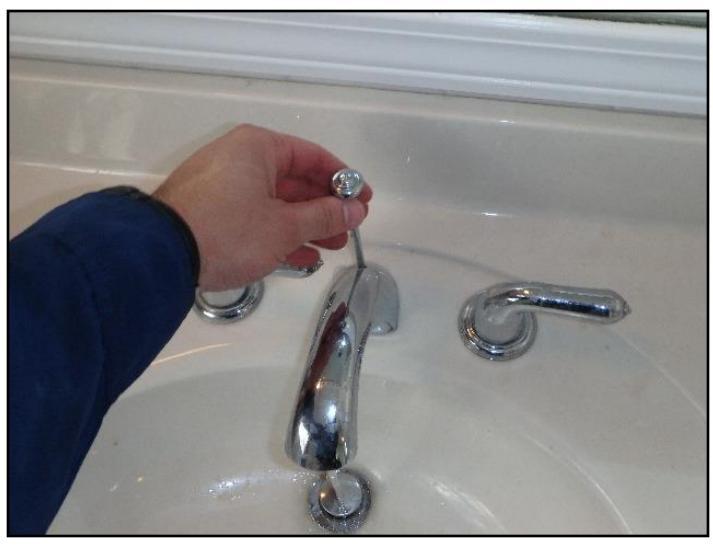
Condition: • Drain stop ineffective **Location**: Throughout First Floor **Task**: Correct.

Drain stop ineffective

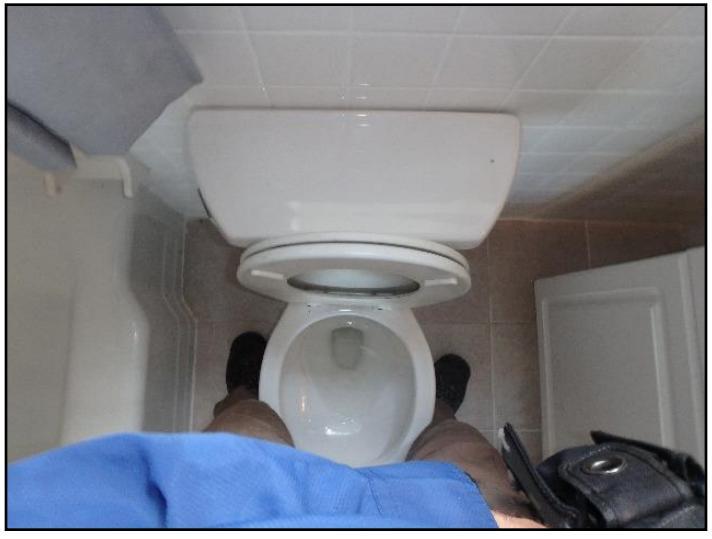
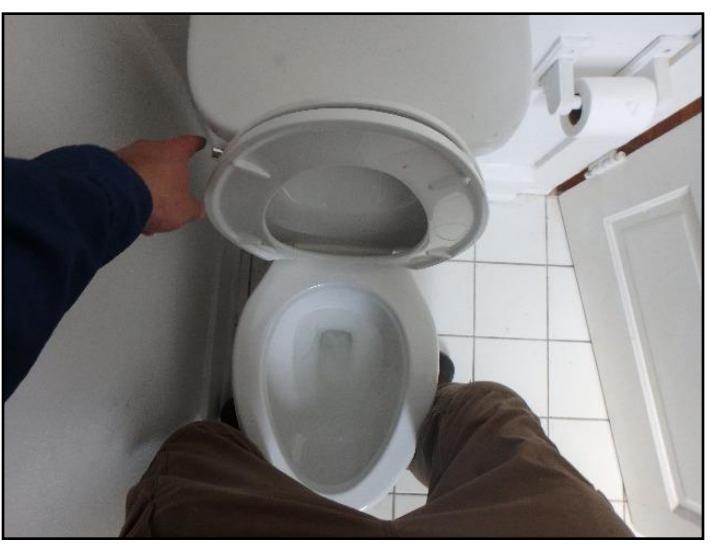
PLUMBING www.axelradhome.com 4520 Burthe St, New Orleans, LA June 1, 2018 SUMMARY ROOFING PLUMBING RELATIVE EL APPENDIX SITE INFO REFERENCE Loose toilet 17 tank check to see if tank is well secured to bowl potential leakage area 17 toilet bowl check to see if toilet is well secured to if toilet isn't well secured, the wax ring can become compressed and allow water to trap the floor _ potential leakage area wax ring escape from the toilet flange/toilet floor E toilet flange

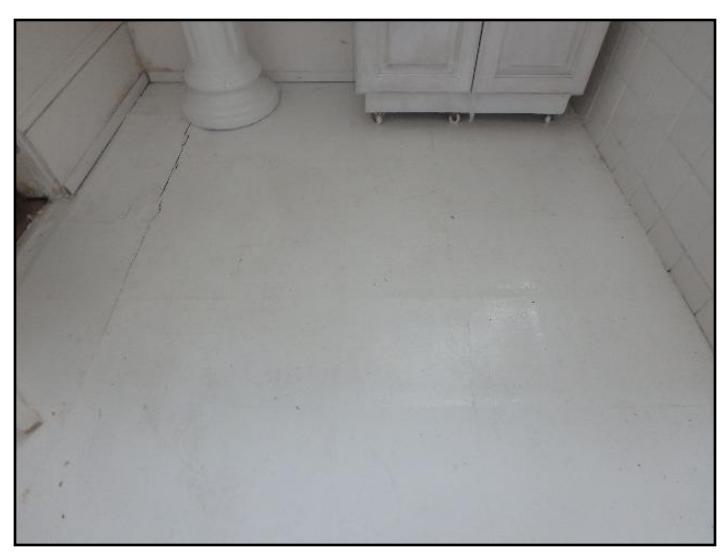
Condition: • Possible vinyl-Asbestos floor tiles. Use the link below for more information.

9x9 tile outline was noted underneath the encapsulant coating.

Possible vinyl-Asbestos floor tiles.Use th...

Task: Information only

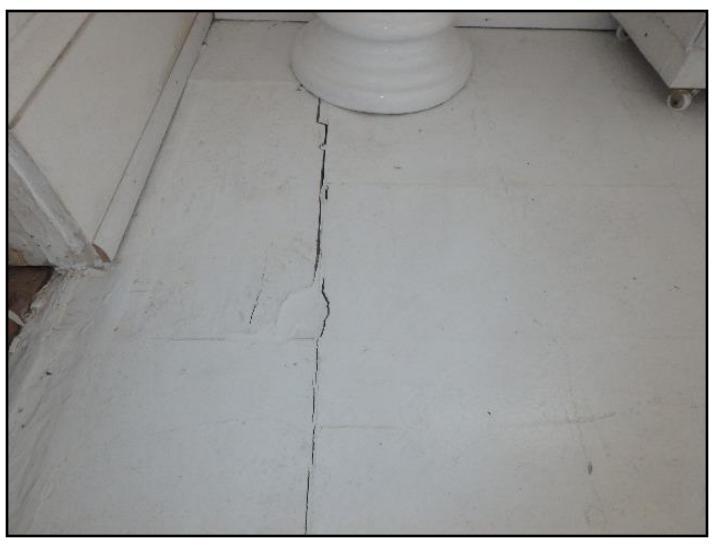
Condition: • Cracks Location: Second Floor Bathroom Task: Repair

Cracks

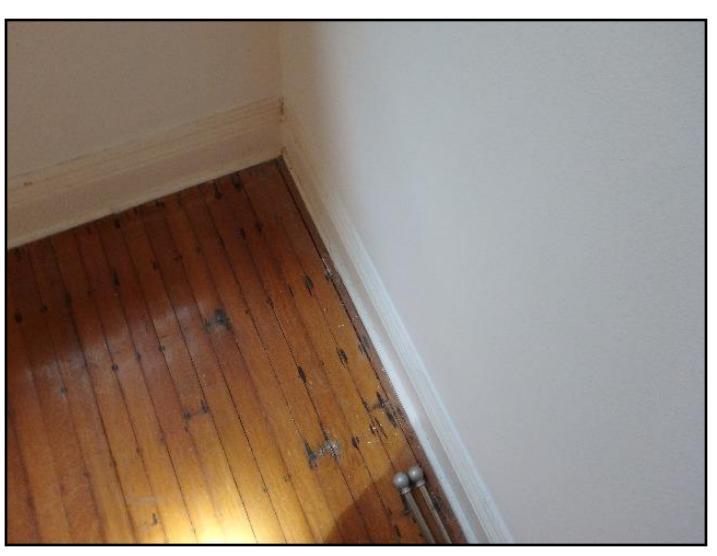
Condition: • Open seams in floor joints Location: Various First Floor Task: Repair or replace.

Open seams in floor joints

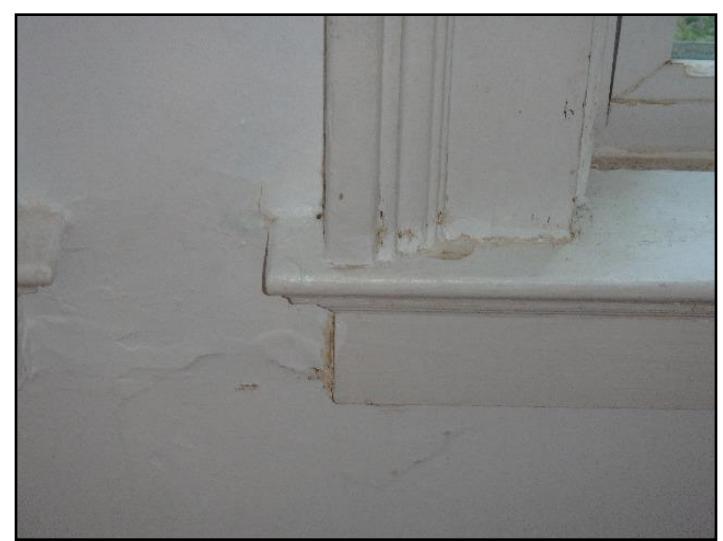
Condition: • Prior water damage. Appeared to be inactive. Also appeared to be related damage note above window on exterior.

Prior Water Damage

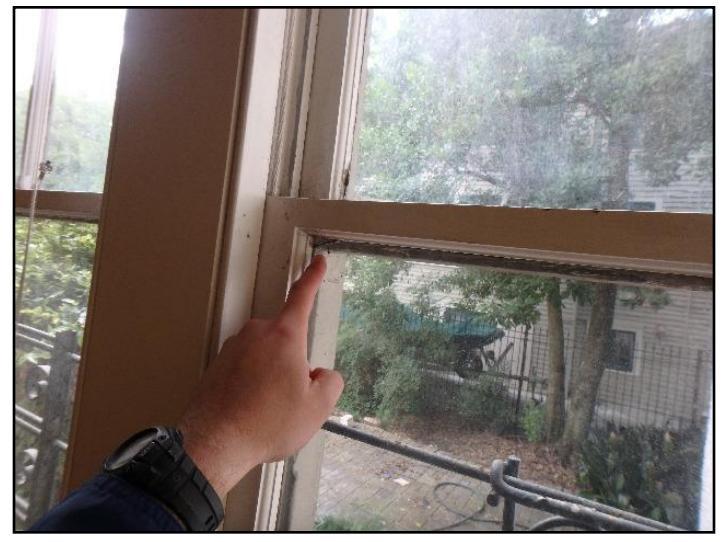
Condition: • General window issues Location: Throughout Task: Repair/Replace

Painted/Sealed Shut

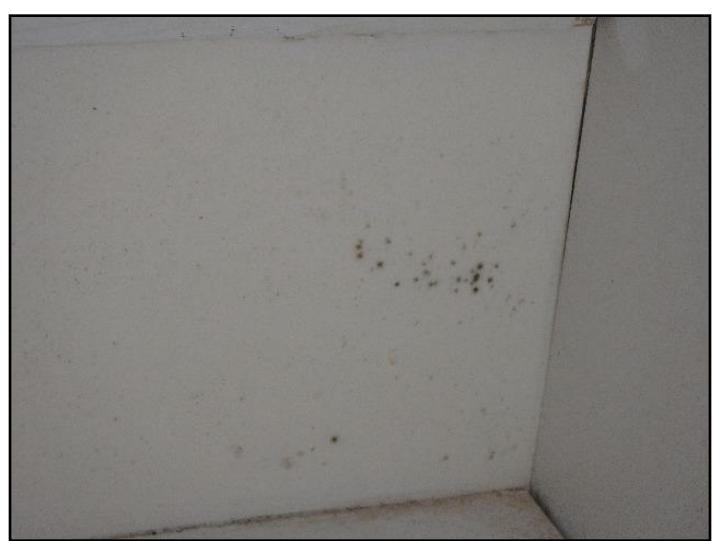
Condition: • Surface mold. Location: First Floor Front Bathroom Task: Remove. Possibility of hidden mold growth - See Appendix

Surface mold.

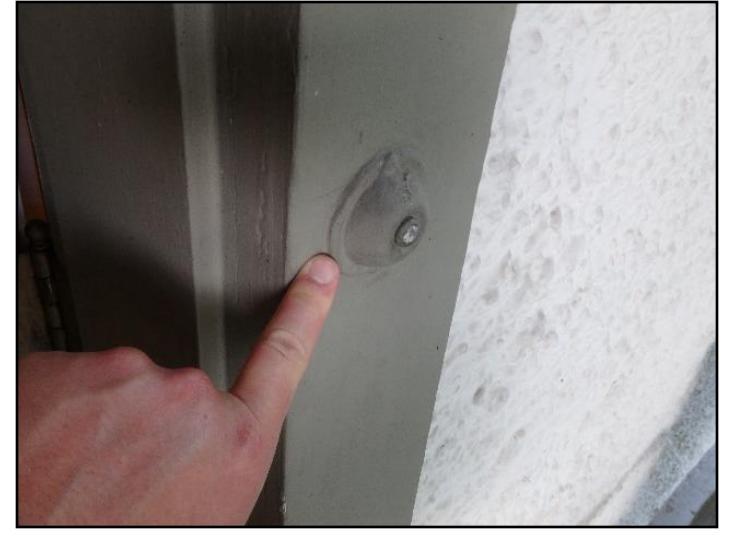
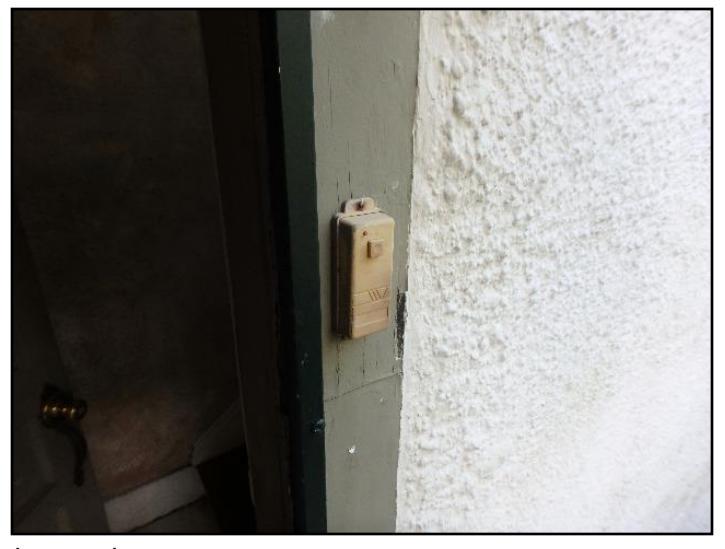
Condition: • Inoperative Location: Throughout Task: Correct.

Inoperative
