INSPECTION REPORT

For the Property at: 4520 BURTHE ST NEW ORLEANS, LA 70118

Prepared for: JOHN BEECHEM Inspection Date: Friday, June 1, 2018 Prepared by: Beau Tanner and Matthew Del Buono

RE: Report No. 8108, v.3 4520 Burthe St New Orleans, LA 70118

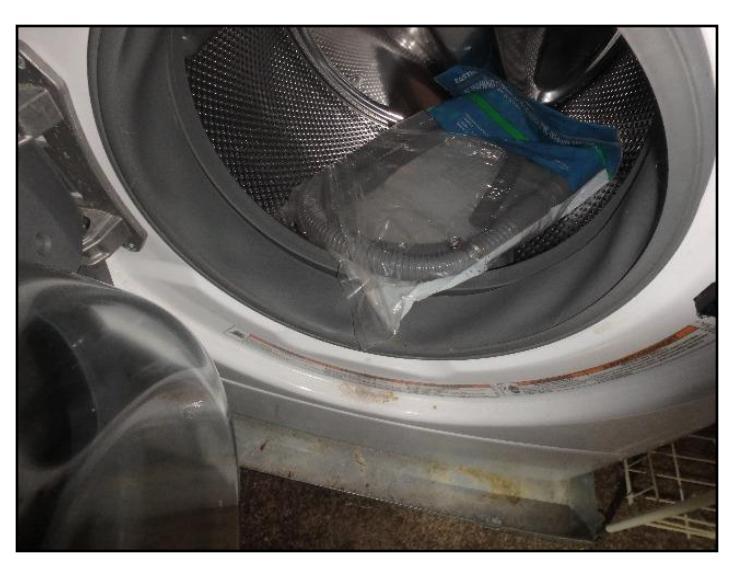
Note: Could not determine if unit was fully installed. Drain hose was inside of unit in packaging.

Washer
