Inspection Report

1431 N. Holland St New Orleans, LA 70119

Inspection Date: Wednesday, May 2, 2018

RE: Report No. 7957, v.8 1431 N. Holland St New Orleans, LA 70119

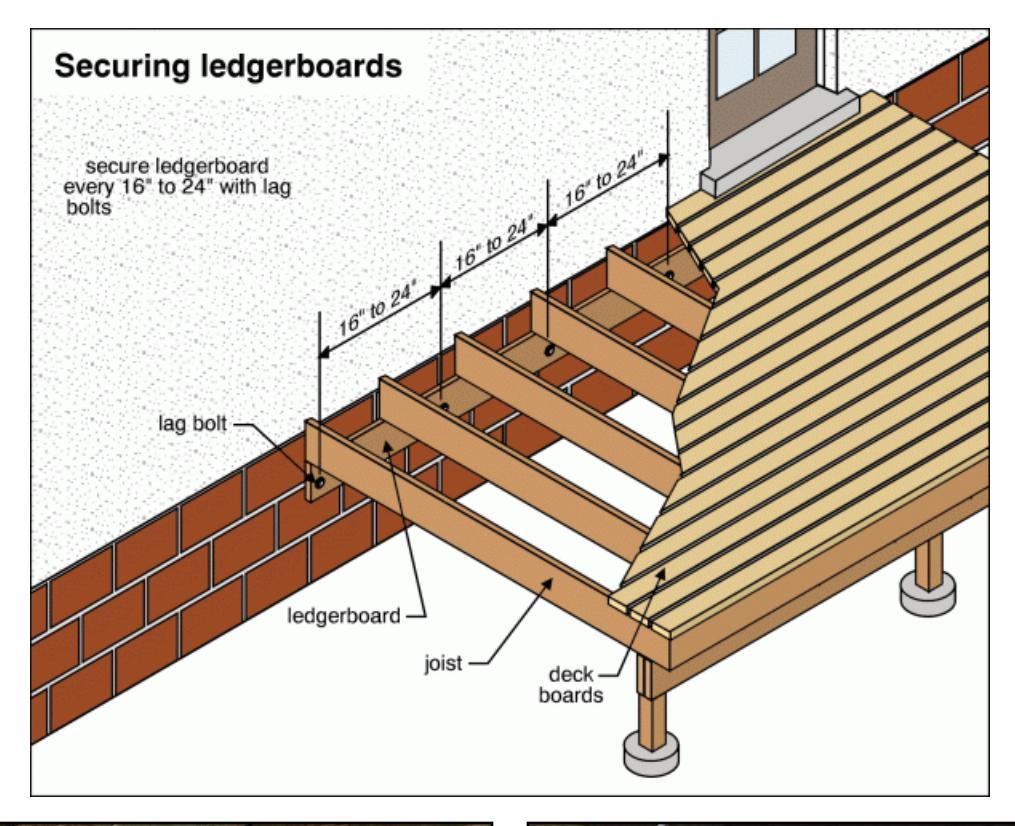
Condition: • Ledgerboard problems

Front and rear decks did not have lag bolts running through the ledgerboards. Recommend installing for additional support.

Location: Various Crawl Space

Task: Improve.

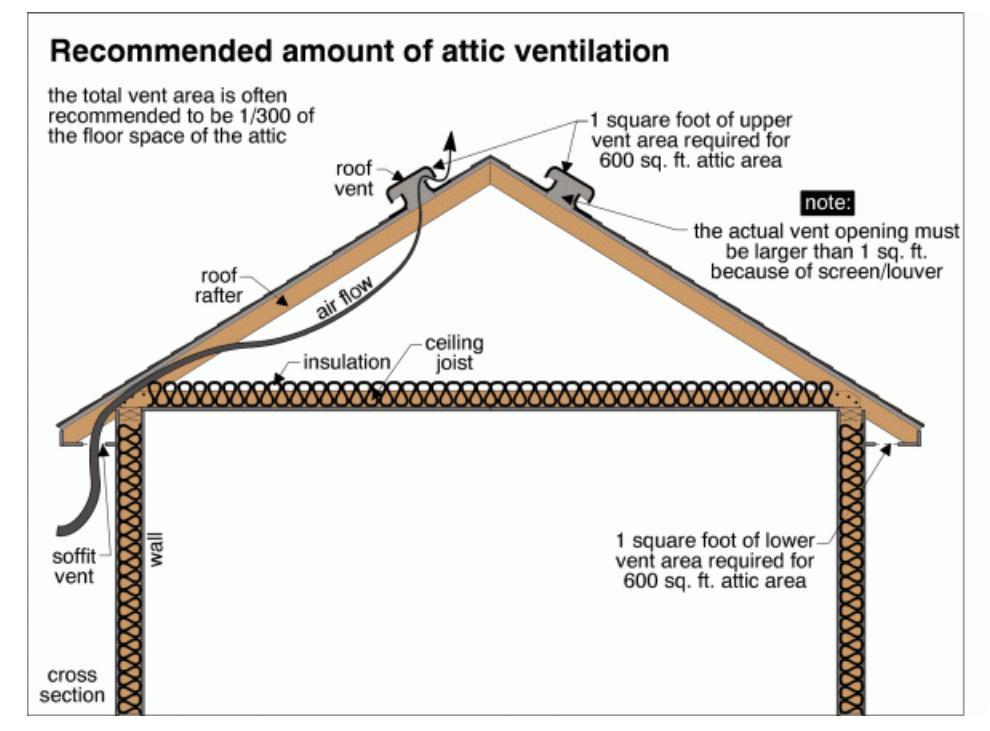
Attic rafter insulation extends too far to the eaves and covers the soffit vents. Inadequate attic ventilation. This can lead to attic moisture, mold, wood rot and metal corrosion as well as reduced roof life. Lack of adequate soffit venting can also create low pressure in the attic, bringing in conditioned air and house moisture through the ceiling gaps and into the attic. **Location**: Attic

Task: Recommend installing rafter baffle vents or pulling back insulation from over soffit vents

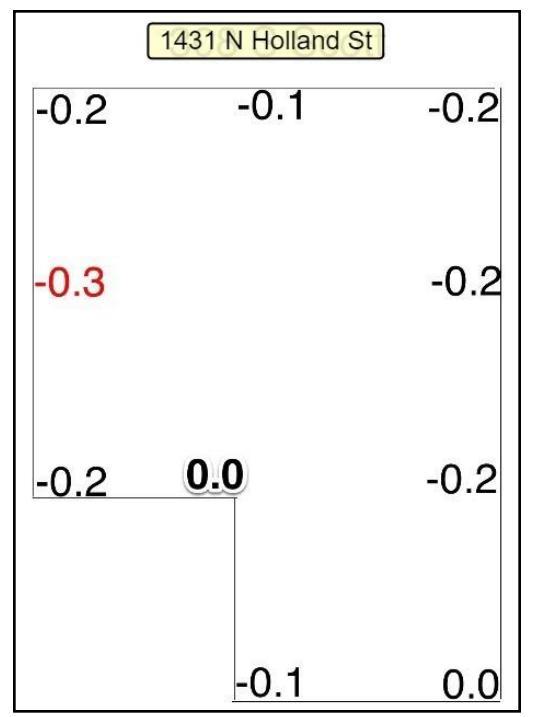
Locations approximate. Not to scale

The maximum differential found was 0.3" as shown on the drawing below. According to one of the leading local engineering firms, the average differential for all residential foundations in the New Orleans area is about 3.2". The average for reinforced concrete slabs about 2.9" and for pier and beam foundations about 3.6". Allowances are made for floor coverings and materials. Additions and enclosed areas built with a designed slope are not included. All measurements taken are not shown. The drawing is not to scale and locations are approximate.
