INSPECTION REPORT

For the Property at:
712 WISTERIA LANE
METAIRIE, LA 70003

Prepared for: JOHN JONES
Inspection Date: Friday, July 6, 2018
Prepared by: Jason Pepitone and Matthew Del Buono

RE: Report No. 8116, v.3
712 Wisteria Lane
Metairie, LA
70003

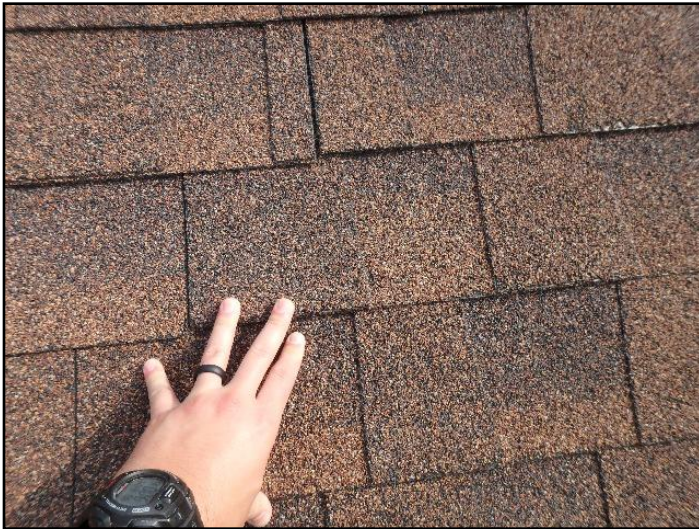
Minor granule loss was noted on the asphalt shingle roof covering. This is typical for a roof covering of this age and should be monitored.

Granule loss

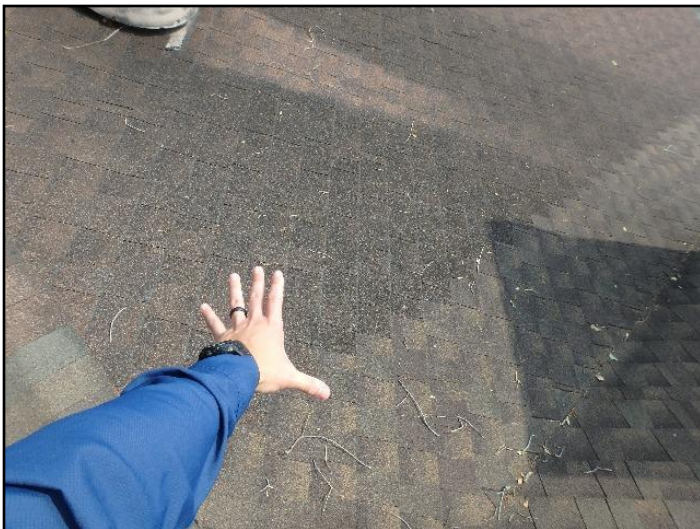
Location: Rear Roof

Patched

Task: Prior repairs should be periodically monitored.

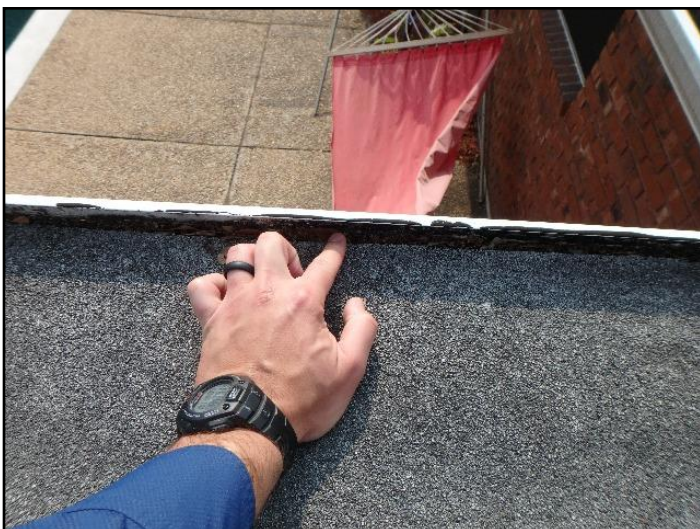
Location: Rear Flat Roof

Openings at seams or flashings

Task: Correct.

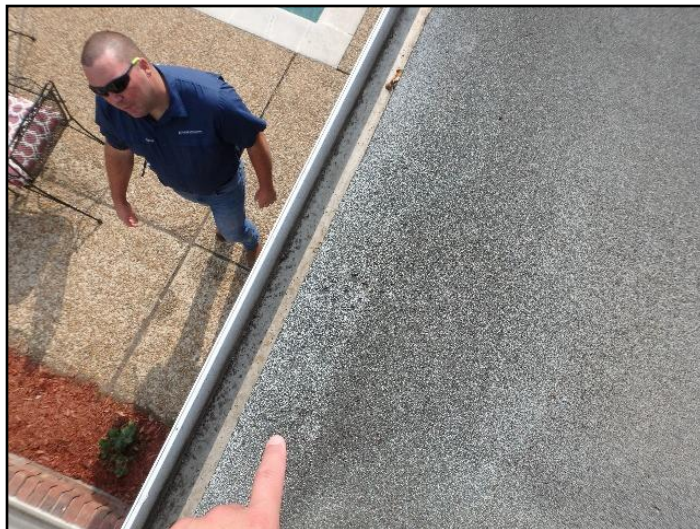
Loss of granules

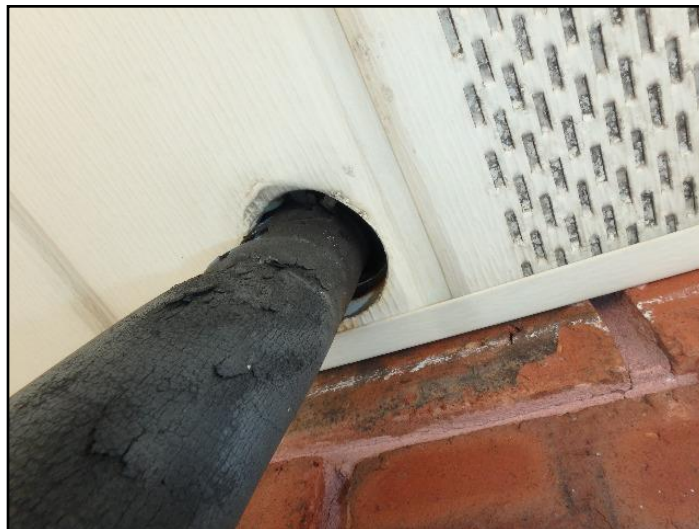
Location: Right Side Exterior

Opening in soffit

Task: Seal openings

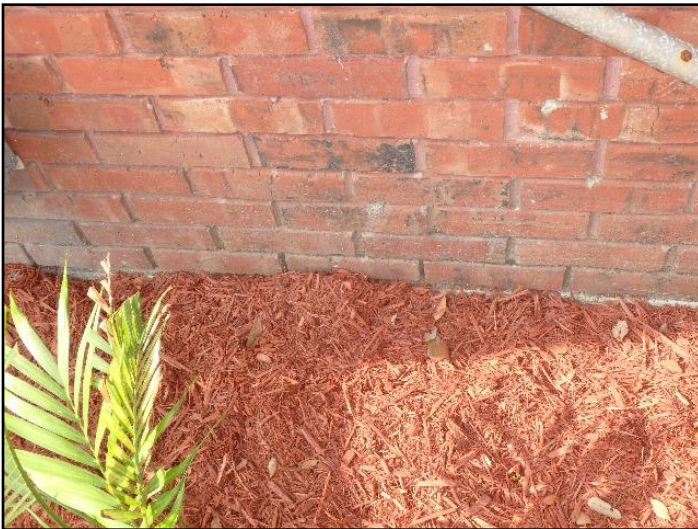
Too close to grade

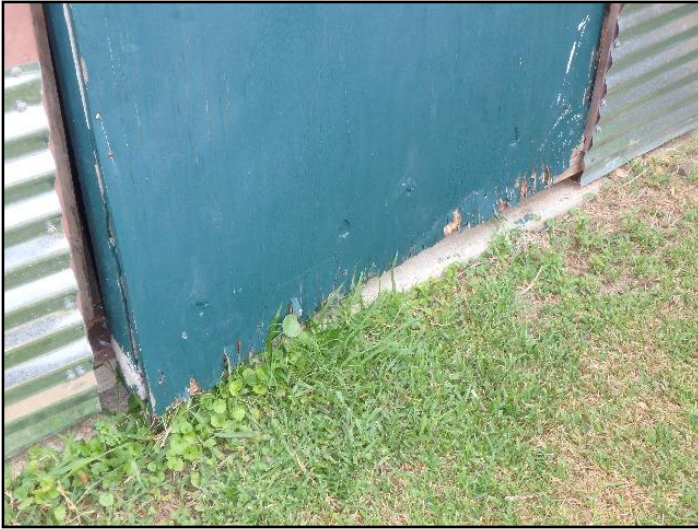
Rear shed issues

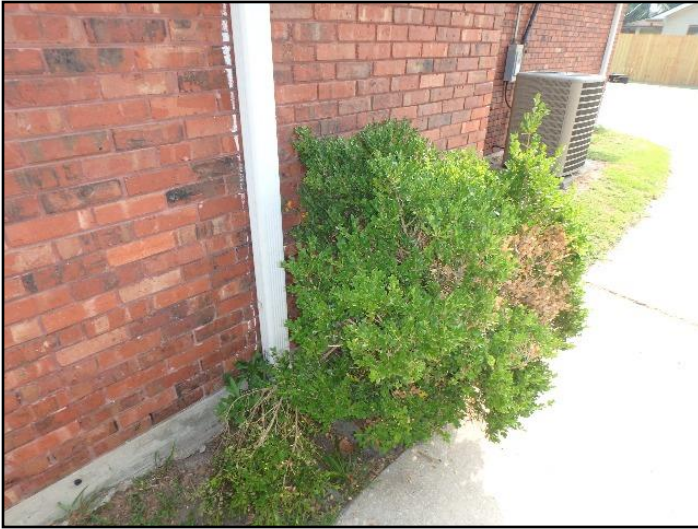
Location: Right Side Exterior/ Front Roof

Trees or shrubs too close to building

Task: Correct.

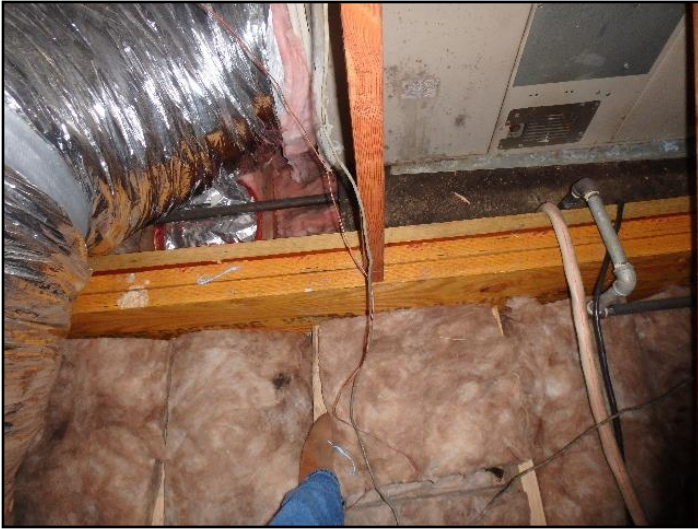
Monitor

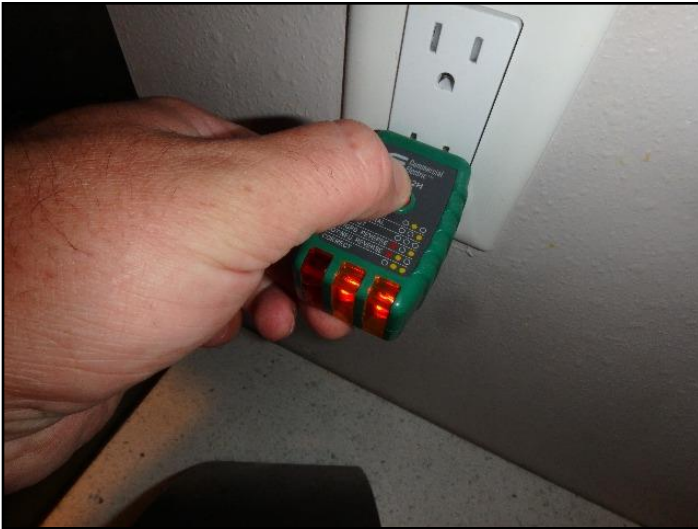
Location: Exterior. Kitchen

For safety reasons, it is recommended that all countertop kitchen outlets, attic outlets, bathroom outlets, exterior outlets, and garage outlets be protected by a GFCI either at the panel or the outlet. Unable to determine if outlets were GFCI protected.

GFCI/GFI needed (Ground Fault Circuit...

Task: Upgrade to current standards

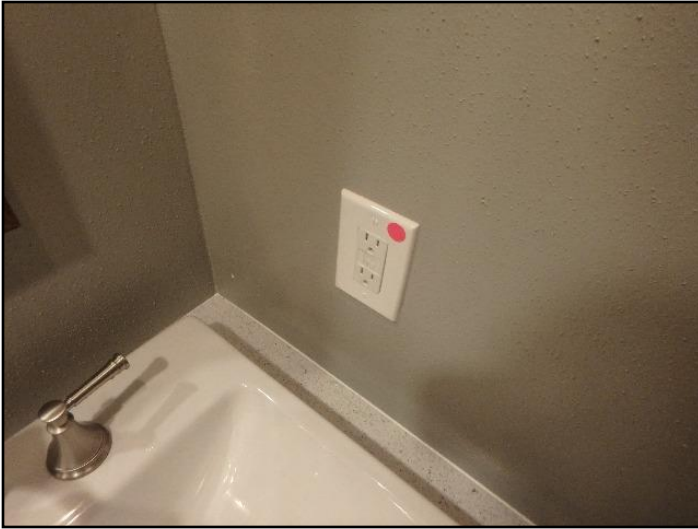
Test faulty on GFCI/GFI (Ground Fault...

Task: Repair or replace.

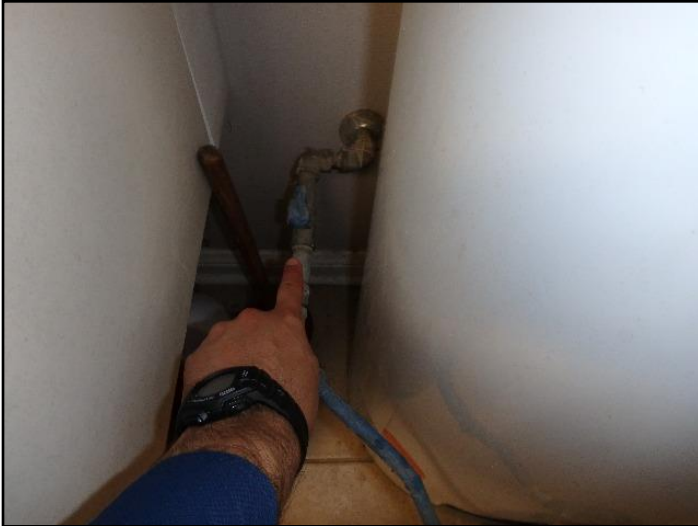
Taped Valve

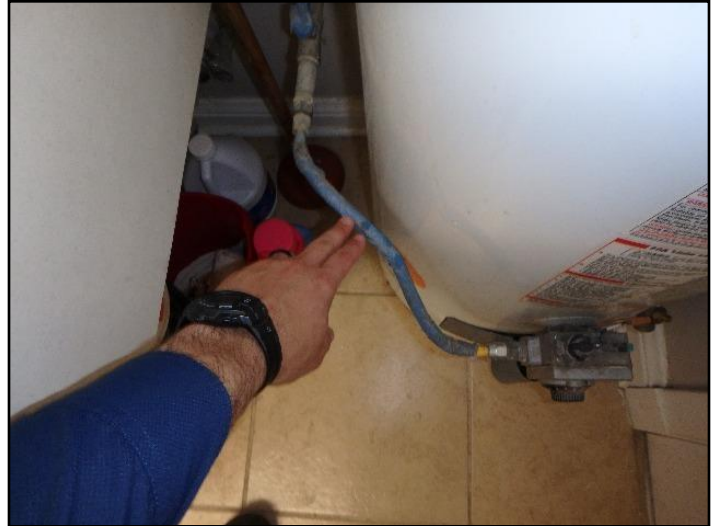
Tapped Pipe

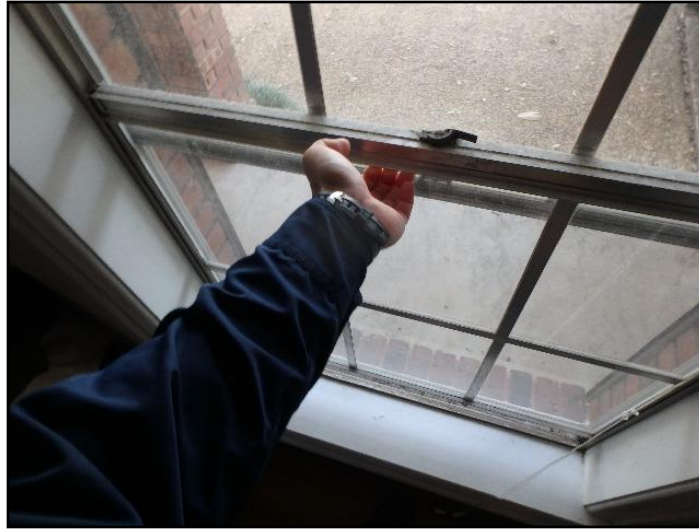
Condition: • [Won't stay open](#)

Won't stay open

Task: Repair or replace.

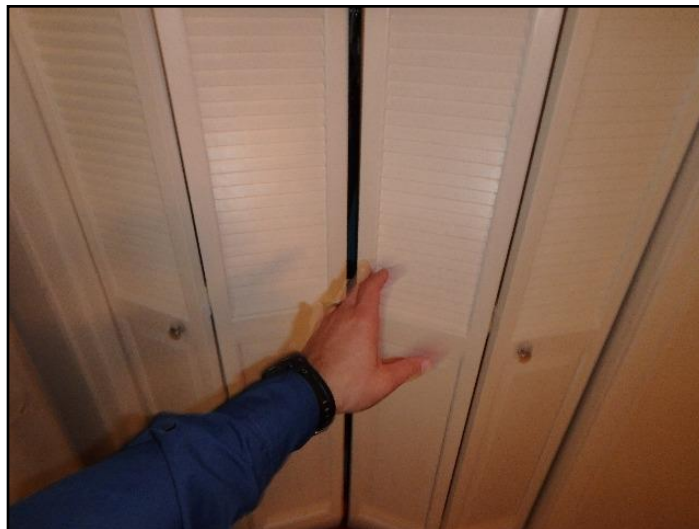
Condition: • Ineffective guide on sliding closet door

Location: Middle Bedroom

Ineffective guide on sliding closet door

Task: Correct. Adjust.
