Inspection Report

1333 SAMPLE FRONT ST New Orleans, LA 70130

Inspection Date: Monday, November 26, 2018

RE: Report No. 8921, v.3 1333 SAMPLE FRONT ST New Orleans, LA 70130

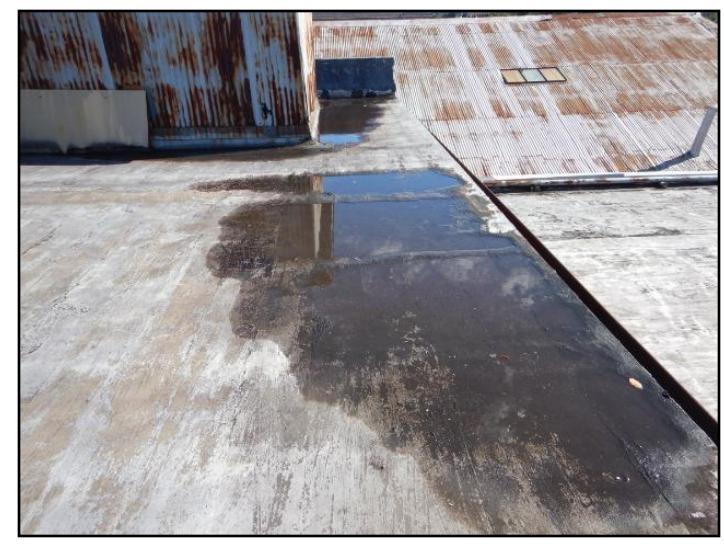
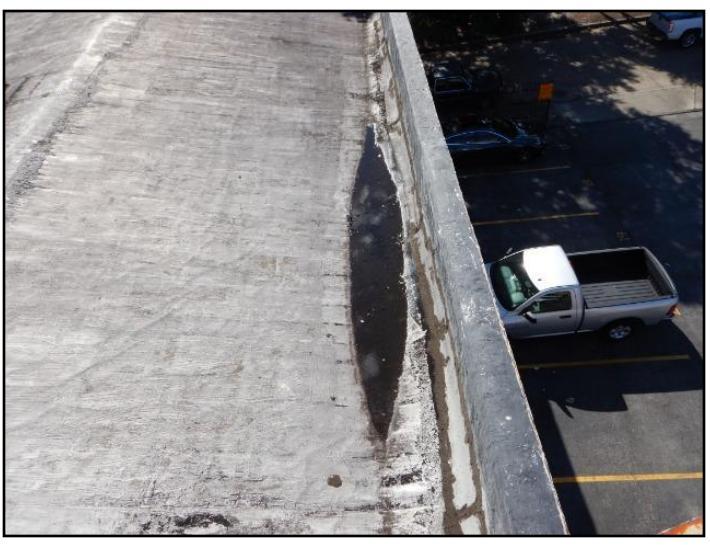
Low areas also noted Location: Various Task: Further evaluation. Improve.

Ponding

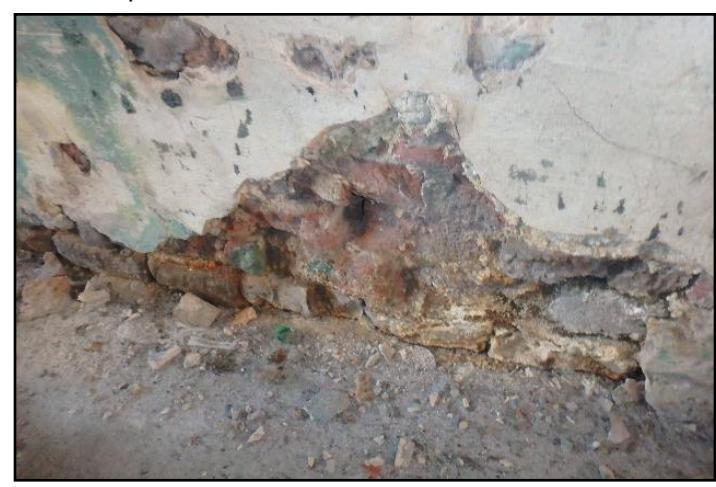
Condition: • The overall condition of the stucco warrants further evaluation from a qualified stucco contractor. Issues noted included: Cracking, open seams and prior repair t
 Location: Throughout Exterior
 Task: Repair.

Stucco repairs needed

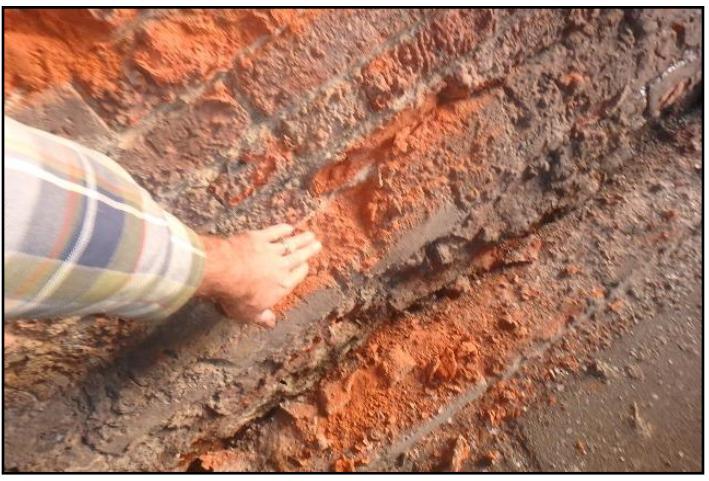
Condition:
• <u>Masonry deterioration</u>

Location: Throughout Left Side and Right Side Exterior Task: Repair.

Masonry deterioration

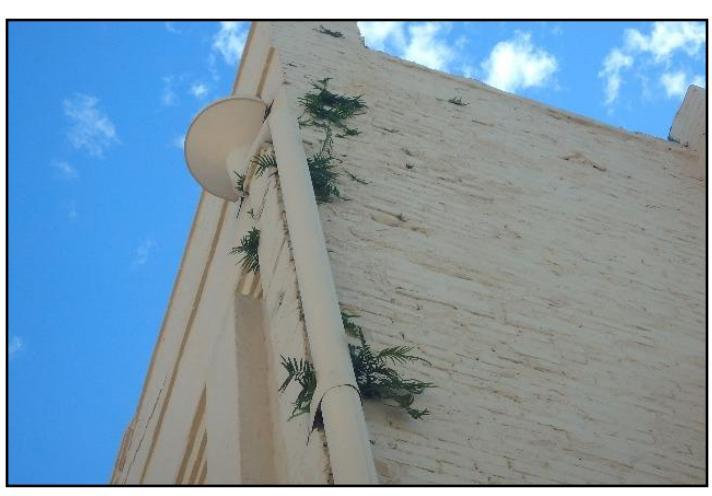
Condition: • Plants and weeds growing in masonry. **Location**: Various Throughout Exterior **Task**: Remove.

plants and weeds

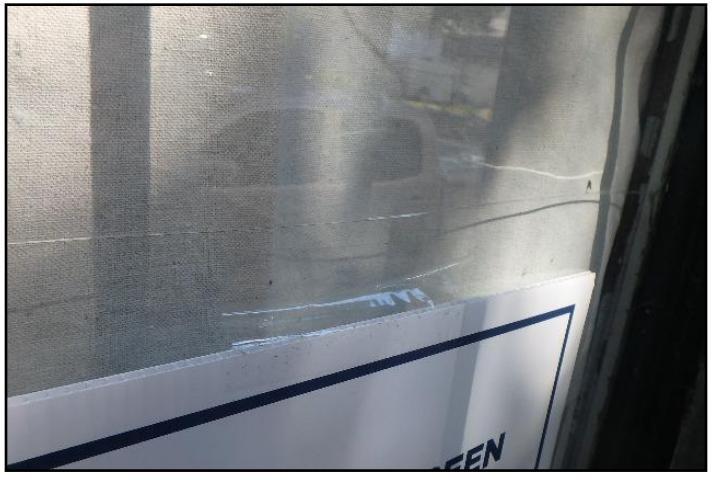
Condition: • <u>Cracked</u> Location: Front Exterior Task: Replace.

Cracked window

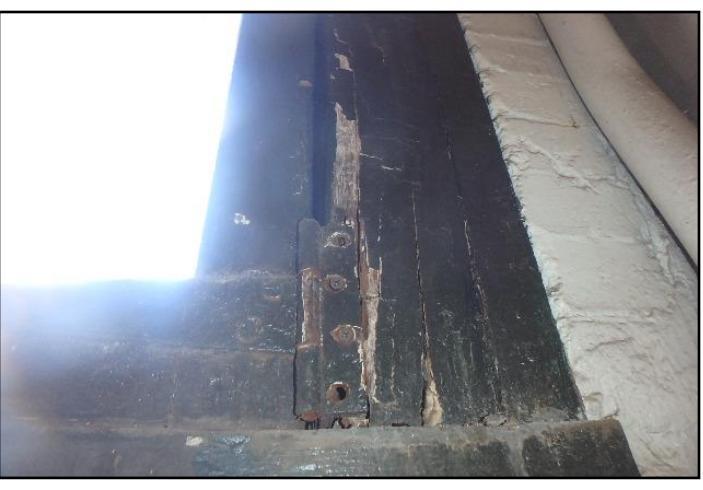
Rot

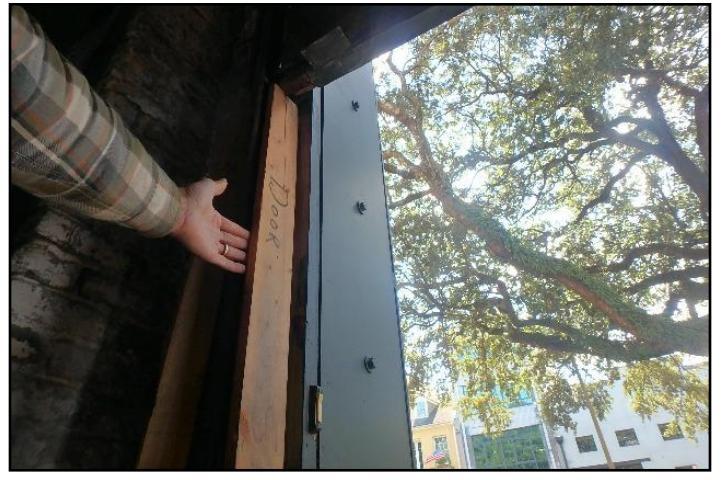
Condition: • Damage
The front garage door is missing the springs and does not stay open. The rear garage door opener is inoperative and must be opened manually.
Location: Both garage doors
Task: Repair or replace.

door must be propped open

opener inoperative

Task: Repair or replace.

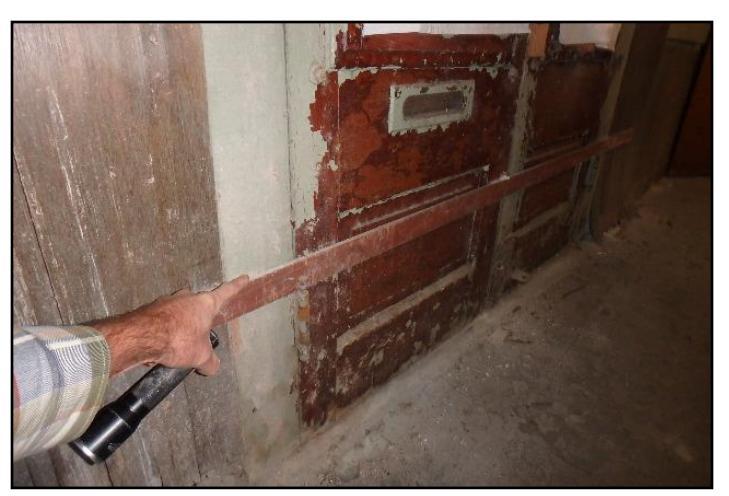
Inspection limited/prevented by: • The front door is barricaded. Unable to test.

Barricaded door

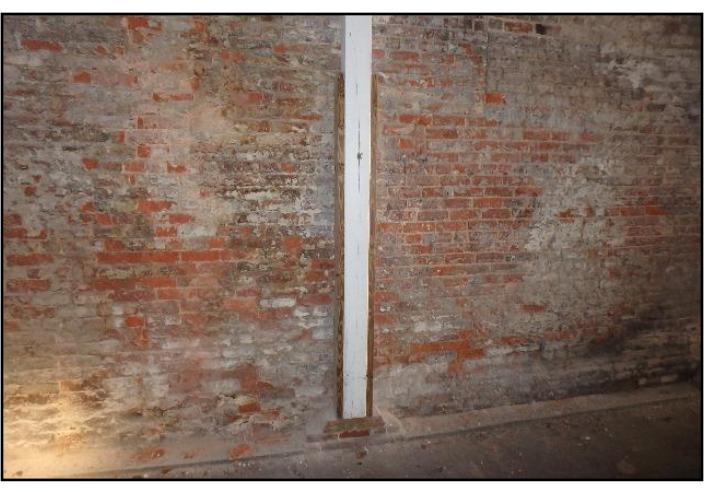
suspect repair

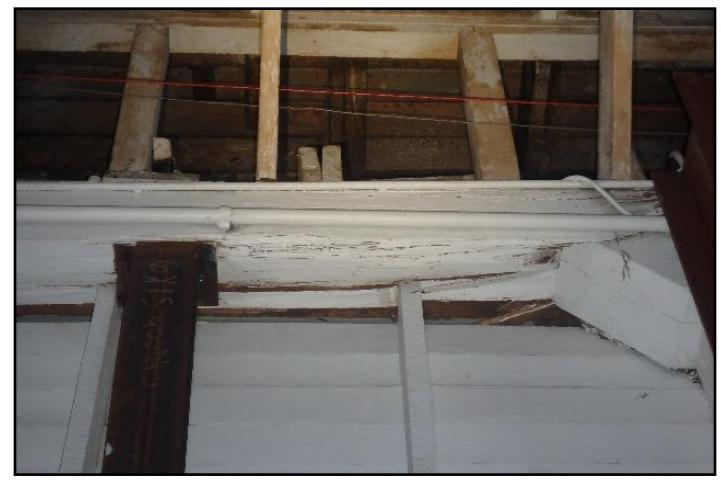
Condition: • Insect damage

Location: Various Throughout Left Center Task: Repair or replace. Further evaluation.

Insect damage, crushed

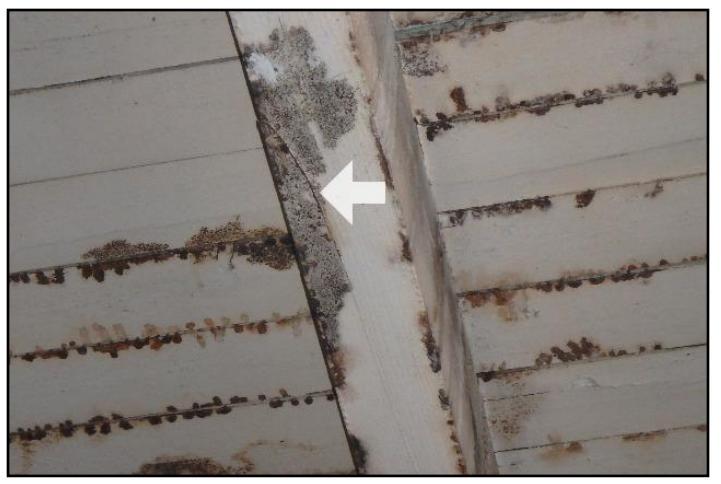
Condition: • <u>Split or damaged</u> Location: Rear and left side Middle Task: Repair.

Split or damaged

Split

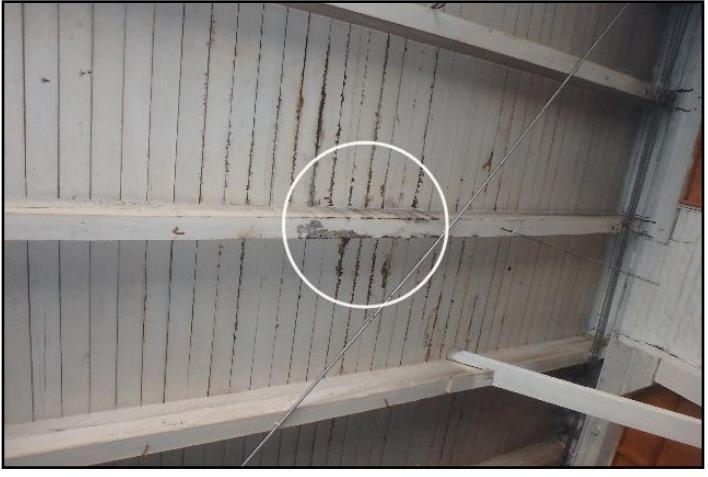
Split at rotted area

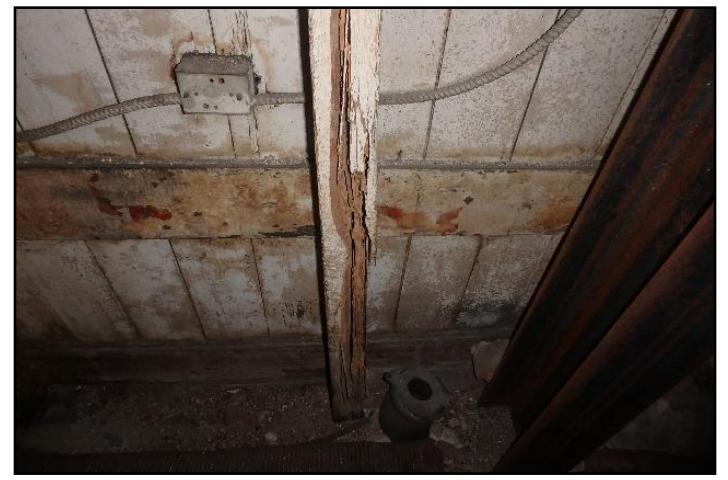
Condition: • Insect damage Location: Various Throughout Task: Repair or replace. Further evaluation.

Insect damage

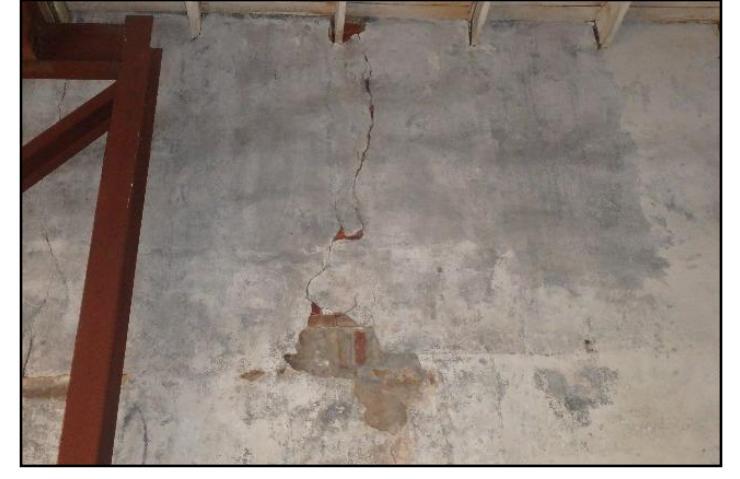
Cracked

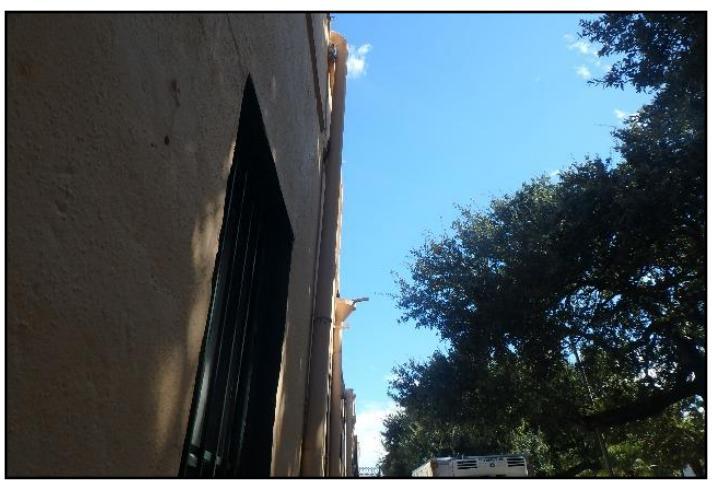
leaning wall

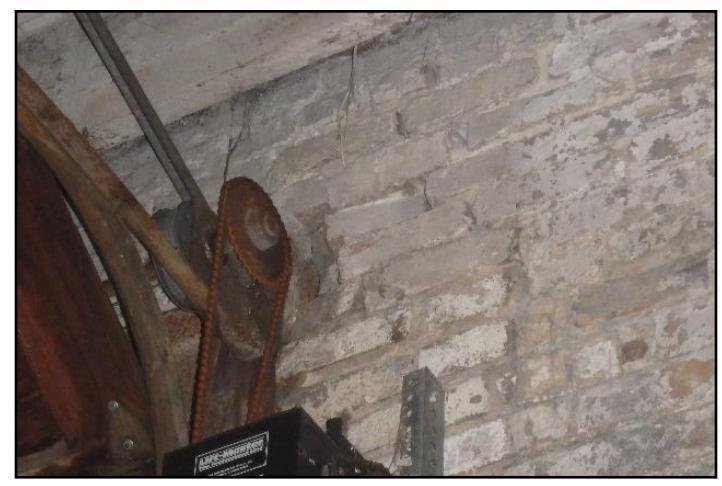
Condition: • Some bricks are loose near the top of the garage door. **Location**: Rear Left **Task**: Repair.

loose bricks

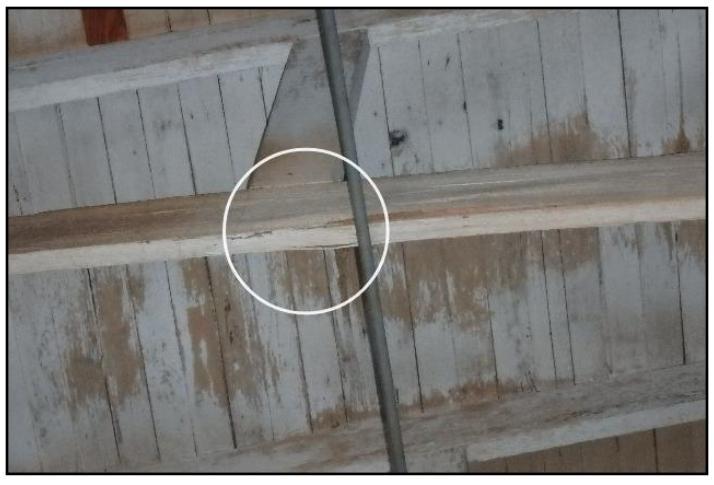
ROOF FRAMING \ Rafters/trusses Condition: • Insect damage Location: Various Left Side

Insect damage

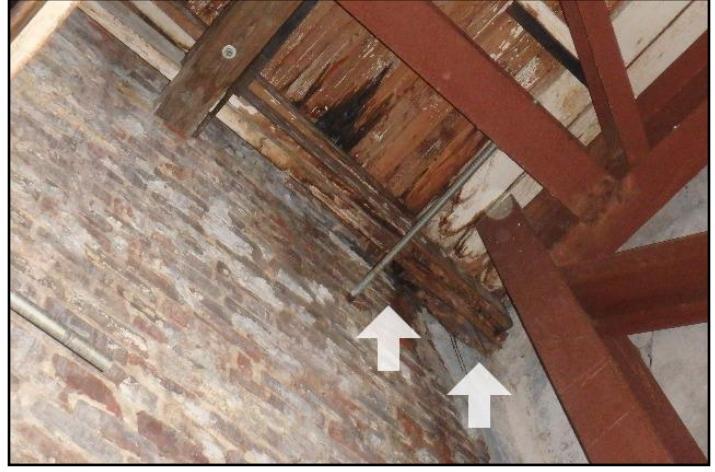
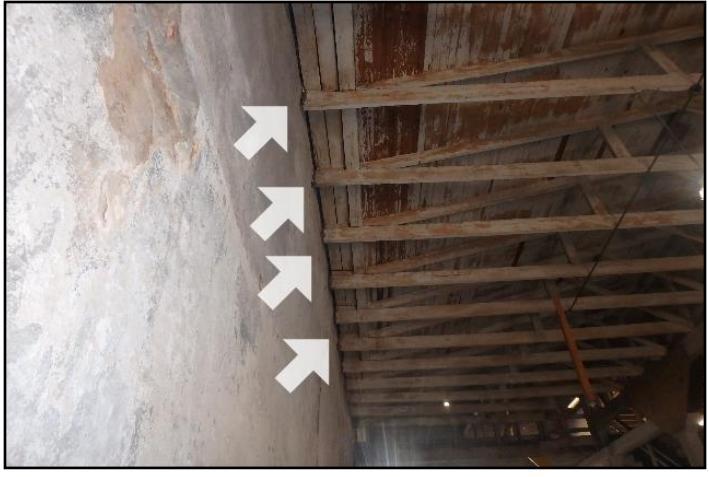
Condition: • End bearing inadequate

Roof leaks have rotted the trusses where they bear in the masonry wall. Many of the truss ends are no longer supported and further evaluation by a structural engineer should be made before any gutting and demo work is performed. **Location**: Various Throughout Left Side

No End bearing

Task: Repair. Further evaluation.

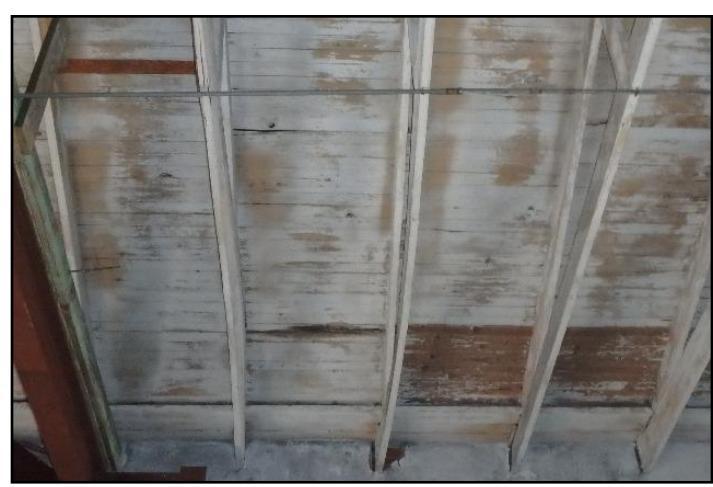
Condition: • A few trusses are bowed. Location: Left Side Task: Repair. Further evaluation.

bowed truss

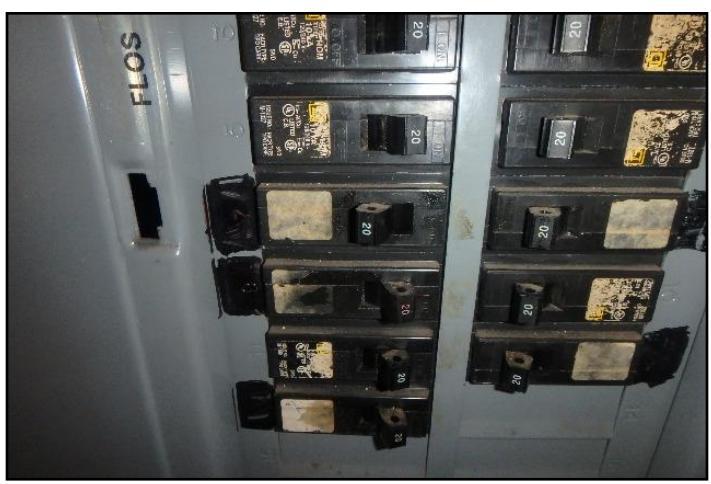
Condition: • Tripped breaker Location: Rear interior wall Task: Further evaluation. Cause could not be determined.

Tripped breaker

Task: Further evaluation. Cause could not be determined.

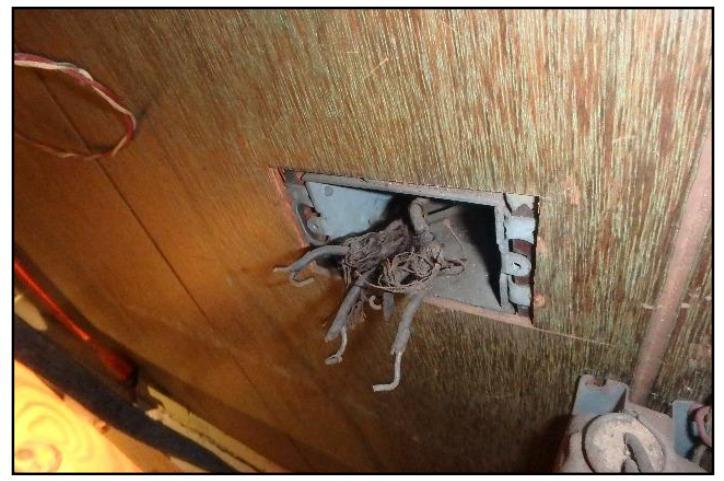
Condition: • Exposed on walls or ceilings Location: Various Throughout Task: Correct.

Exposed on walls

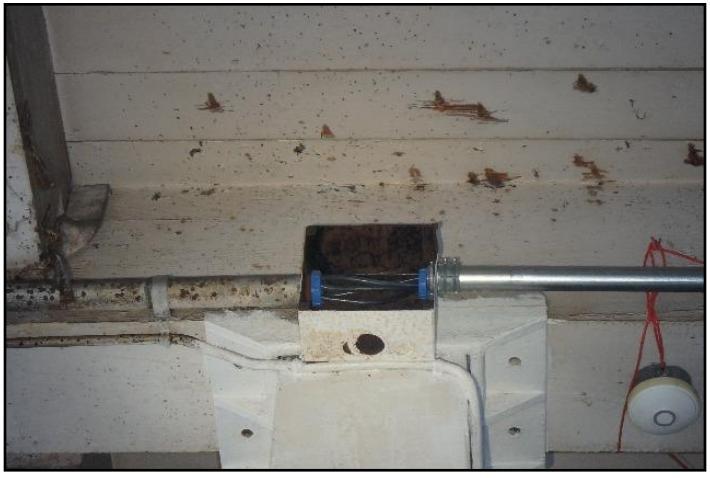
Cover missing

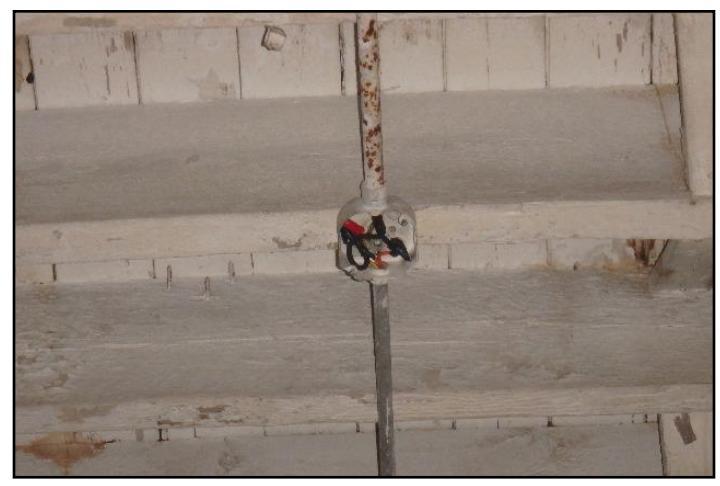
Cover missing

Exposed on walls

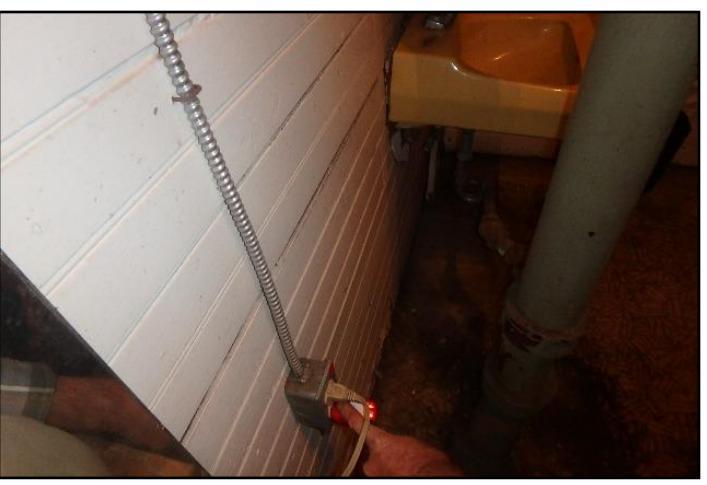
Condition: • GFCI needed (Ground Fault Circuit Interrupter)

For safety reasons, GFCI protection is recommended either at the outlets or at the panel for the following locations: Kitchen, attic, bathroom, exterior, garage, and within five feet of a laundry tub.

GFCI/GFI needed (Ground Fault Circuit...

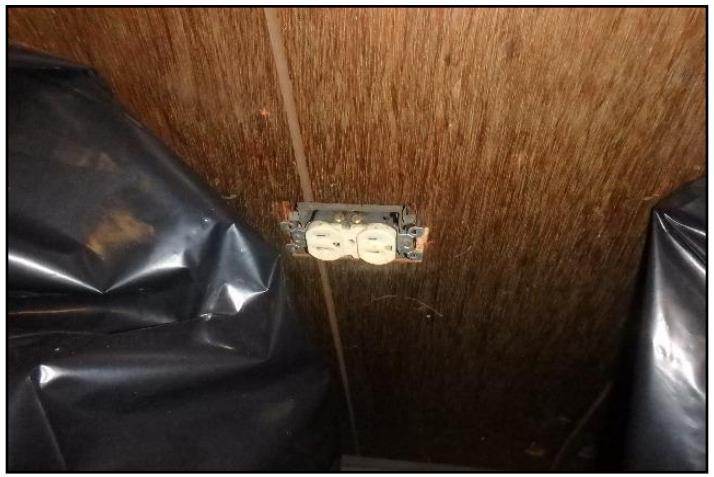
Condition: • Inoperative Location: Front Office, Various Two Slots Task: Repair.

Inoperative

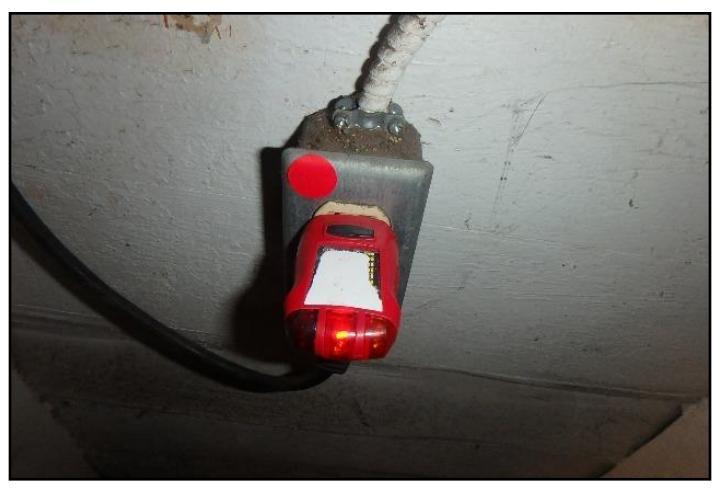
Condition: • Weak ground Location: Rear Center Task: Repair.

weak ground

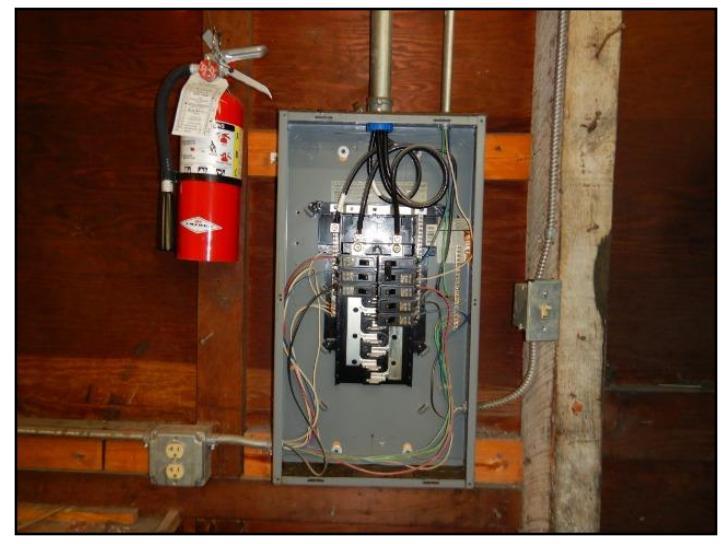
Condition: • Loose Location: Front Right First Floor Task: Correct.

Loose

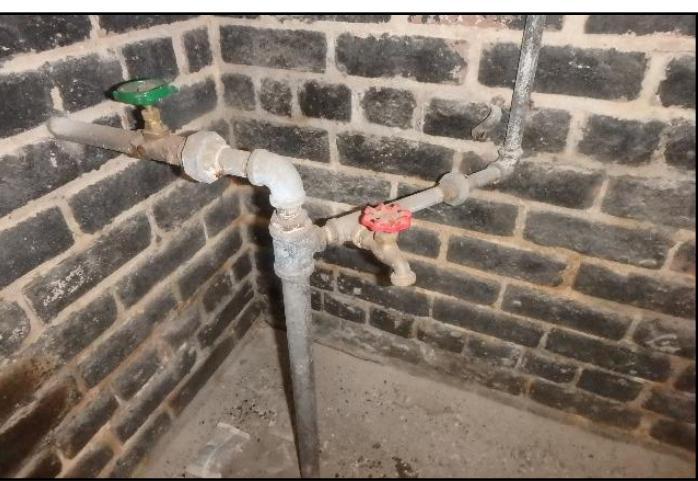
Condition: • Poor pressure or flow **Location**: Throughout Task: Further evaluation. Improve.

Poor water pressure

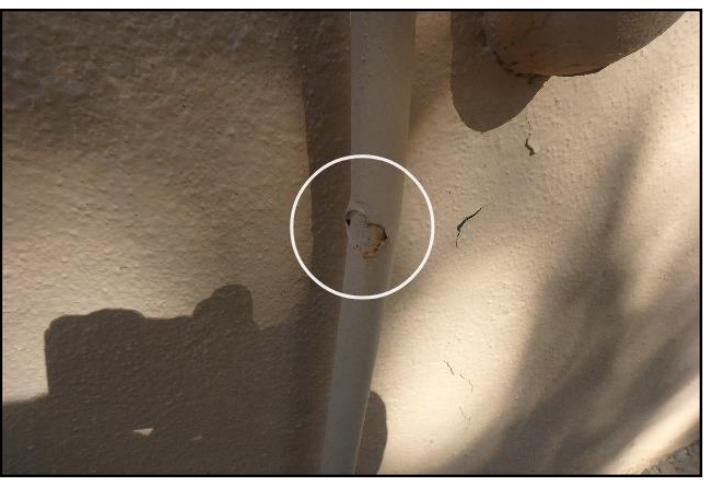
GAS SUPPLY \ Gas piping Condition:
• Mechanical damage Location: Front Exterior Task: Repair or replace.

Mechanical damage

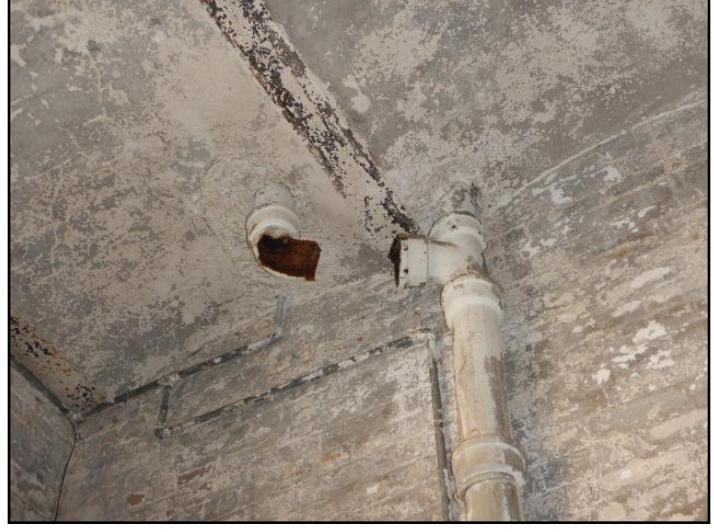
Condition: • Incomplete installation **Location**: Rear Right First Floor **Task**: Complete.

Incomplete installation

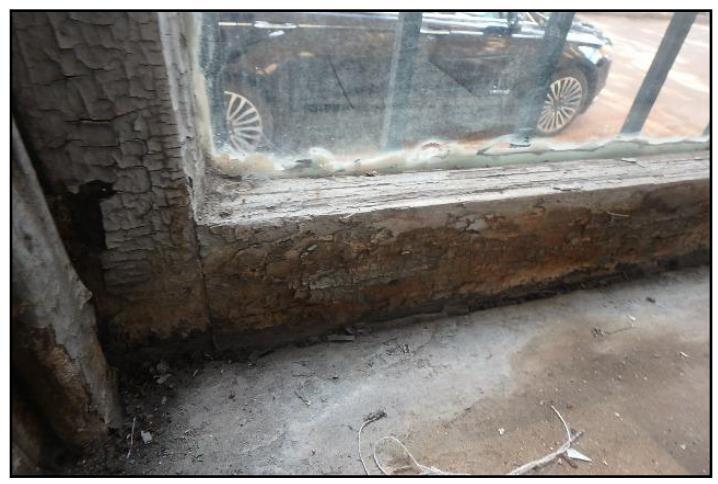
Condition: • Old paint (prior to 1978) typically contained lead and care should be taken when removing the paint. In most cases if the paint is in good condition (not chipping peeling or cracking), is not on a door or window that will create friction on the paint, and is not in a place where children can chew on it, It can be painted over or sealed with a thick varnish. If the paint is to be removed, liquid paint removers are recommended.

old paint

Task: Information only.

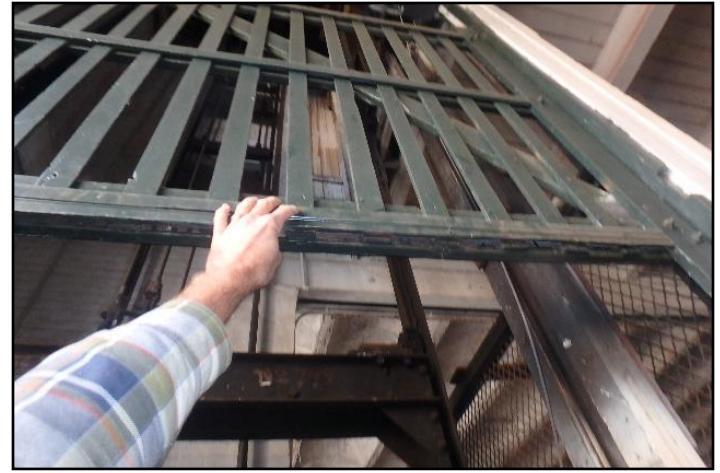
Condition: • Damaged elevator safety door. The counterweight for the elevator safety door is missing. Location: Rear First Floor

safety door does not stay open

Task: Repair.

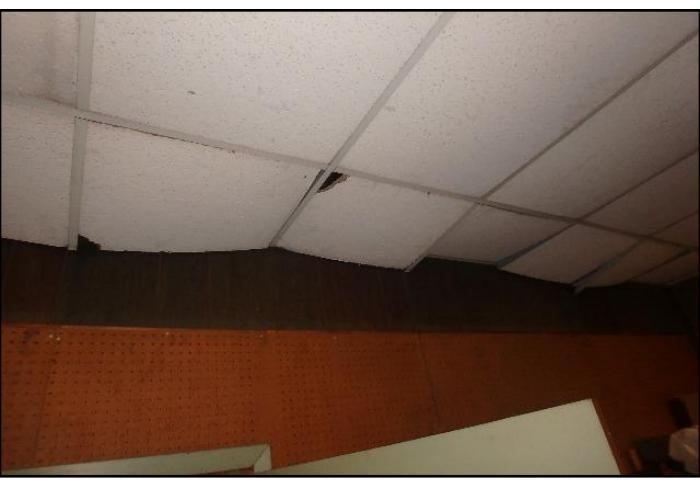
Condition: • Damage Location: Various Task: Repair or replace.

Damaged ceiling tiles

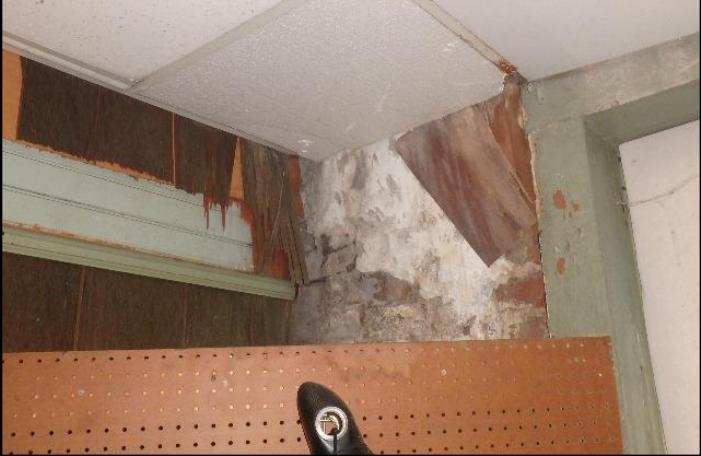
Condition: • Broken, cracked or split Location: Front Office Task: Replace.

Broken, cracked or split

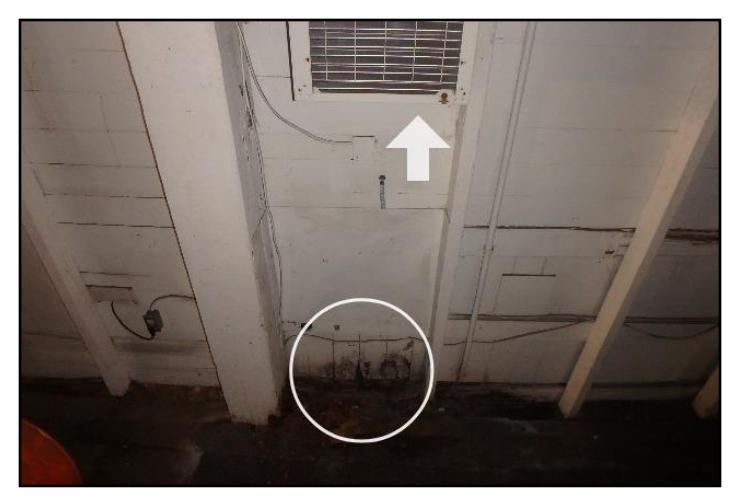
Condition: • Rot The AC window units are dripping condensation on the interior walls causing them to rot. Location: Front Left Task: Improve.

Rot

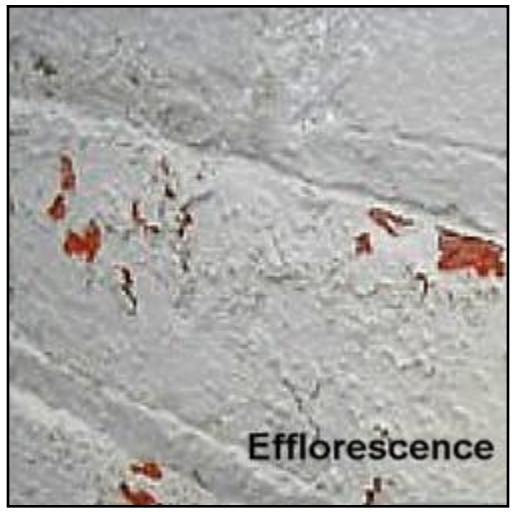
Condition: • Efflorescense on painted brick - paint damage

Where there is moisture trapped in brick walls, efflorescence can be a problem. Efflorescence is the surface crystallization of soluble salts in the masonry as the moisture evaporates. When this occurs on a painted brick surface, the crusty white salt deposits bubble through the paint film from the masonry, causing damage to the paint. The possible, and most likely causes of interior efflorescence are: 1) Moisture migrating through the masonry walls from the outside 2) Poor paint surface preparation where prior efflorescence was not entirely removed and properly cleaned, rinsed and dried fully prior to painting. Cleaning is with trisodium phosphate is usually recommended or 3) Painting new or newly repaired masonry before it has had time to cure and fully dry out.

Efflorescence example - stock photo

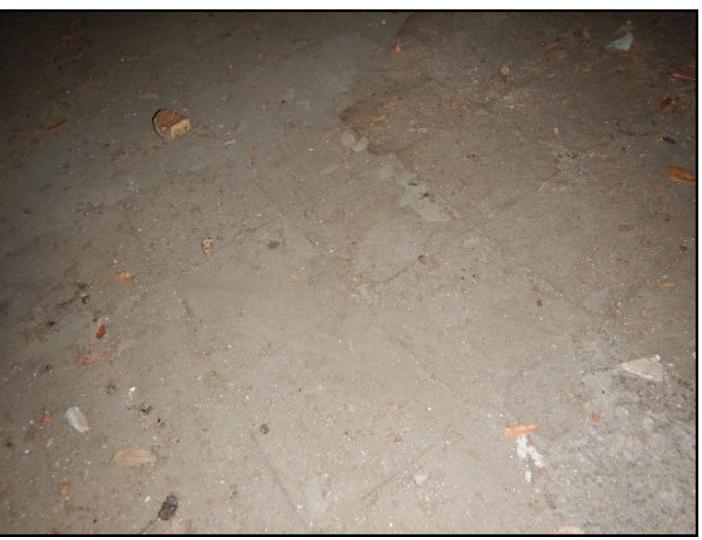
Condition: • <u>Suspect Floor Tiles - Possible Asbestos Hazard</u> The age, type and style of the tiles make them suspect for asbestos.

Asbestos was very commonly used in vinyl and asphalt based floor tiles from the early 1950's until about 1980. Asbestos is hazardous when the fibers become airborne or "friable". Friable asbestos material is any material containing more than 1 percent asbestos that, when dry, can be crumbled, pulverized, or reduced to powder by hand pressure. Non-friable asbestos-containing material is less likely to be an asbestos hazard in buildings, unless it is mechanically ground or pulverized.

Suspect Floor Tiles - Possible Asbestos...

Task: Further evaluation. Cover-see Appendix

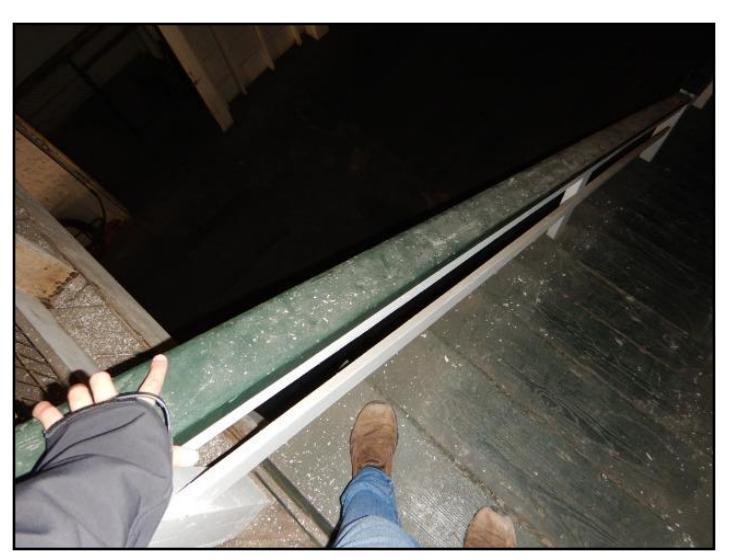
STAIRS \ Handrails and guards Condition: • Too low Location: Top of Staircase Task: Improve.

Too low

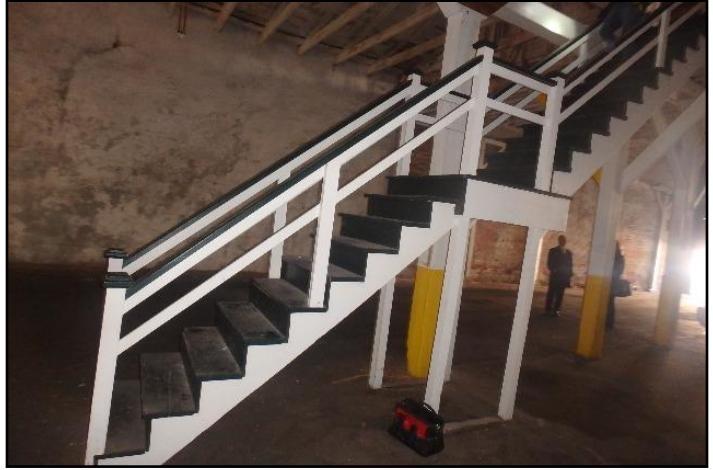
Too far apart

Task: Correct.

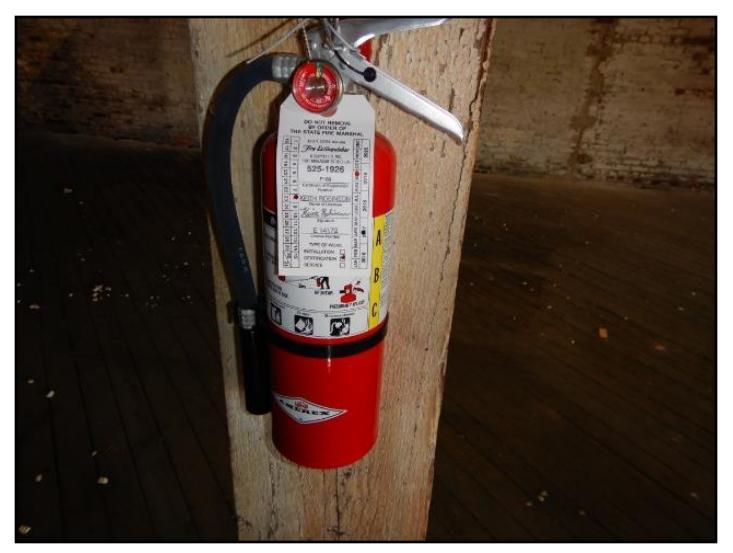
Note: Fire extinguisher inspection tags out of date

Inspection Tags
