# Inspection Report

1020 - 1022 Sample St  
New Orleans, LA 70115

Inspection Date:  
Monday, January 24, 2022

RE: Report No. 14696, v.2  
1020 - 1022 Sample St  
New Orleans, LA  
70115

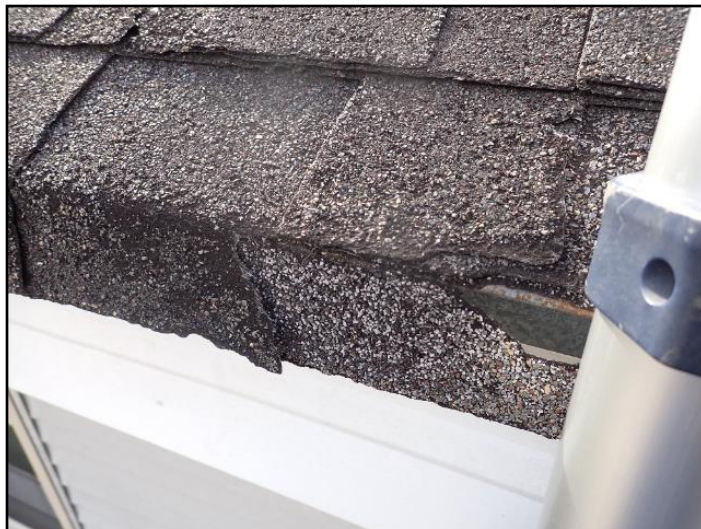
**Condition:** • [Missing, loose or torn](#)

Missing, loose or torn

**Task:** Replace damaged, missing shingles

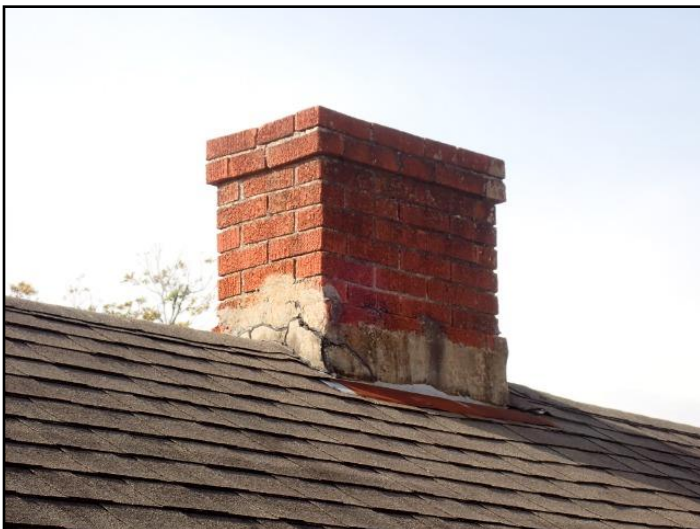
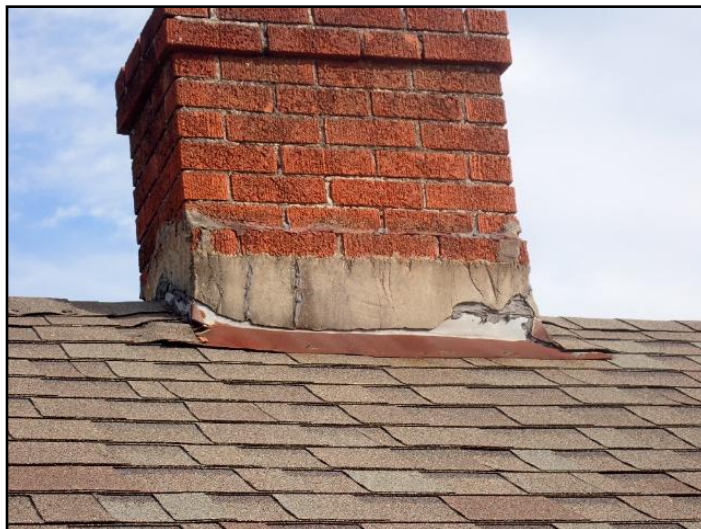
Metal flashing not visible

**Task:** Re-flash chimneys

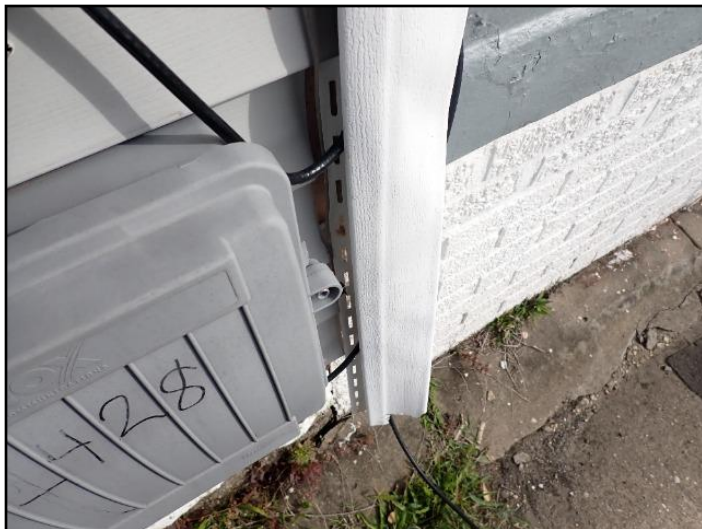
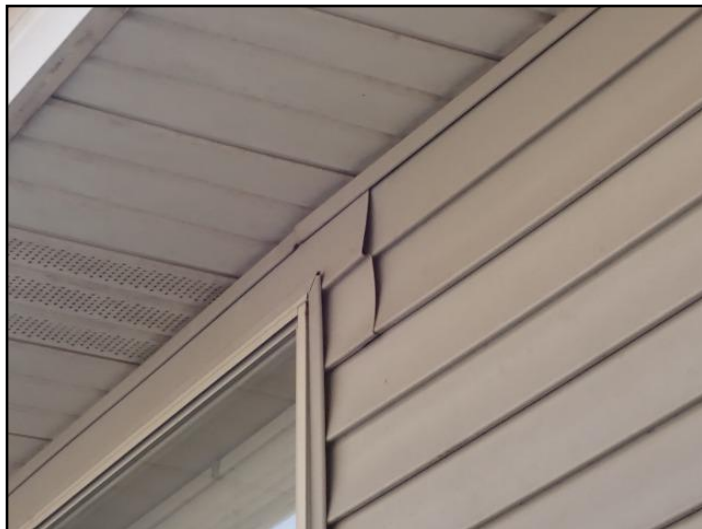
*Loose or missing pieces*

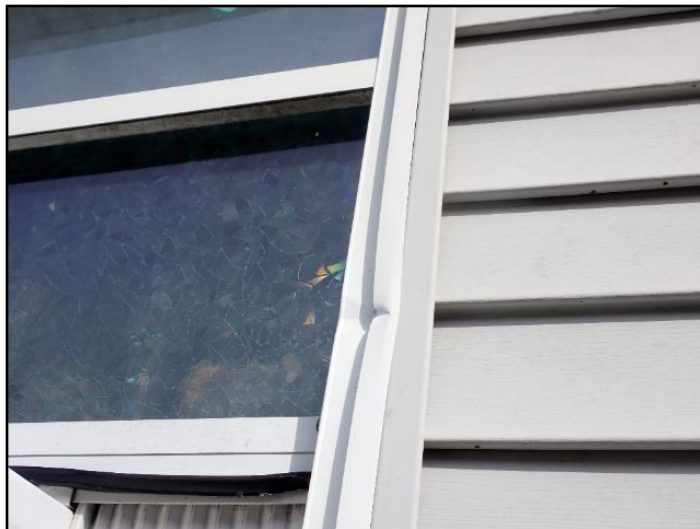
*Damage*

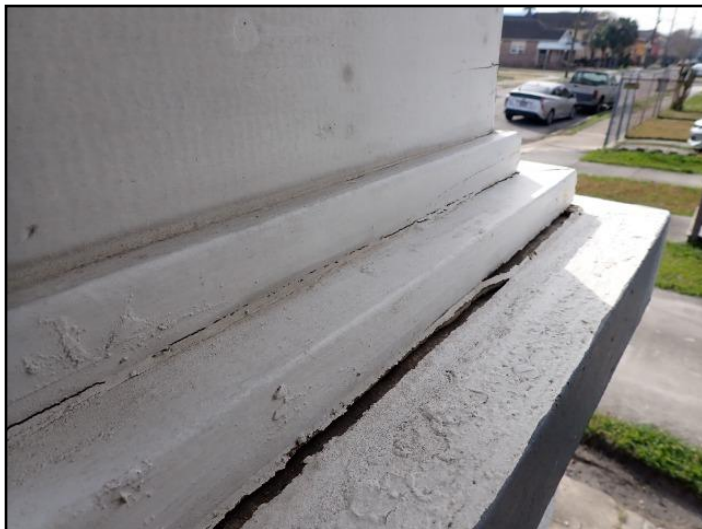
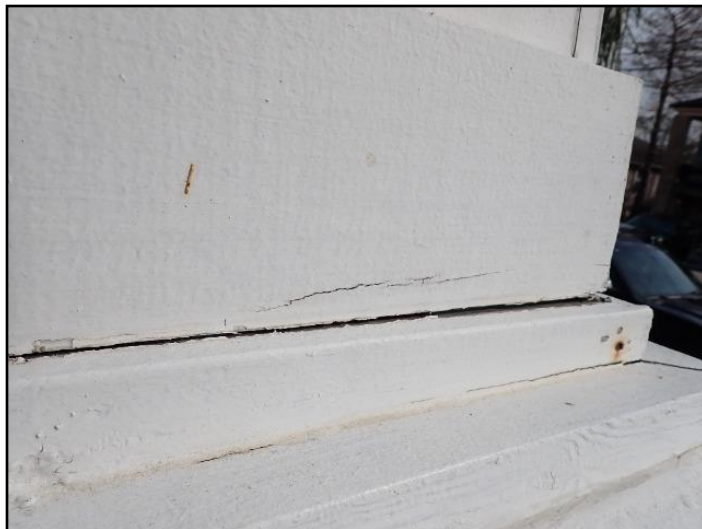
Open seams

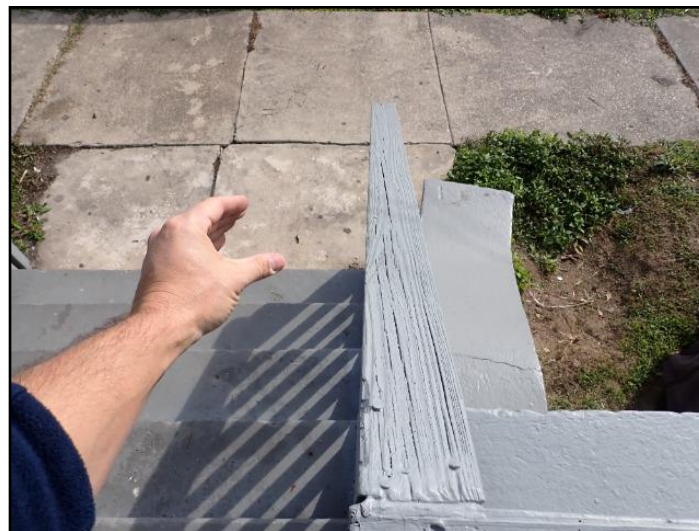
*Handrail may be too wide to be properly...*

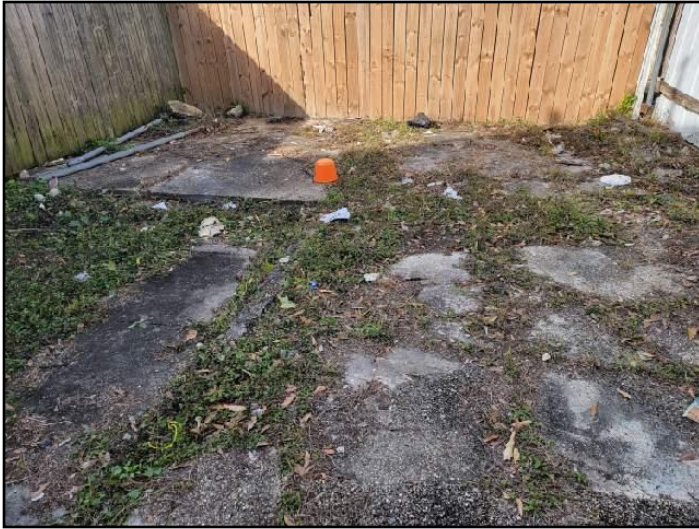
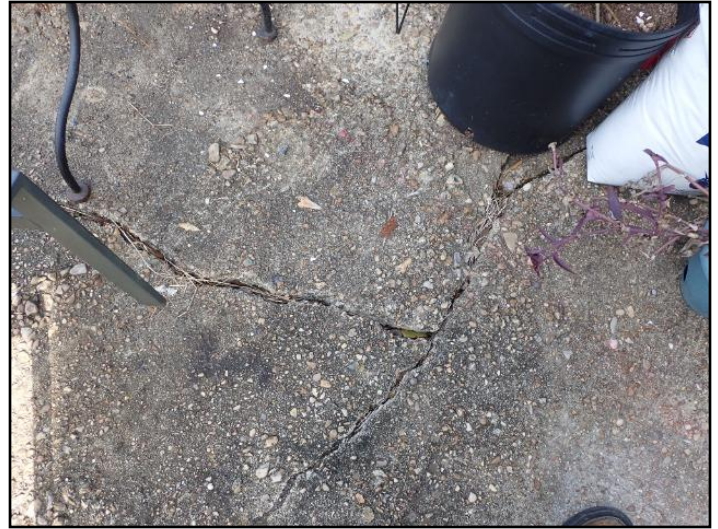
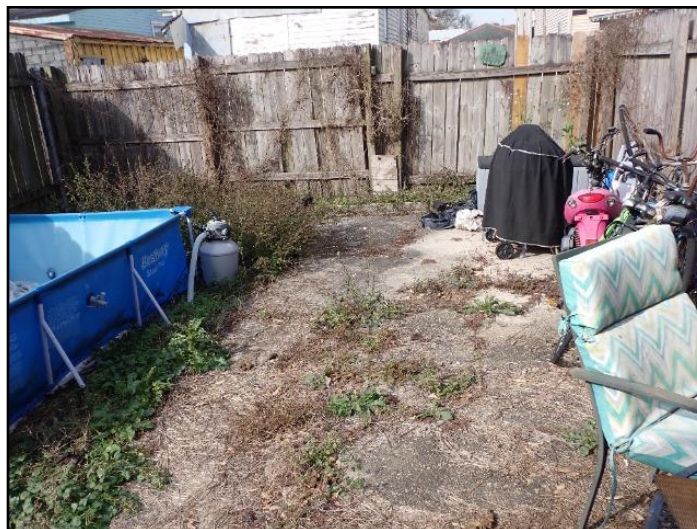
*Uneven (trip hazard)*

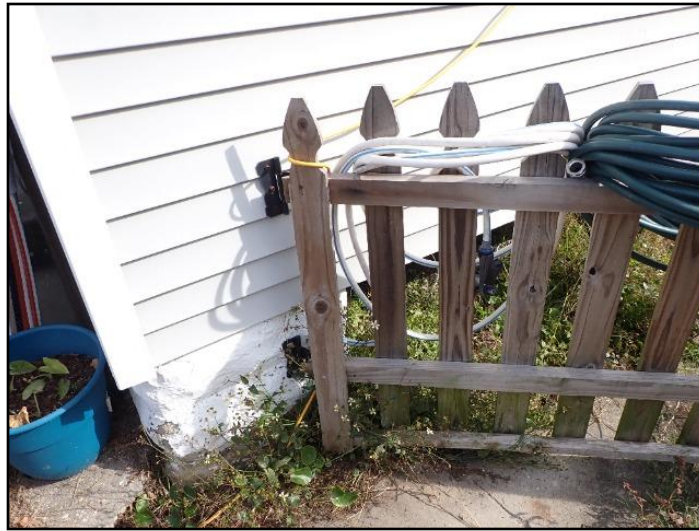
*Gate damaged*

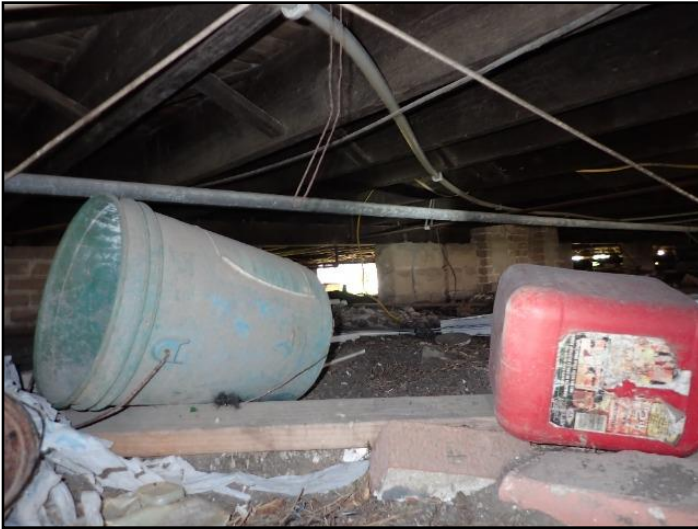
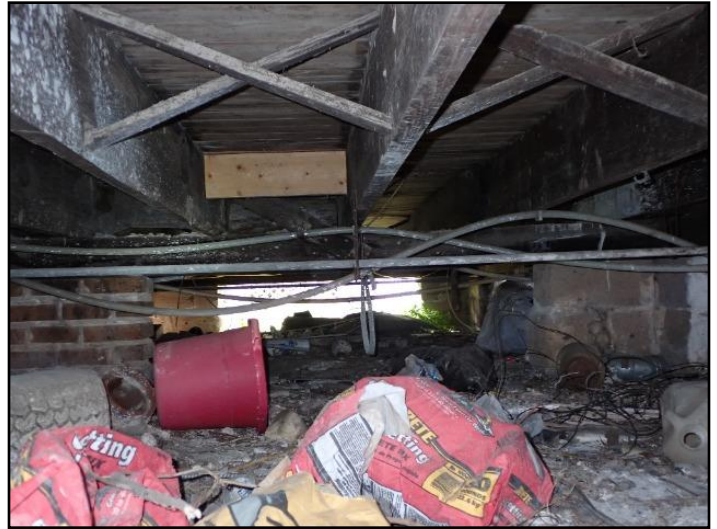
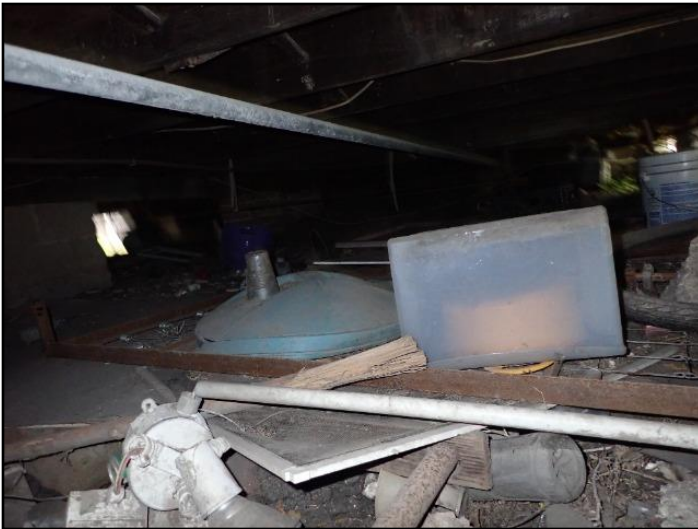
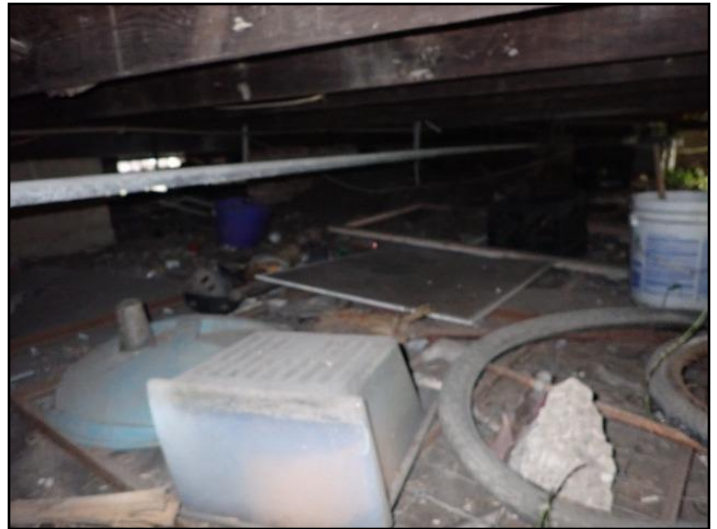
*Crawlspace debris*

**Task:** Clean.

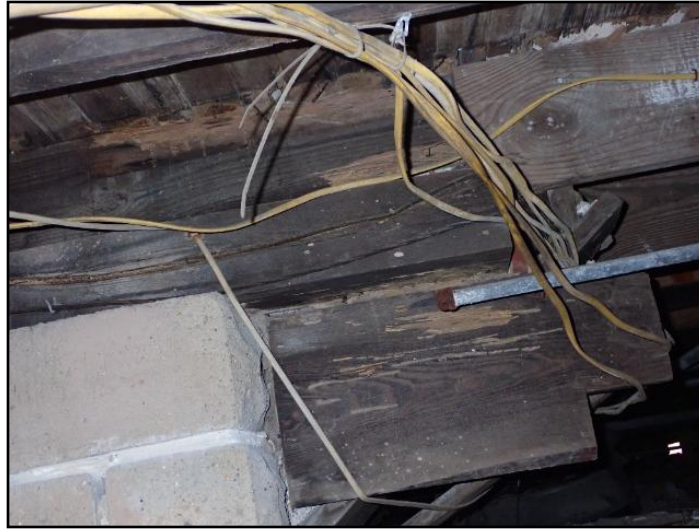
**Condition:** • Insect damage was noted on the framing around the stairs, the full extent of the damage could not be determined

*Insect damage*

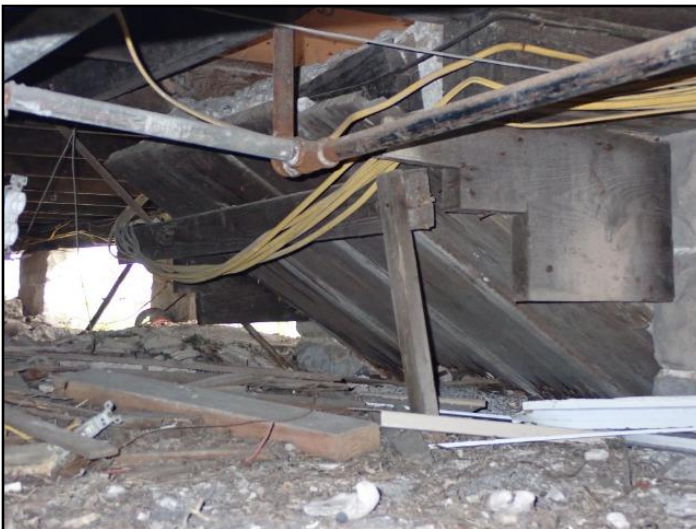
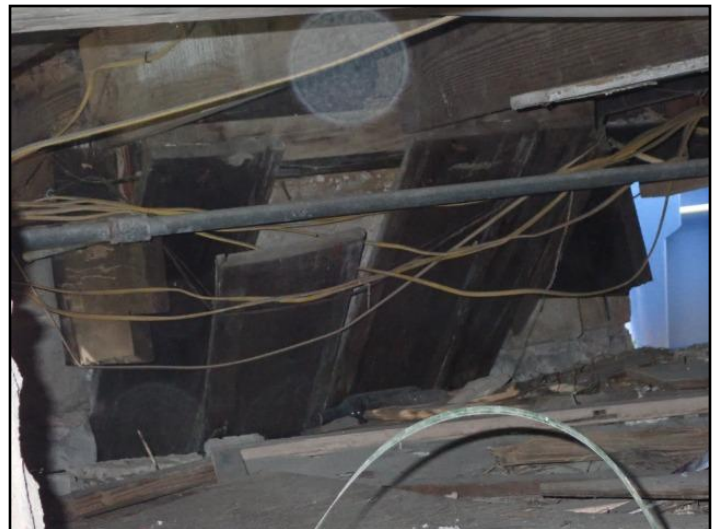
**Condition:** • [Wood/soil contact](#)

*Wood/soil contact*

**Task:** Correct.

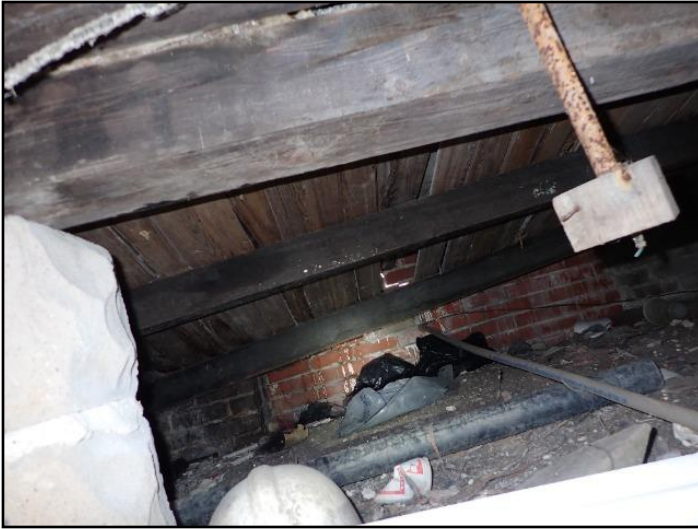
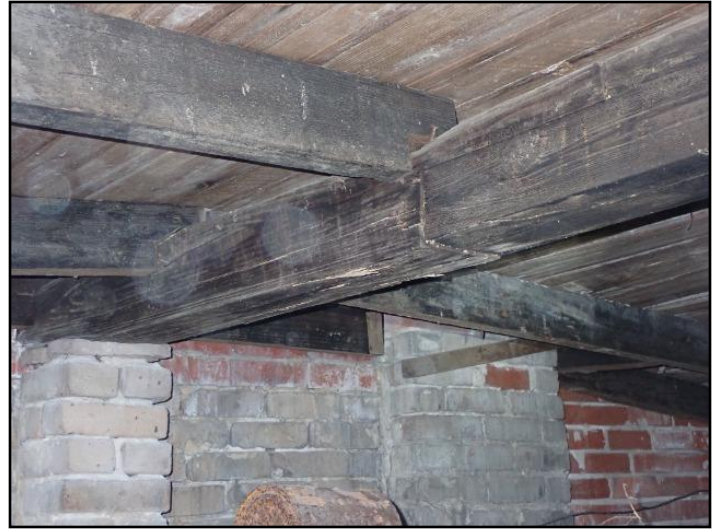
**Condition:** • Form boards not removed

Form boards not removed

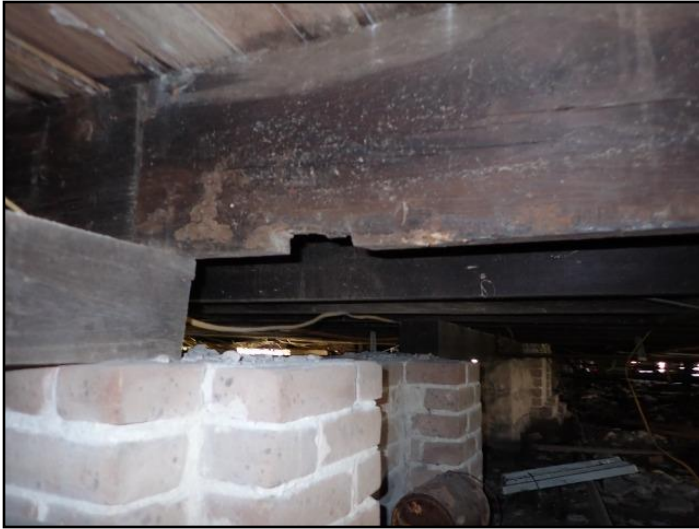
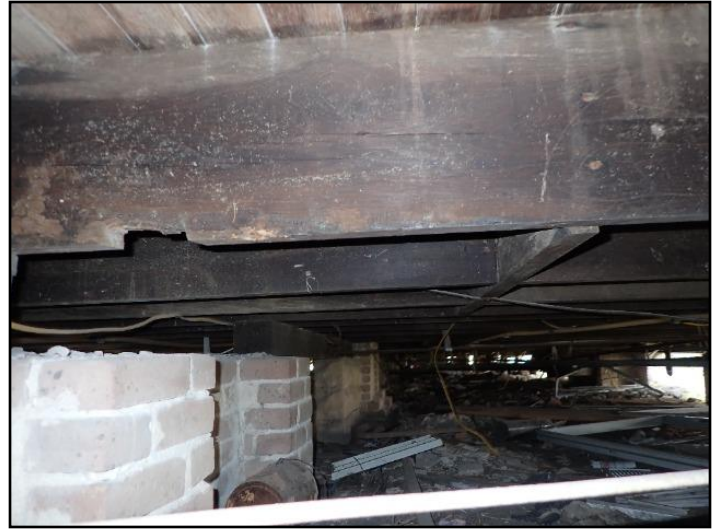
*Unusual installation*

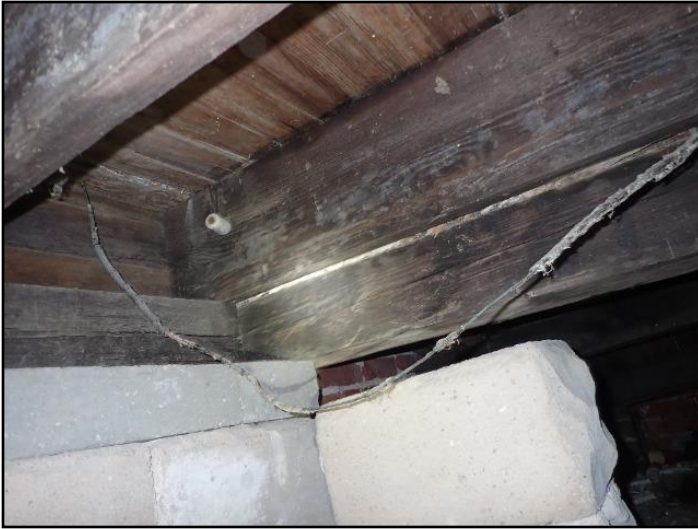
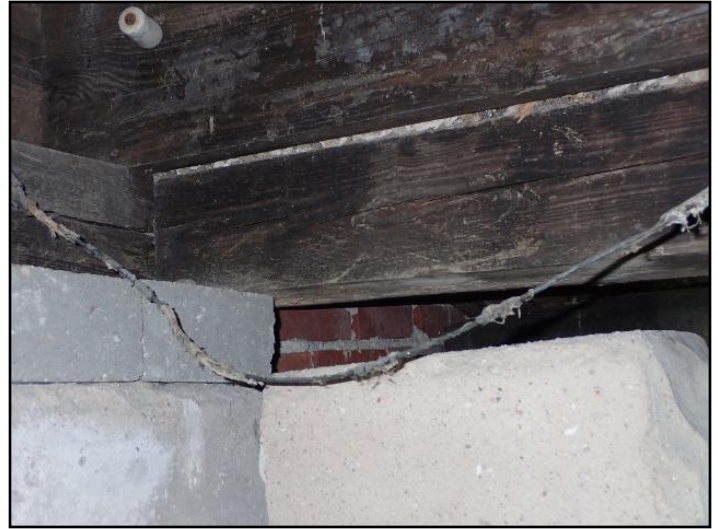
**Condition:** • Poor end bearing on pier.

*Poor end bearing on pier.*

**Task:** Repair.

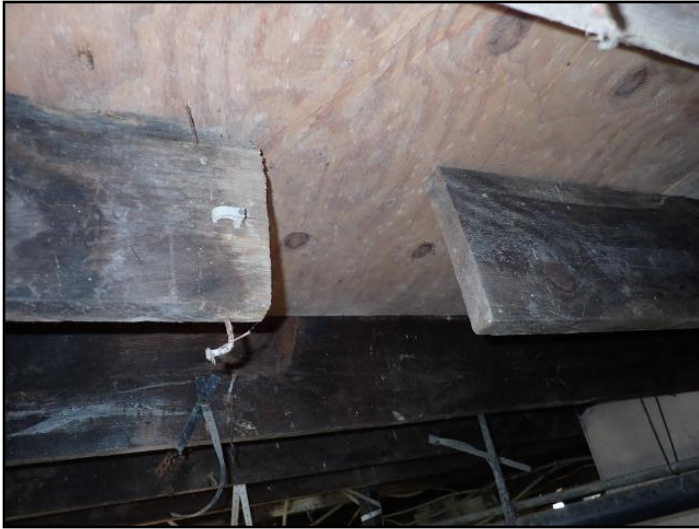
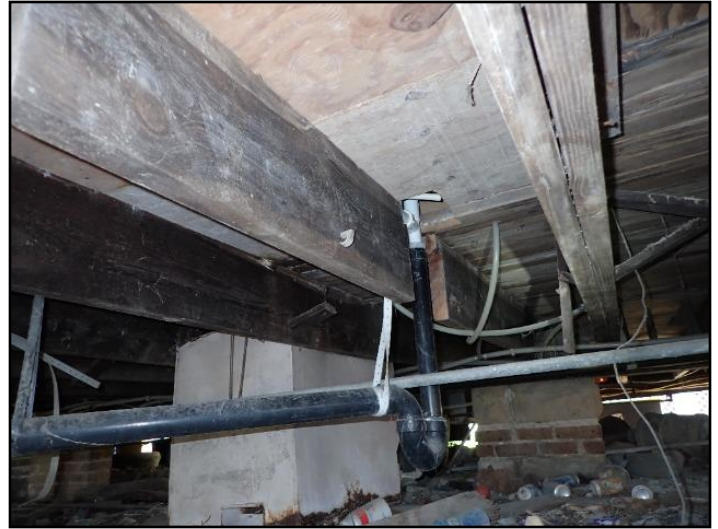
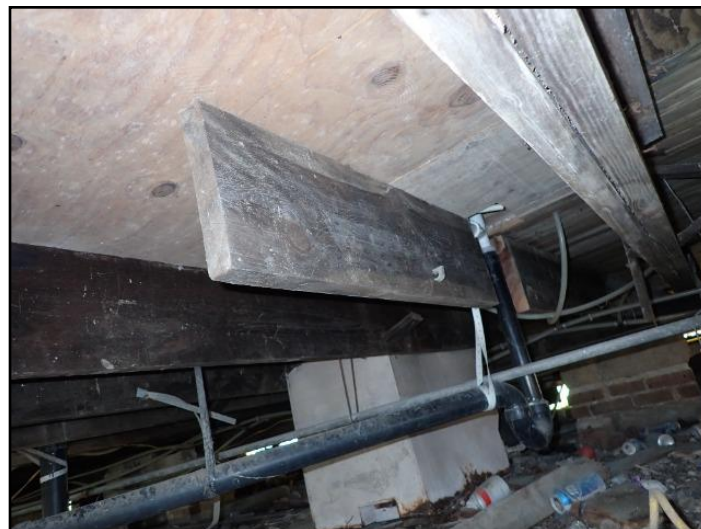
**Condition:** • Cut joists

*Cut joists*

**Task:** Repair.

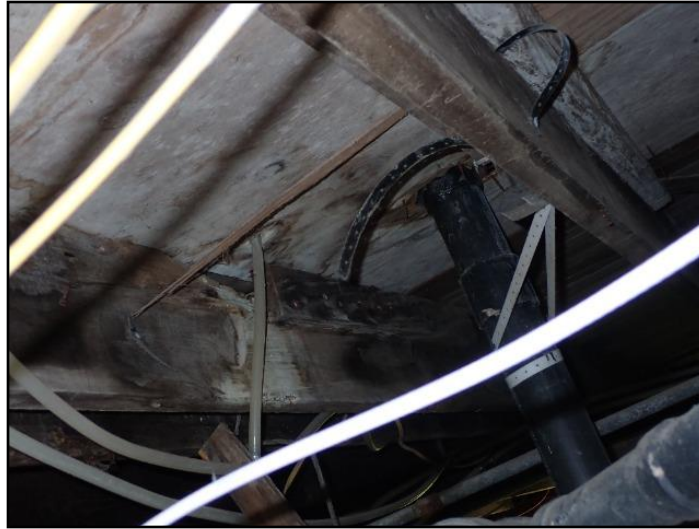
**Condition:** • Water stains

Water stains and the beginnings of rot were noted on the subfloor, It was not determined if this is an active leak.

*Water stains*

**Task:** Verify and repair as needed

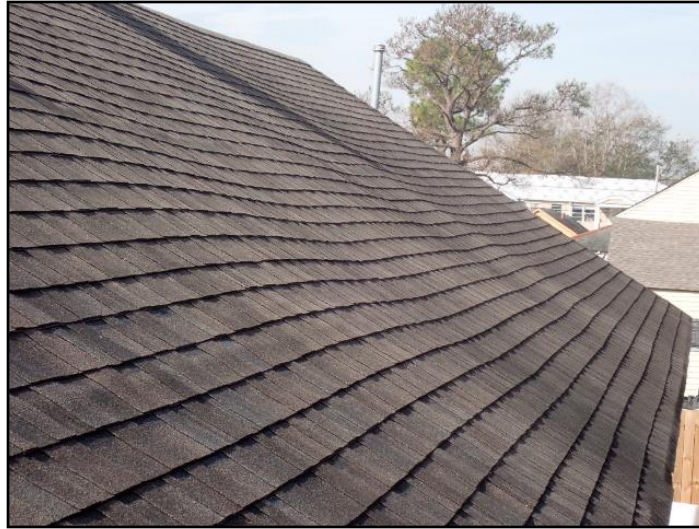
Wavy

**Task:** Further Investigation

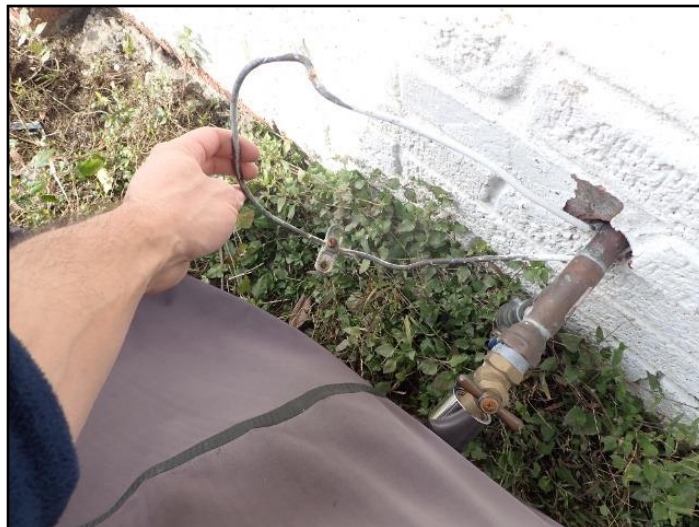
*Disconnected ground wire*

**Task:** Re-secure

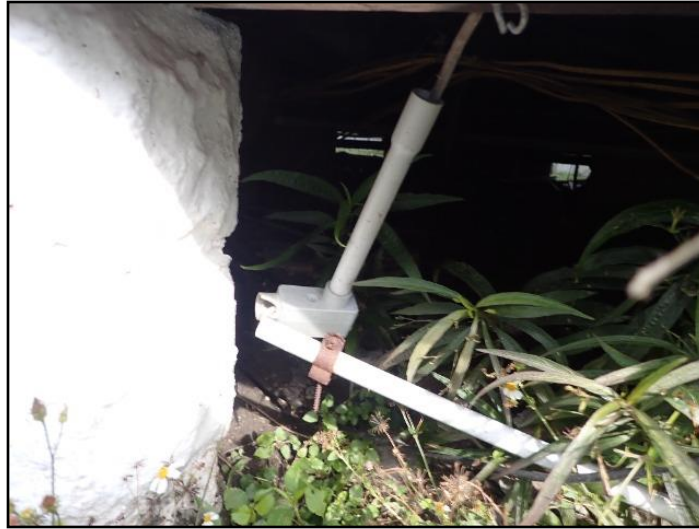
**Condition:** • Damaged, missing, or corroded conduit

*Damaged, missing, or corroded conduit*

**Task:** Repair.

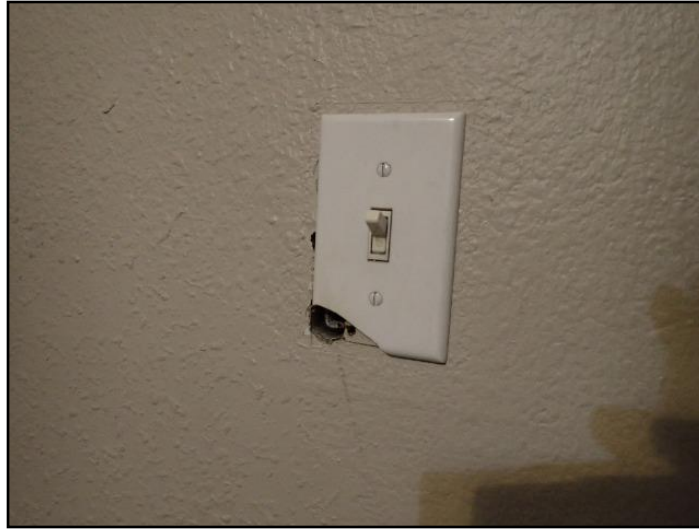
**Condition:** • [Damaged](#)

*Damaged*

**Task:** Replace

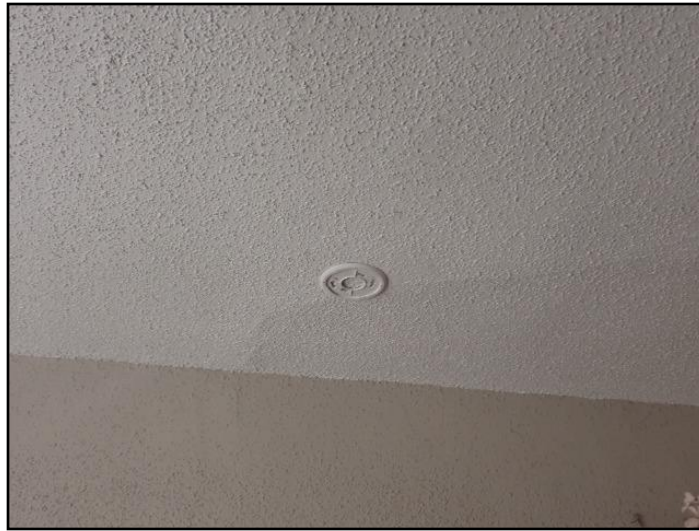
1 or more smoke detector was missing. The National Fire Protection Association recommends installing smoke alarms inside each bedroom, outside each sleeping area and on every level of the home, including the basement. On levels without bedrooms, install alarms in the living room (or den or family room) or near the stairway to the upper level, or in both locations.

*Missing***Condition:** • [Reminder to replace units when necessary](#)

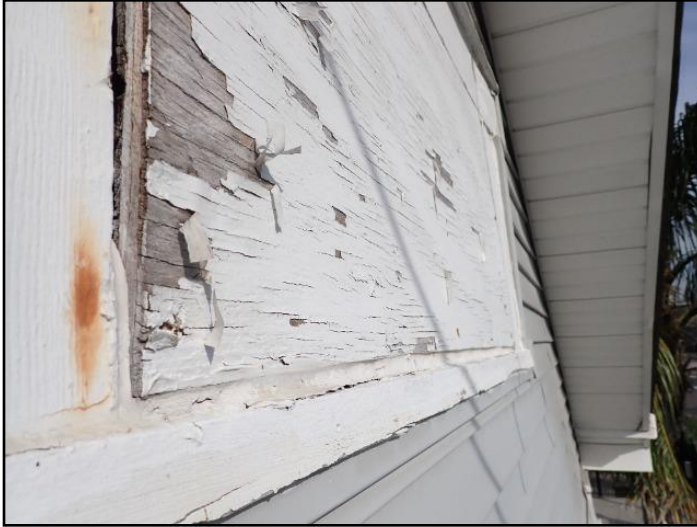
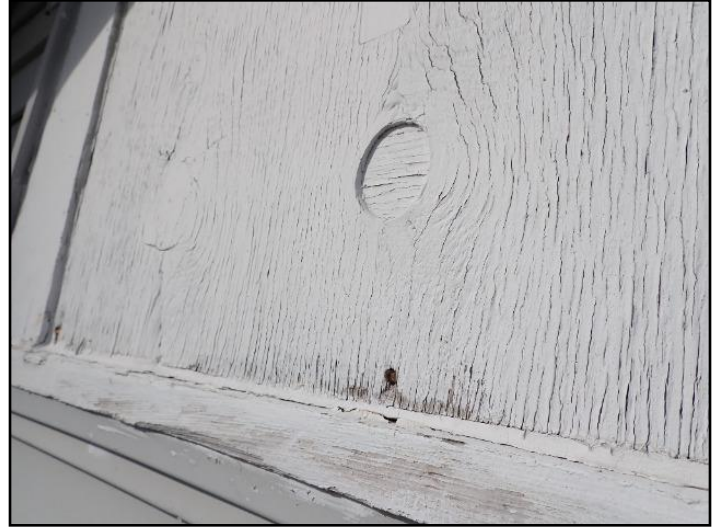
**Location:** Front Gable

There is no access to the attic space. The front gable plywood is nailed and caulked in place. We recommend installing a more accessible means of an attic entrance.

*Inaccessible*

**Task:** Install

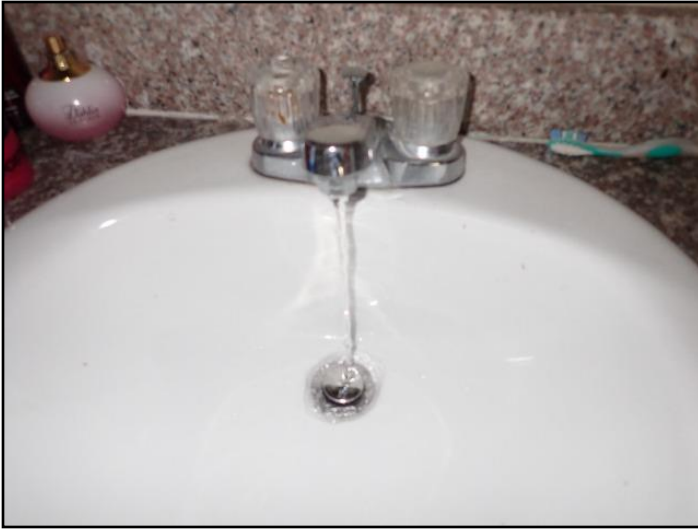
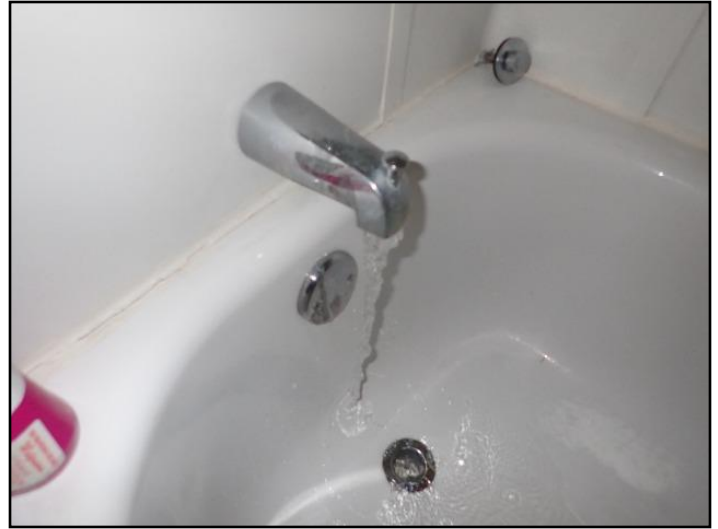
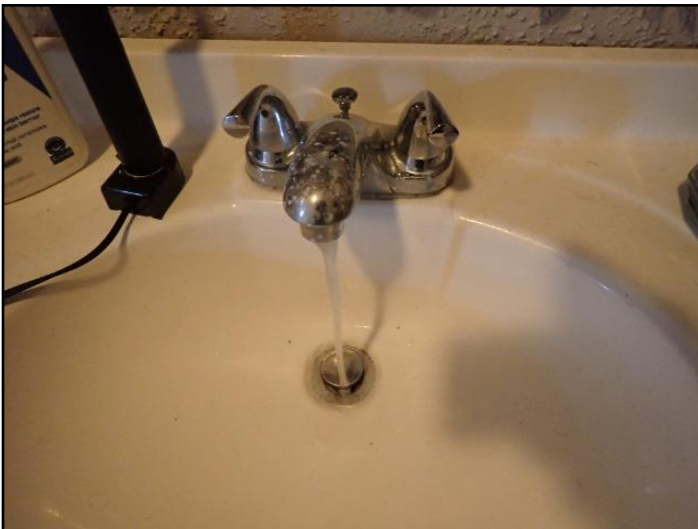
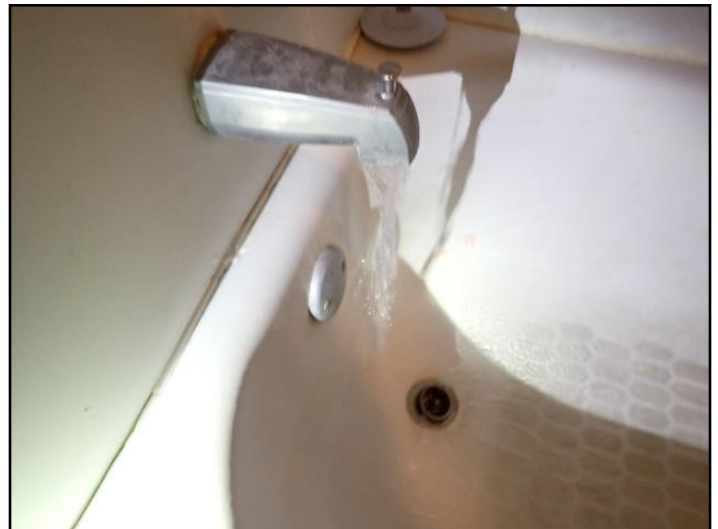
Location: Bathroom Sinks and Bathtubs

Condition: • [Poor pressure or flow](#)

*Poor pressure or flow*

Task: Further Investigation. Repair

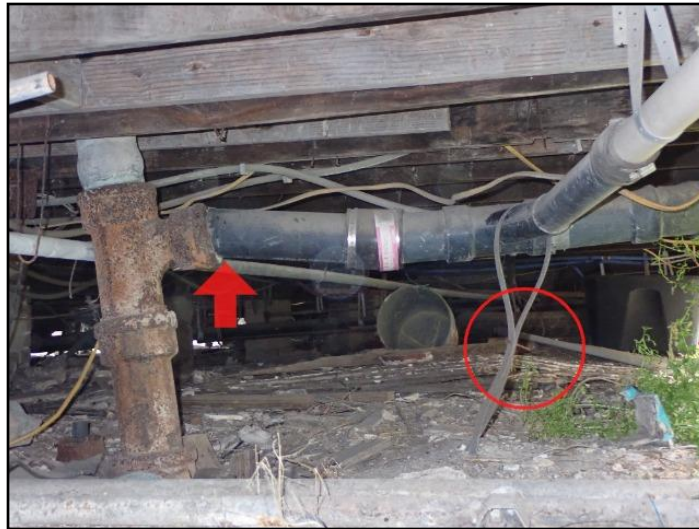
The waste line is poorly supported one strap is damaged. This has caused an uphill slope to form, and a poor connection between the ABS and the cast iron

Poor support

Task: Repair.

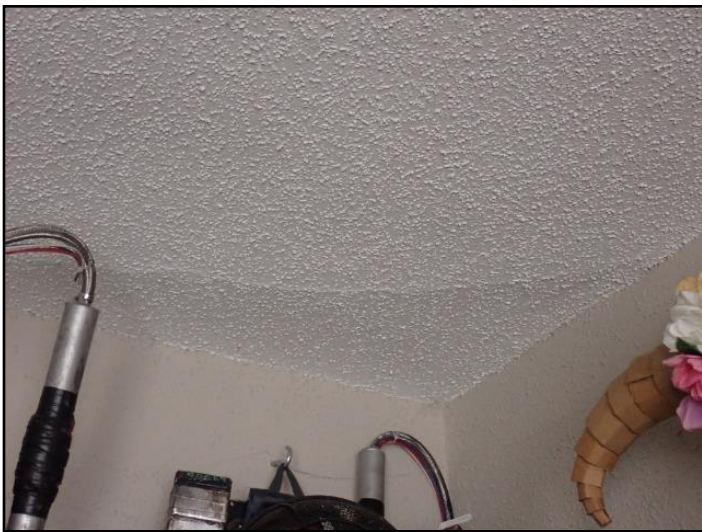
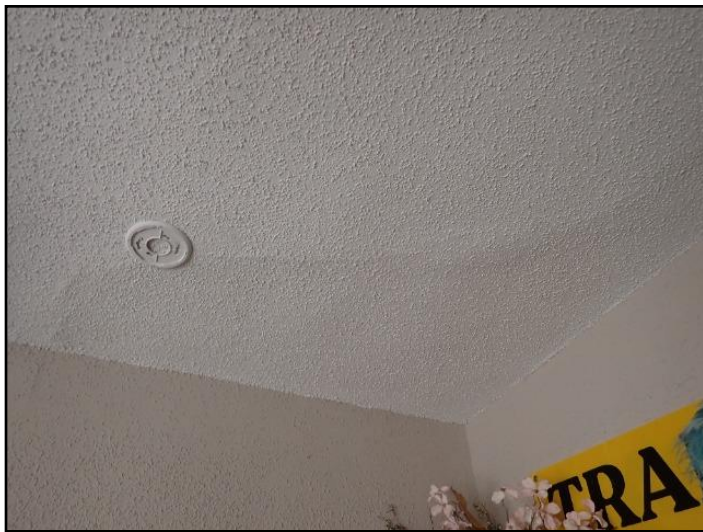
*Patched*

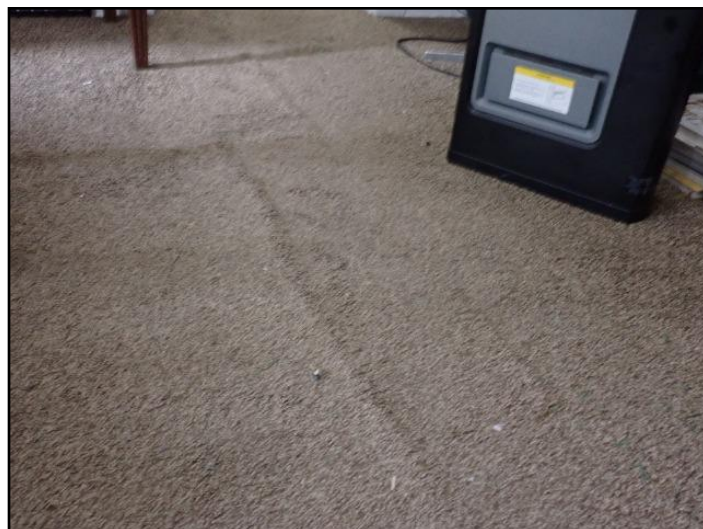
*Buckled*

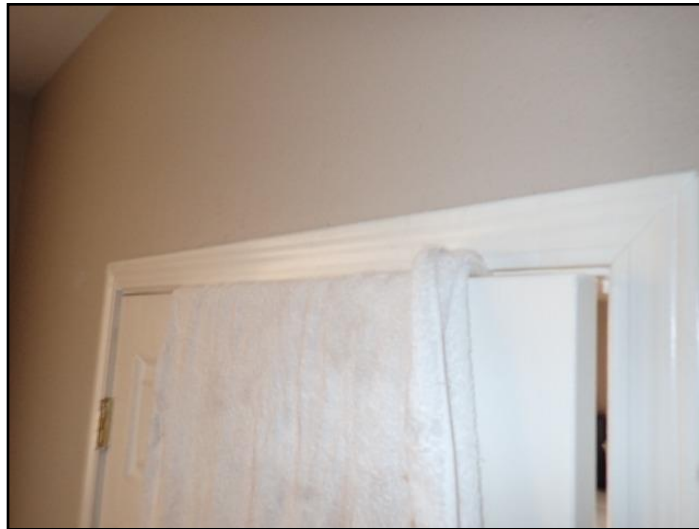
*Does not latch properly*

**Task:** Repair. Adjust

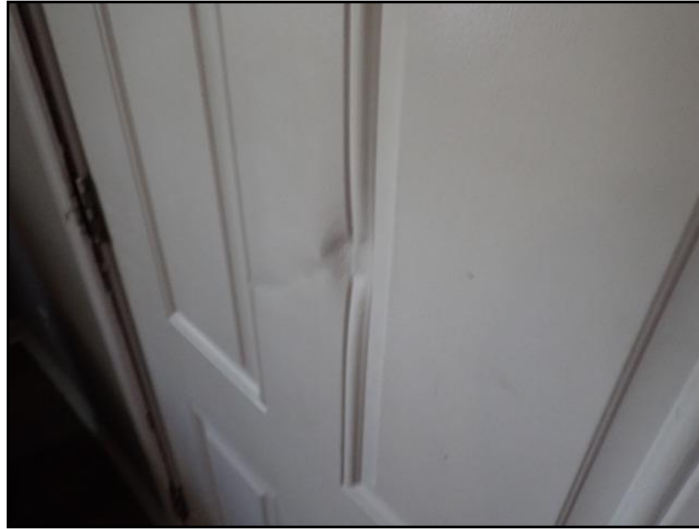
*Dented*

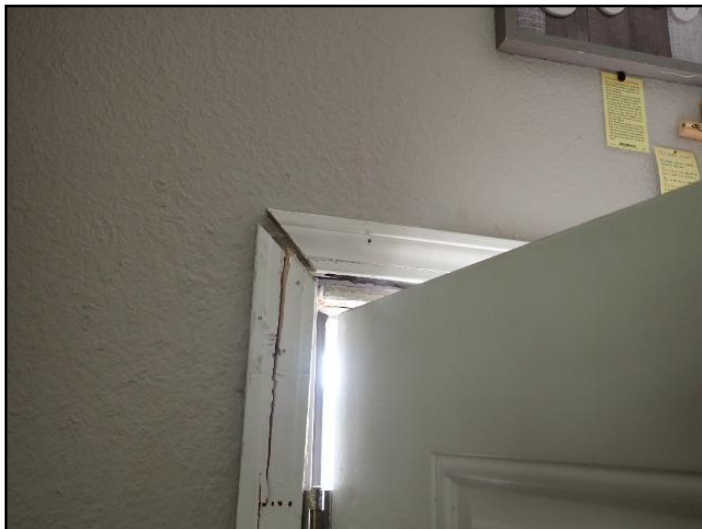
Cracked

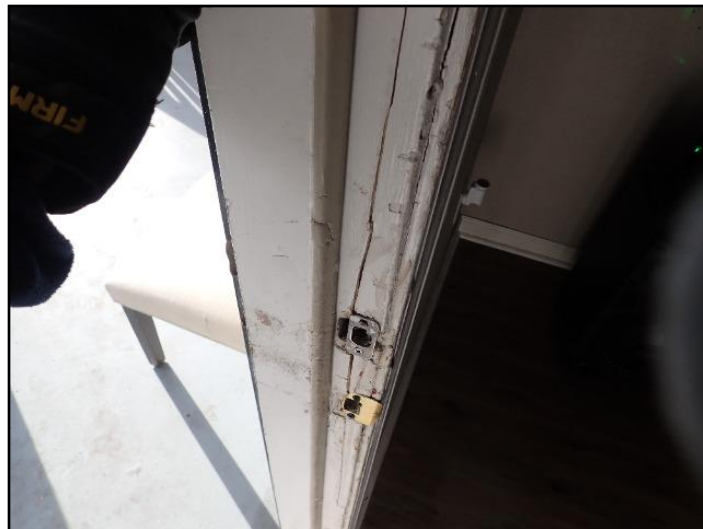
Cracked

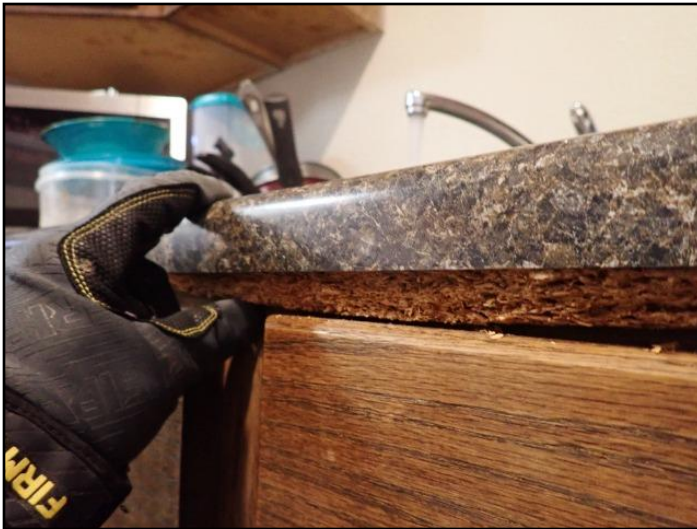
Delaminated particle board under countertop. Countertop was loose.

*Delaminated*

Task: Repair. Replace

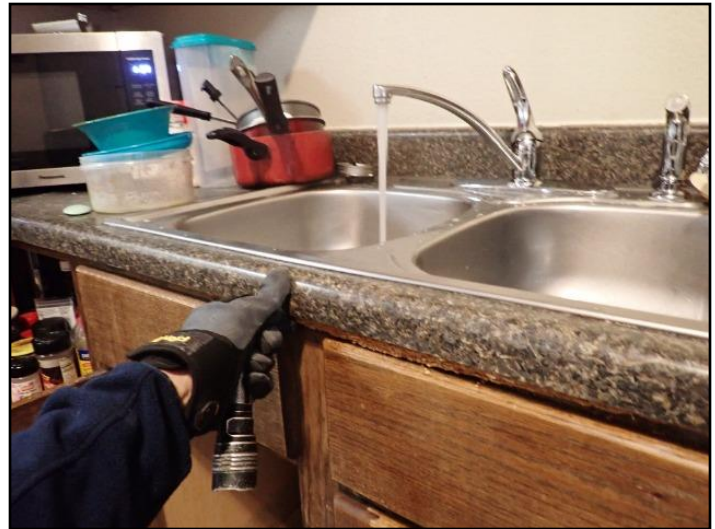
Condition: • [Entire top loose](#)

*Entire top loose*
